FIRST-IN HOME INSPECTION

GENERAL HOME INSPECTION

104 Paw Paw Lake Dr
Chagrin Falls, OH 44022

Mindy Goodin
SEPTEMBER 1, 2022

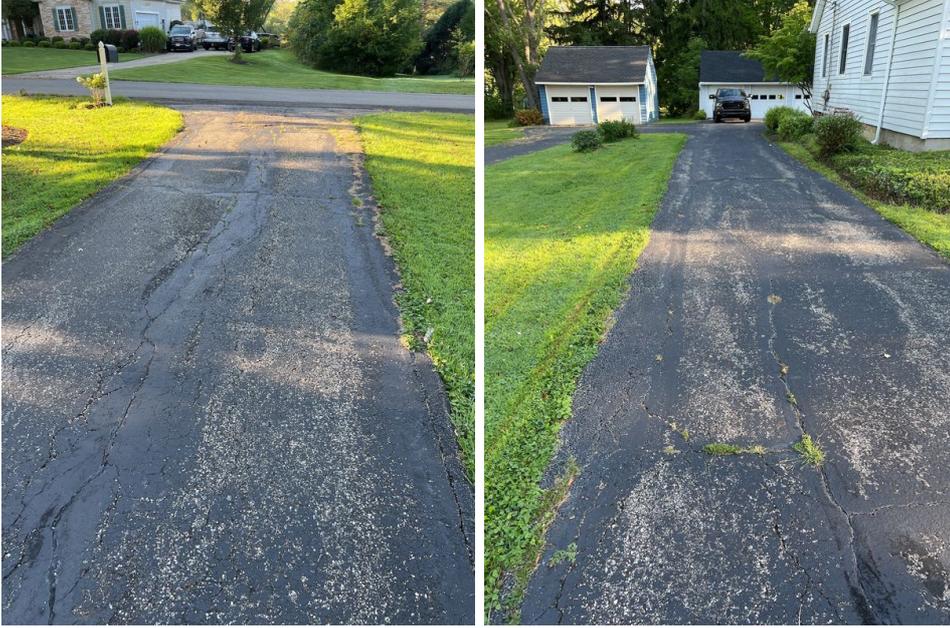
Minor cosmetic cracks present in the driveway. Recommend monitor and/or patch/seal to prevent further damage.

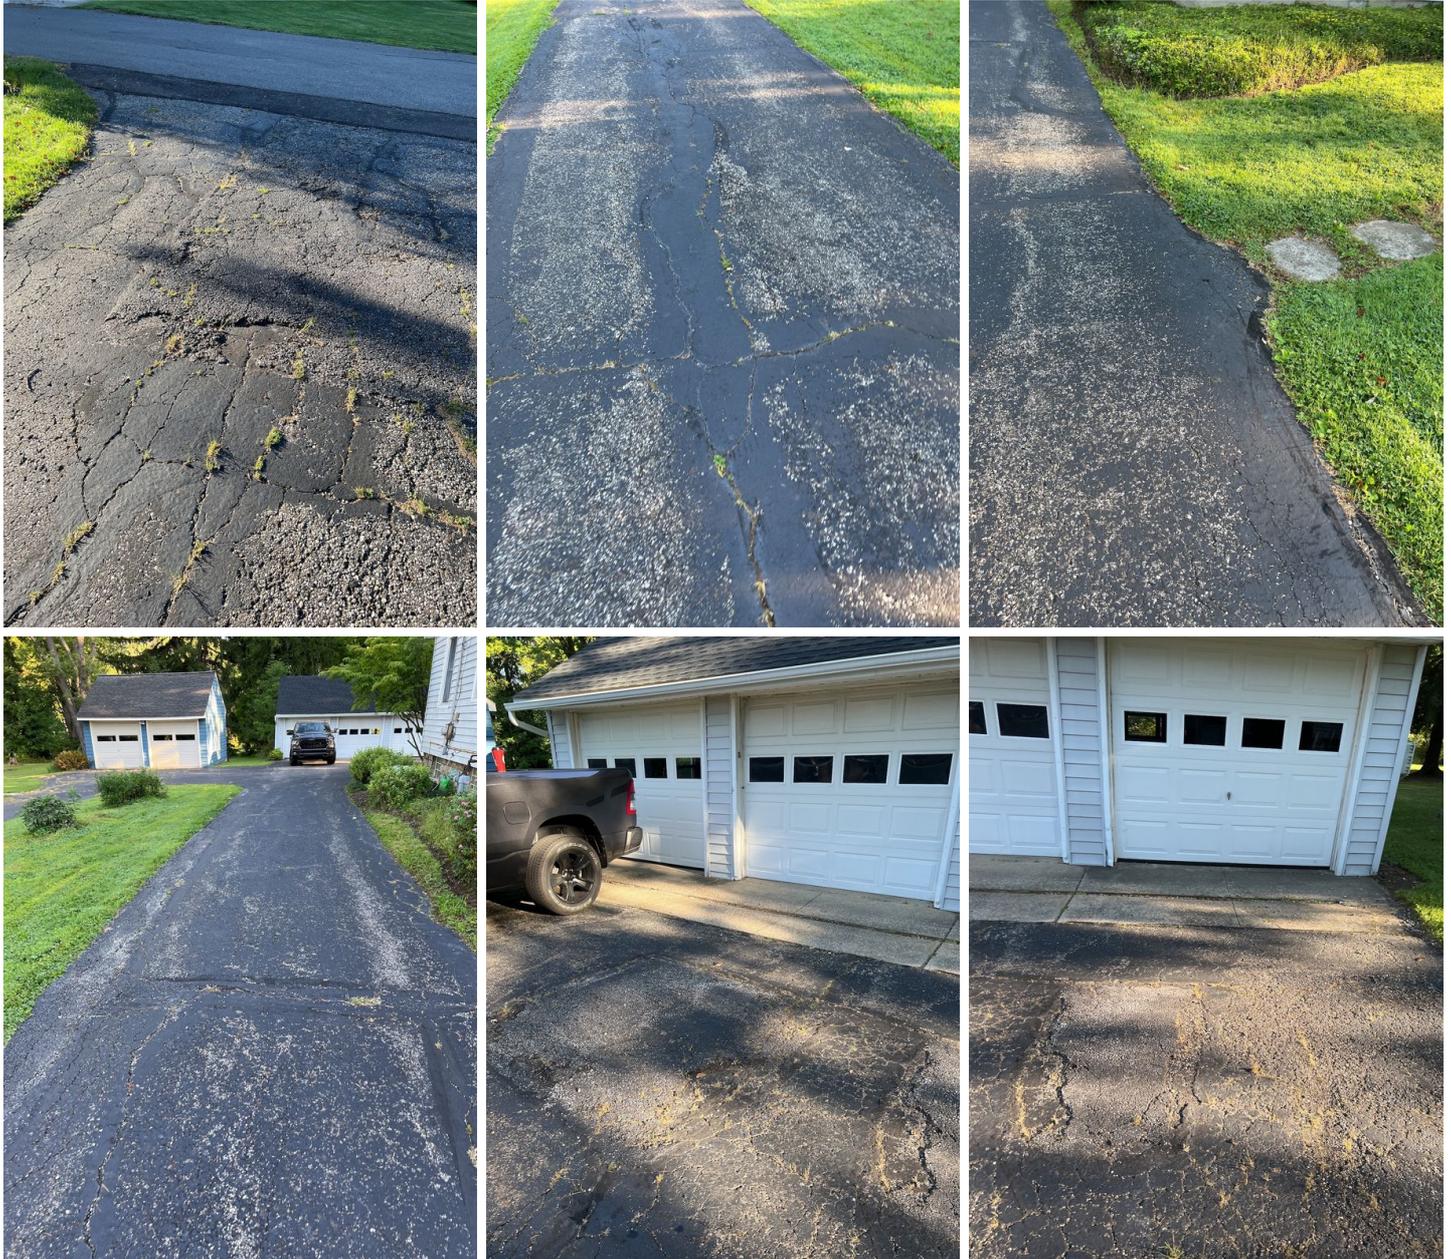
2.1.2 Driveway

Trip hazards in the driveway appeared to be the result of the expansion or contraction (heaving or settling) of underlying soil. This condition should be corrected by a qualified contractor.

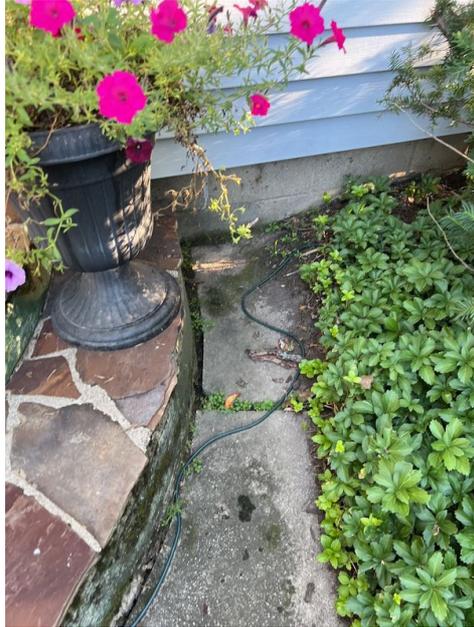
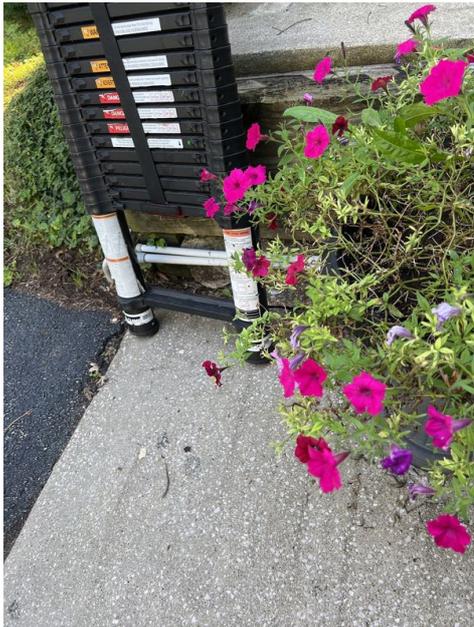
SIDEWALK (SEAL EXTERIOR WALL)

The joint at which the sidewalk met the exterior walls was not sealed. Saturation of soil near the foundation can lead to moisture intrusion. The Inspector recommends that the joint at which the driveway met the exterior walls should be protected by a sealant that will need to be maintained.

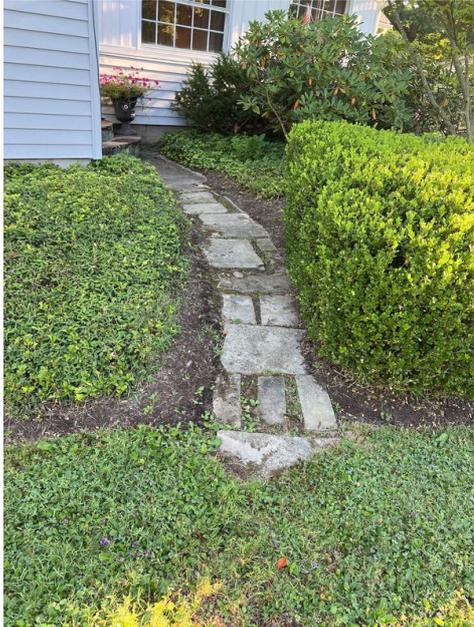
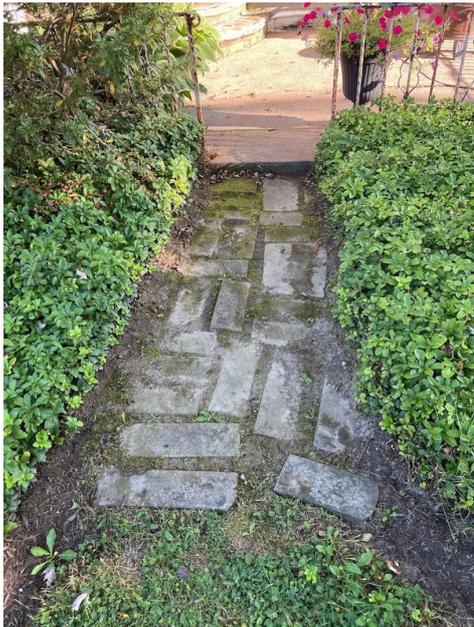
2.2.2 Sidewalk/Walkway

UNEVEN

Areas of the sidewalk were uneven. This could pose a trip and fall hazard. Recommend leveling the sidewalk.

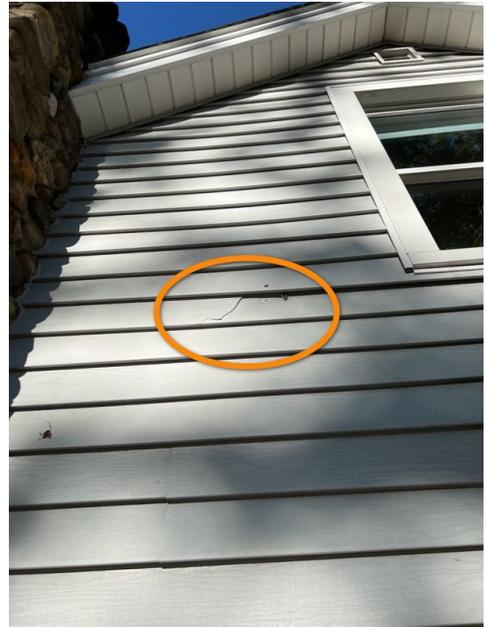
2.3.1 Siding & Trim

SIDING/TRIM (DAMAGED)

Moderate Defects

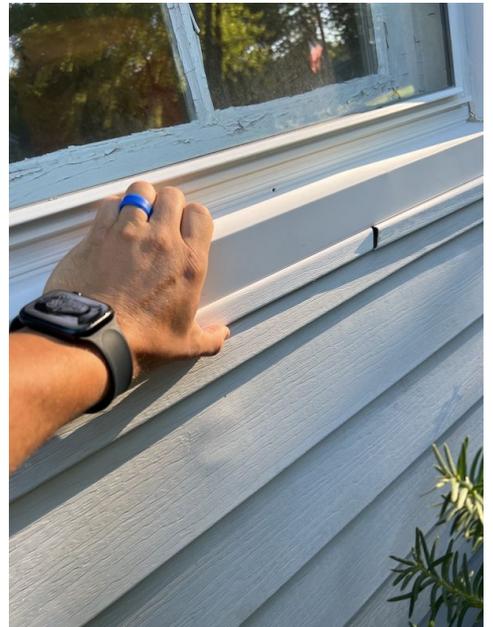
2.3.2 Siding & Trim

SIDING/TRIM (LOOSE AREAS)

Moderate Defects

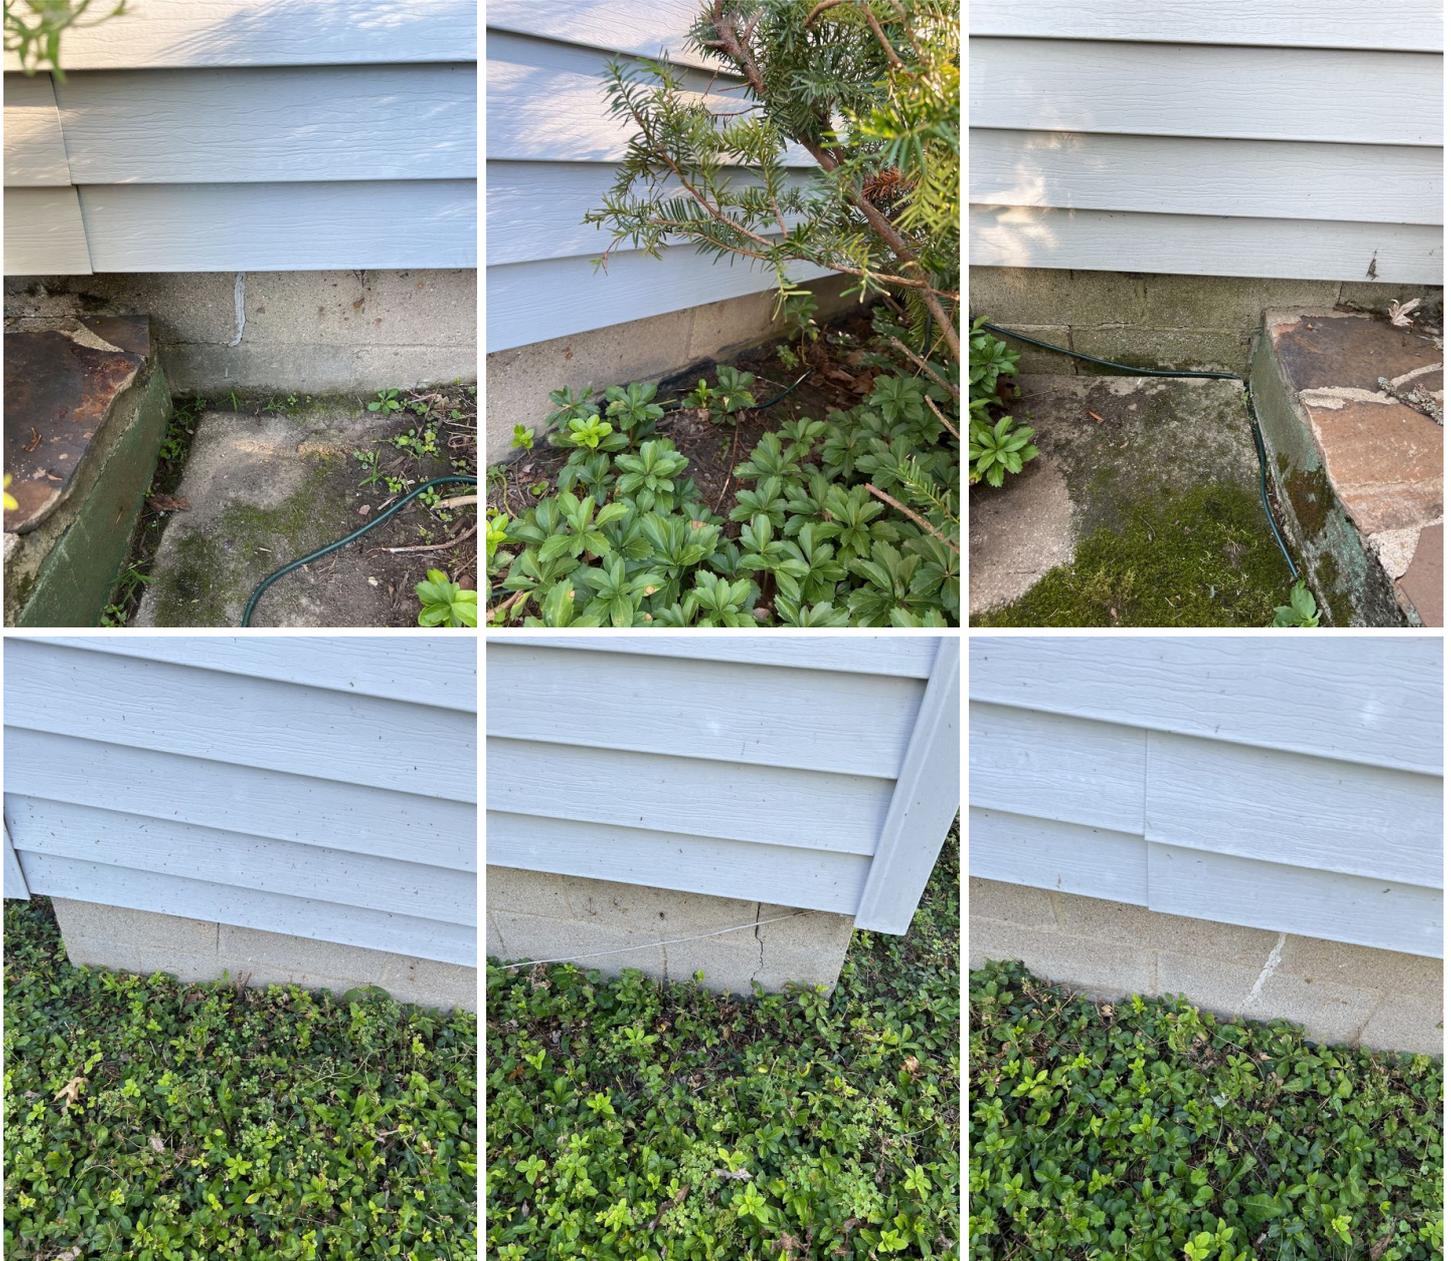
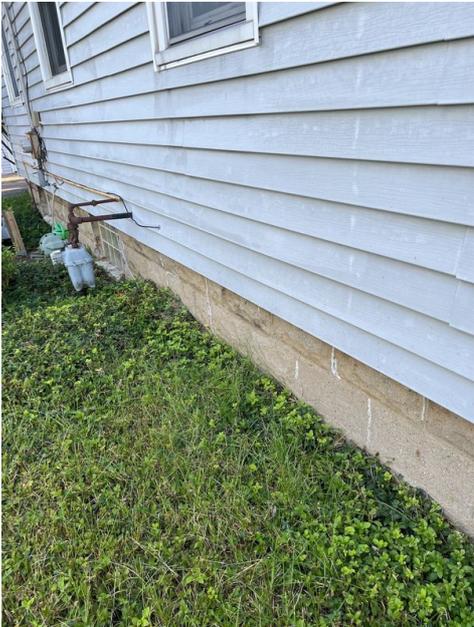
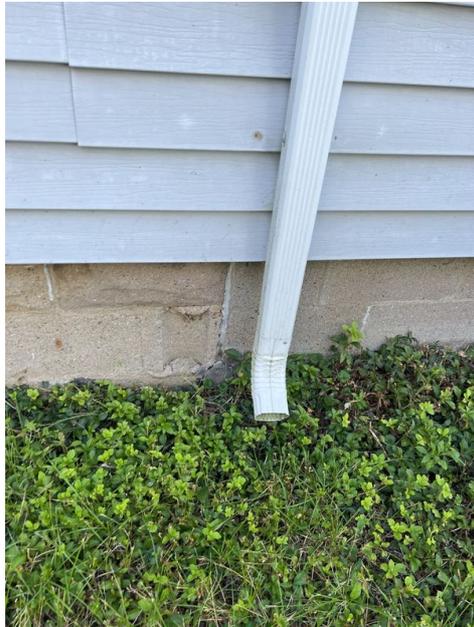
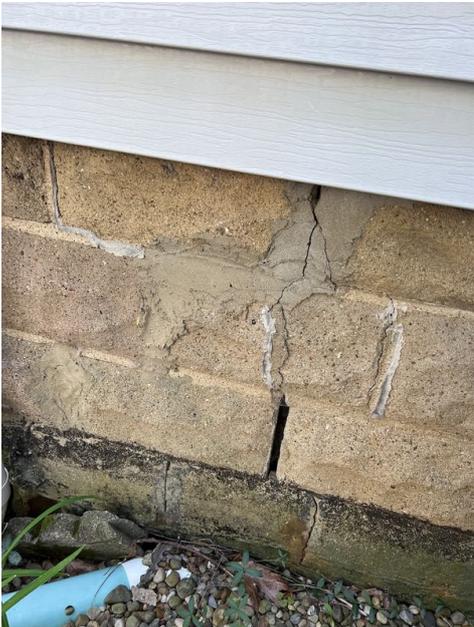
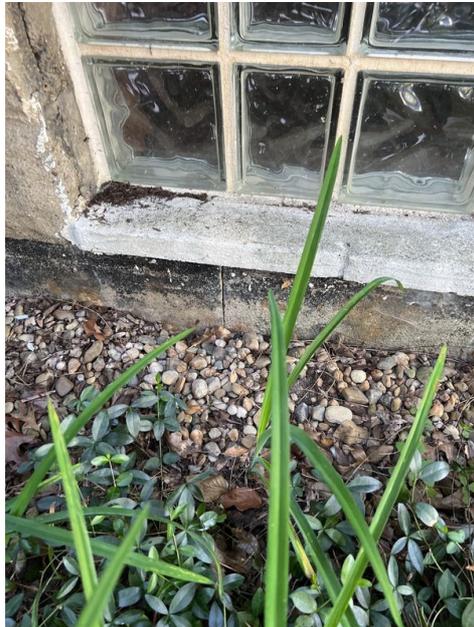
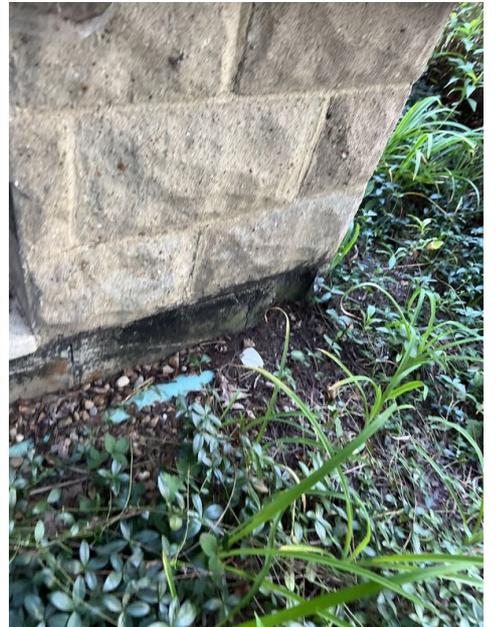
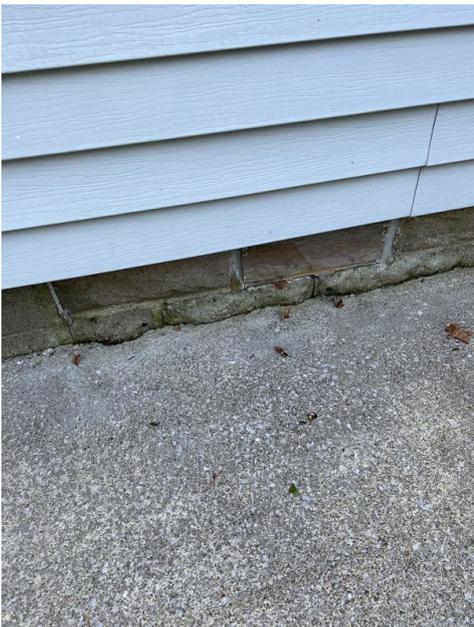
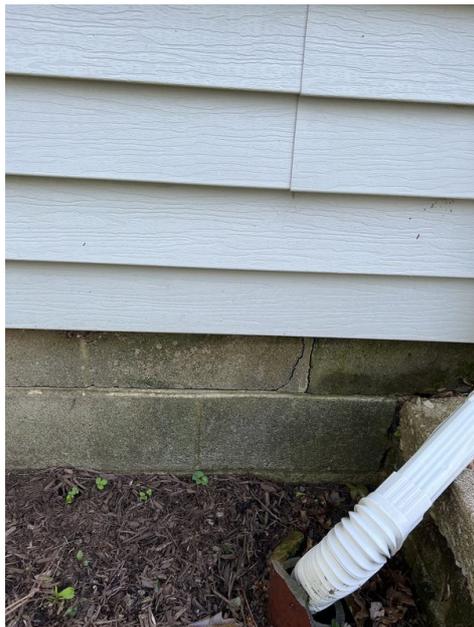
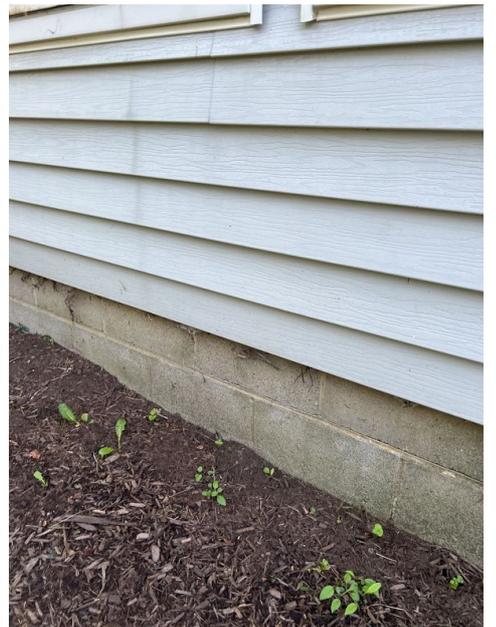
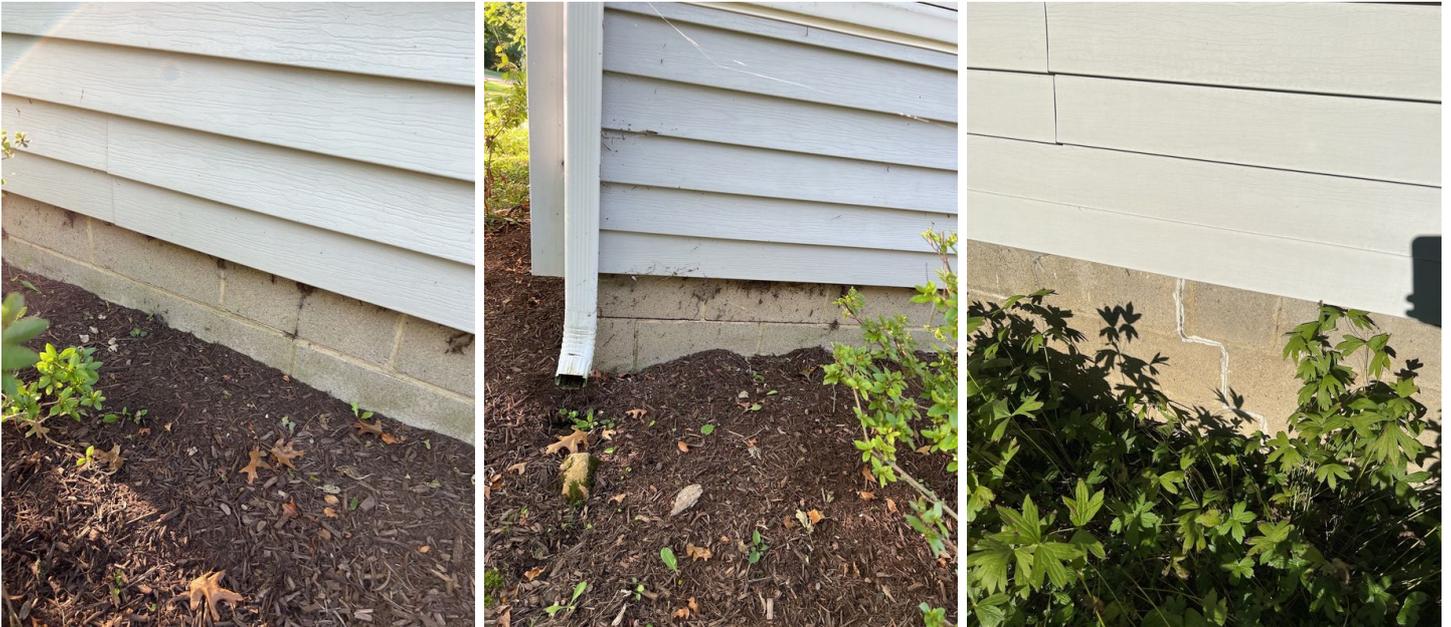
2.3.3 Siding & Trim

Moderate Defects

SIDING/FOUNDATION (TUCK POINTING)

Exterior brick, stone or concrete block has loose mortar joints/cracks. Recommend evaluation and repairs as needed by a qualified mason contractor.

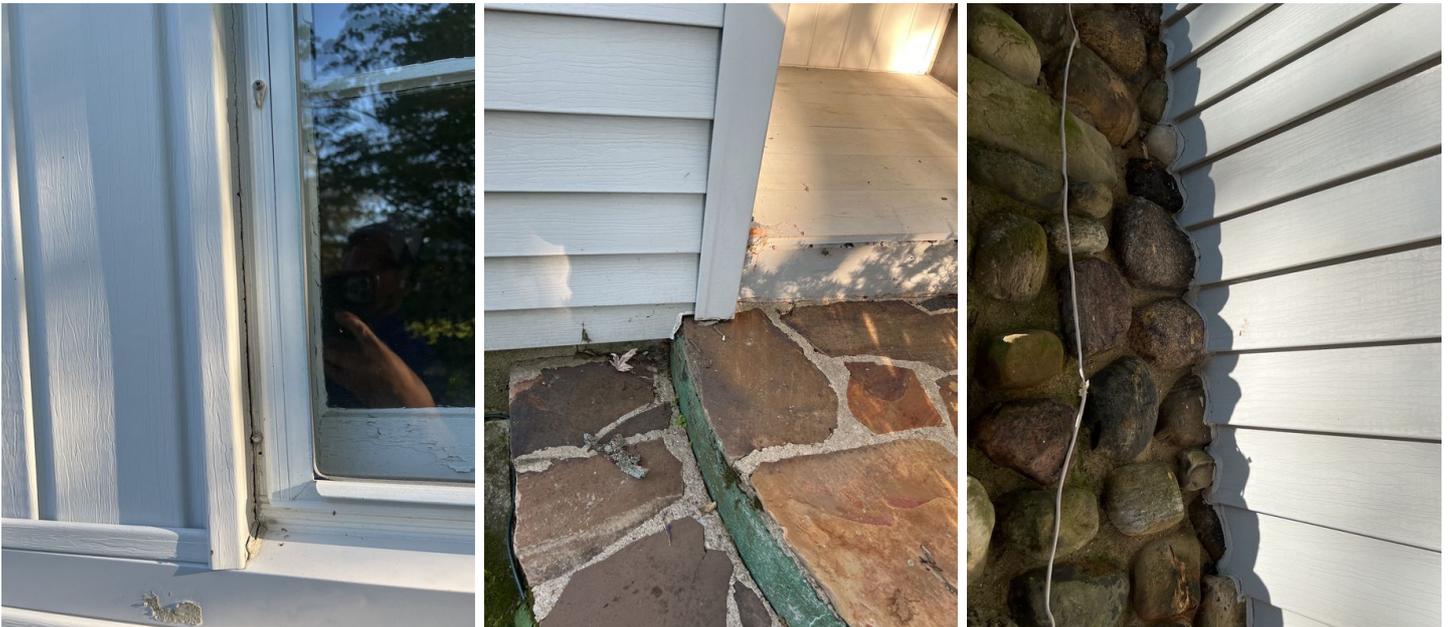
2.3.4 Siding & Trim

SIDING/TRIM (CRACKED/DRIED/MISSING CAULKING)

One or more areas around windows, doors or trim showed signs of dried/cracked/missing caulking. Recommend sealing with fresh caulk to prevent possible moisture and/or pest intrusion.

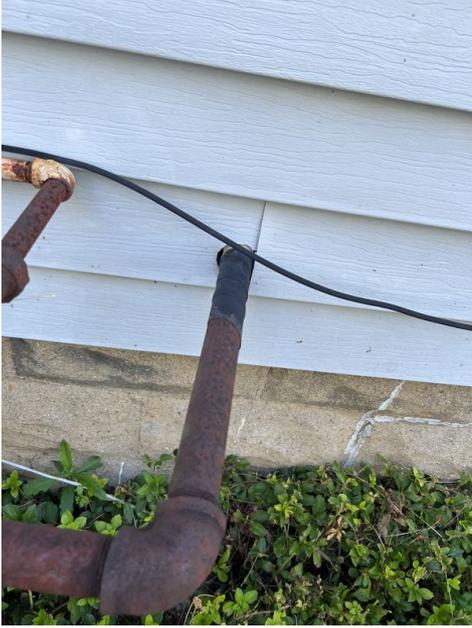
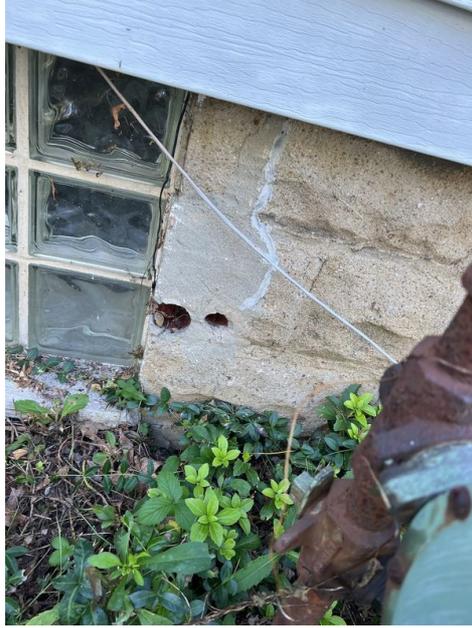
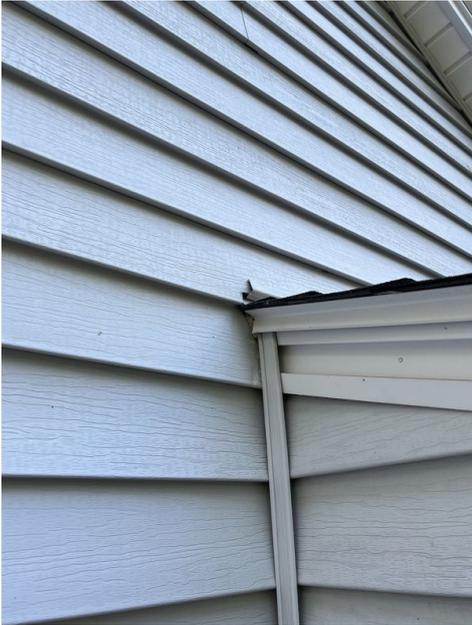
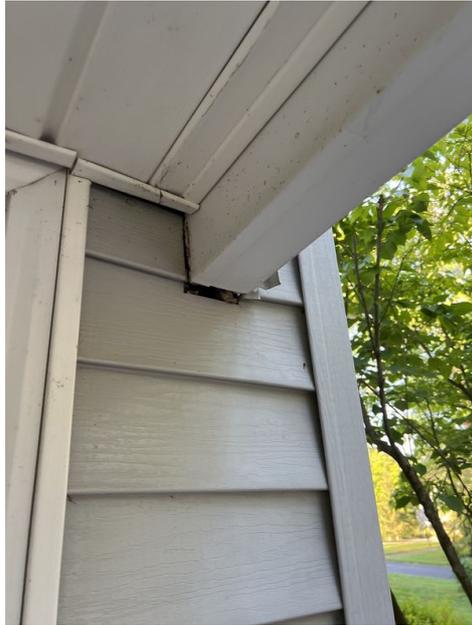
Minor Defects/Maintenance Items/FYI

There are gaps or holes present at siding/trim in one or more areas of the structure. Recommend sealing or repairing siding/trim to prevent moisture and/or pest intrusion.

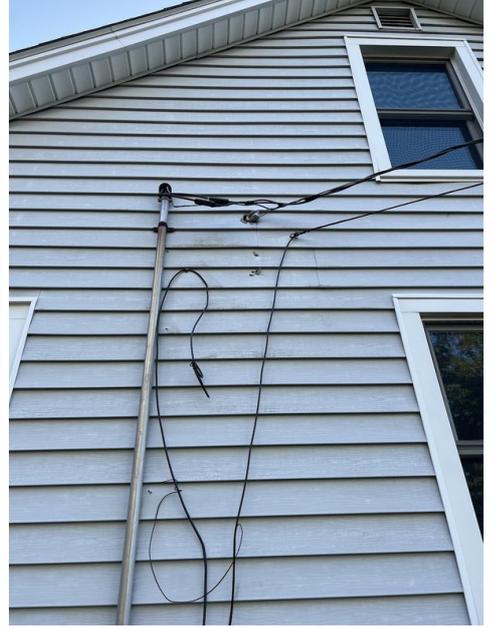
2.3.6 Siding & Trim

SIDING/TRIM (GAPS/HOLES)

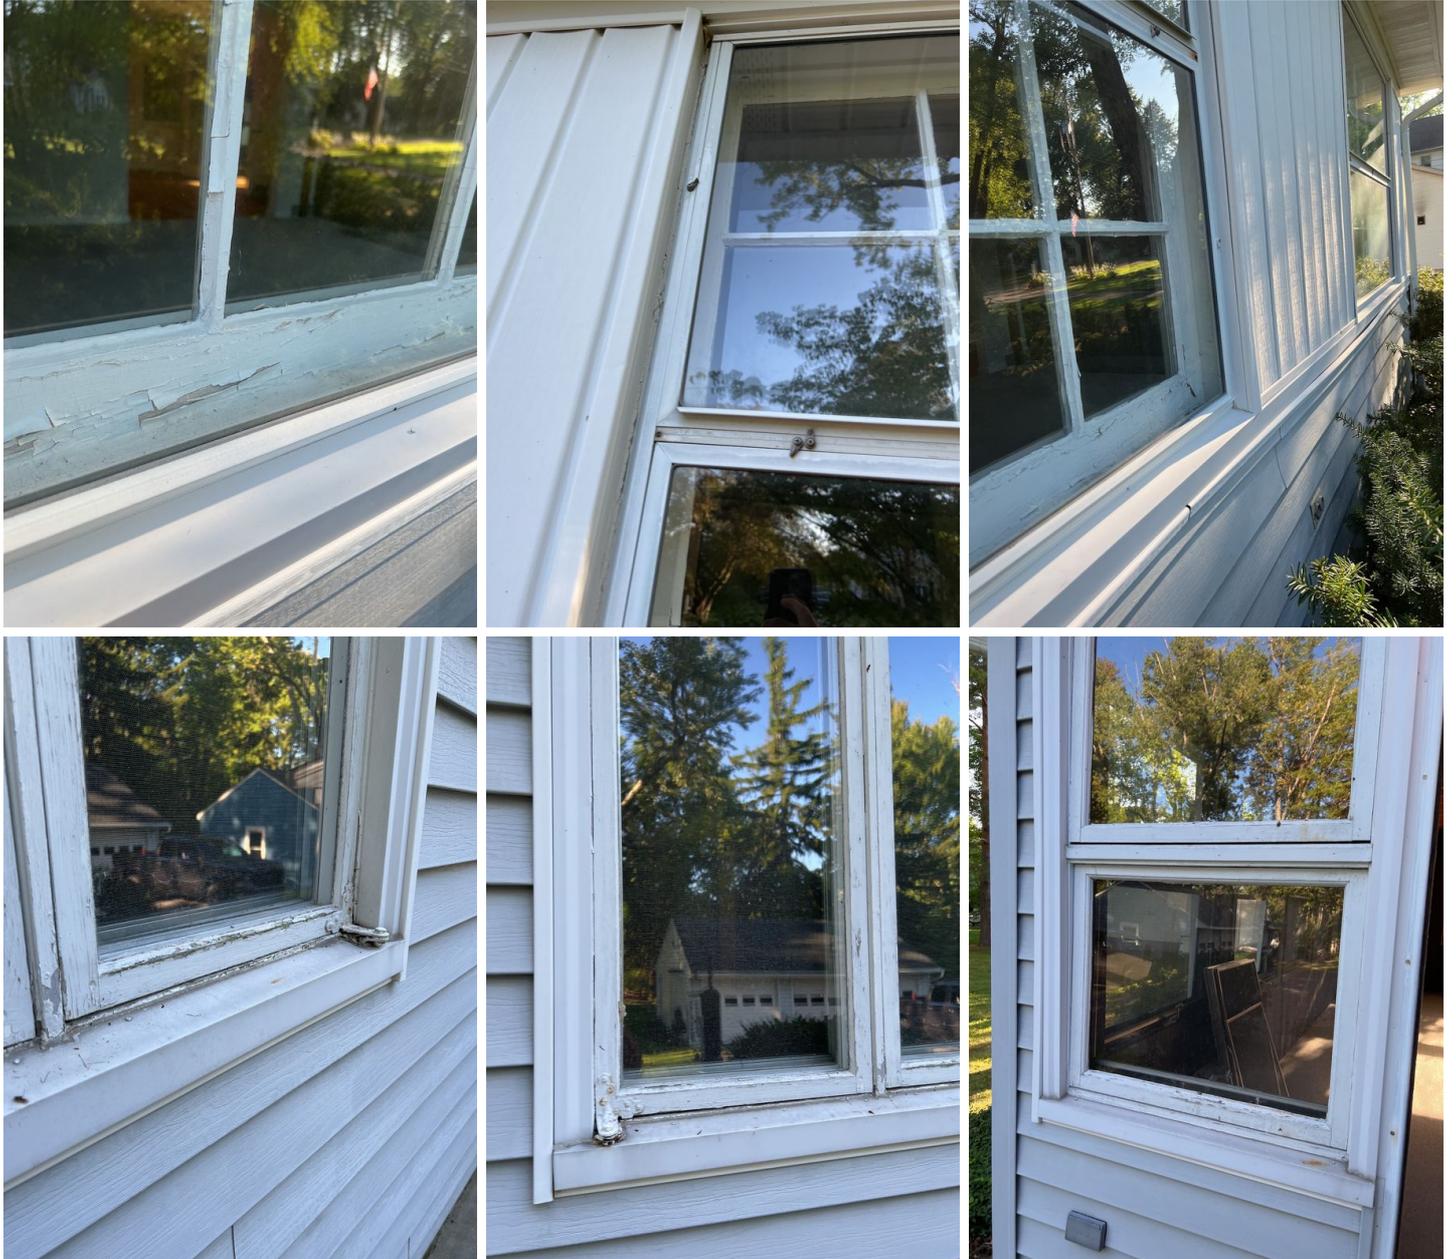
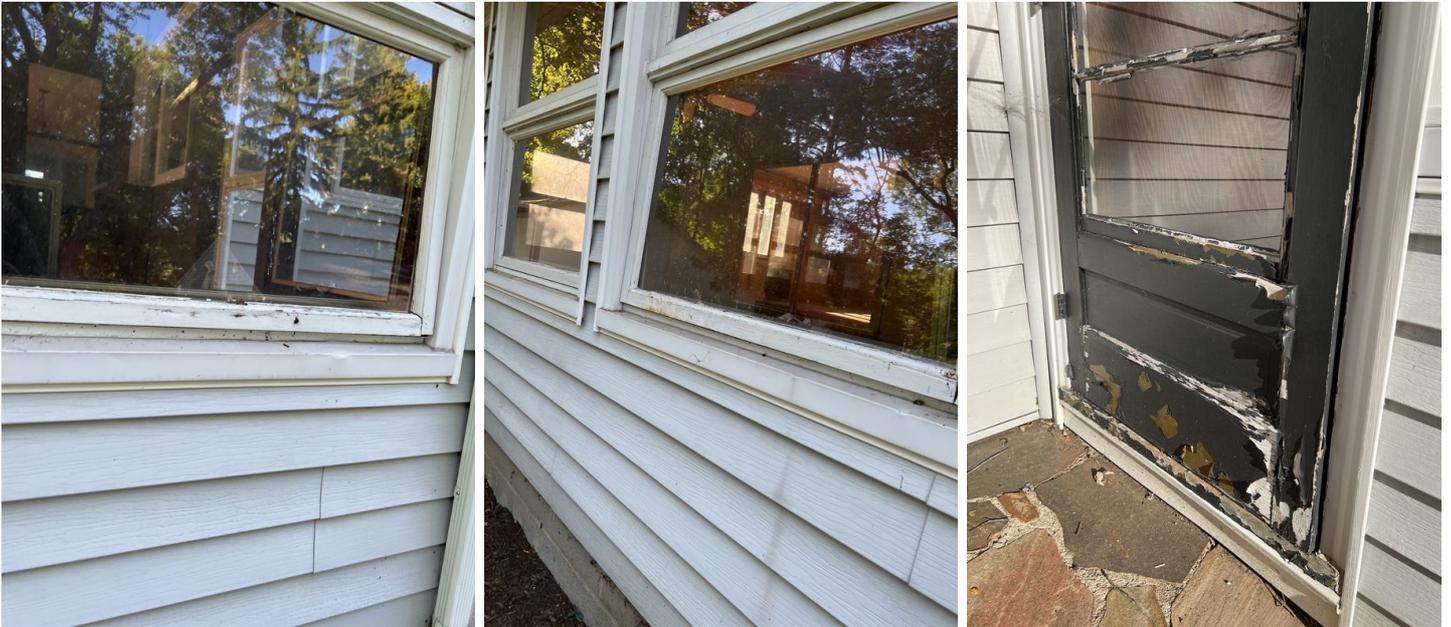
2.3.7 Siding & Trim

SIDING/TRIM (FLAKING PAINT)

One or more areas of the exterior showed signs of flaking paint. Recommend fresh paint in these areas to prevent wood rot.

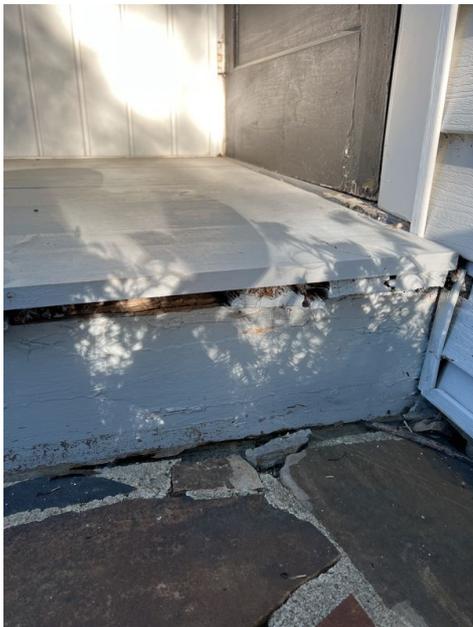
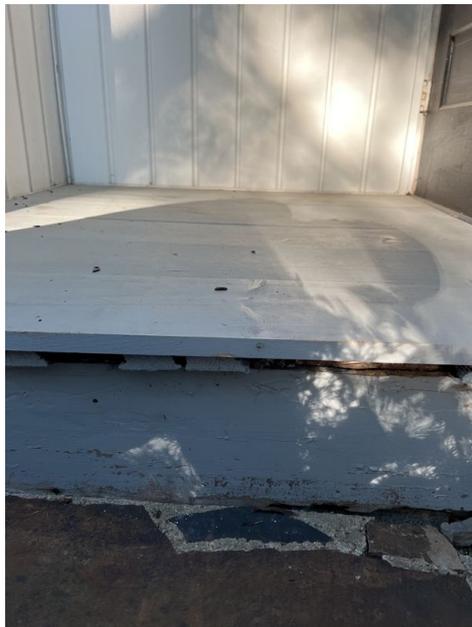
2.4.2 Porches, Decks & Balconies

PORCH/DECK (DAMAGED/LOOSE BOARDS)

One or more porch/deck boards were observed to be damaged or loose. Recommend they be refastened.

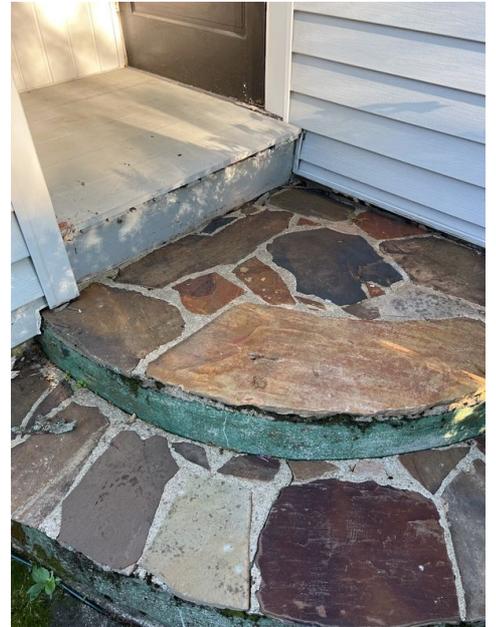
2.4.3 Porches, Decks & Balconies

SETTLED TOWARDS HOUSE

The porch settled and is pitched towards the house which can lead to increased water at or around the foundation. Recommend leveling to help manage water flow away from the structure. All evaluations and repairs should be completed by a qualified contractor.

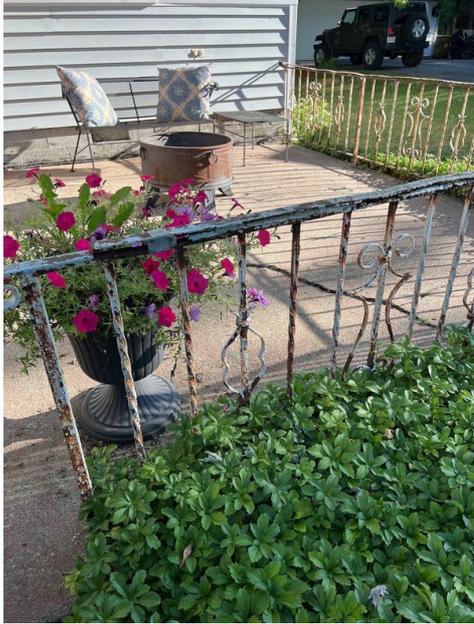
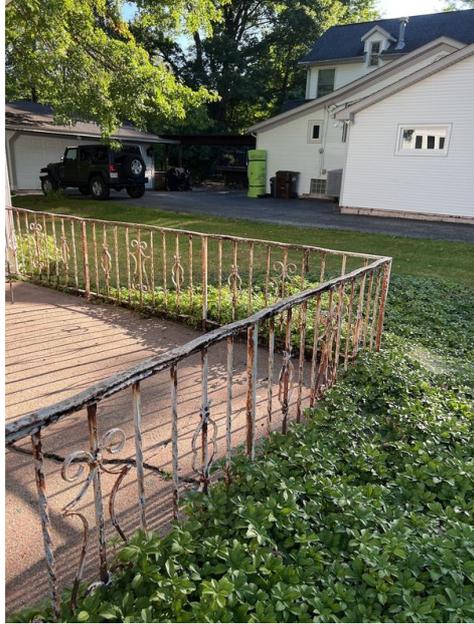
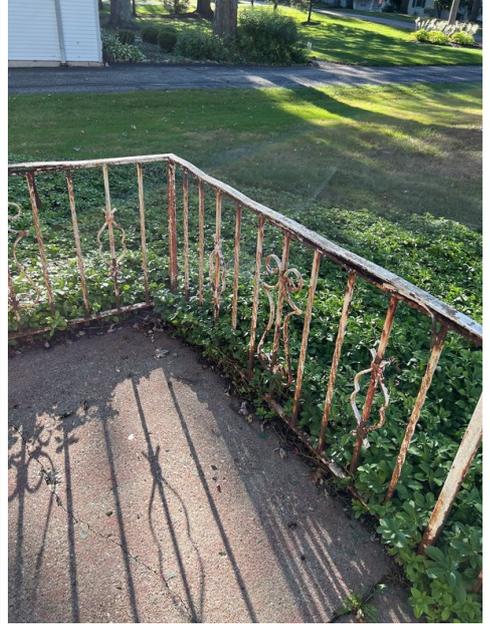
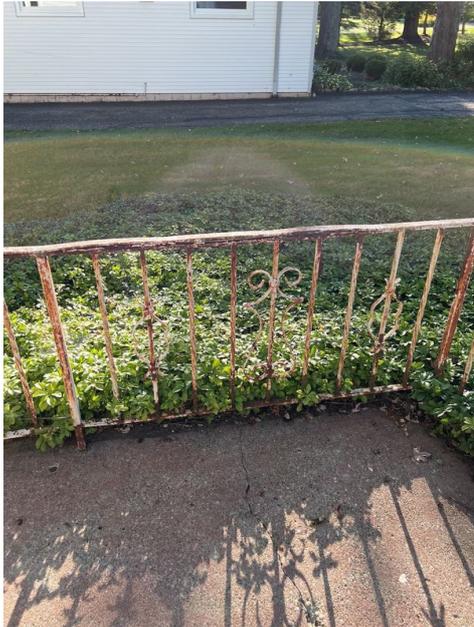
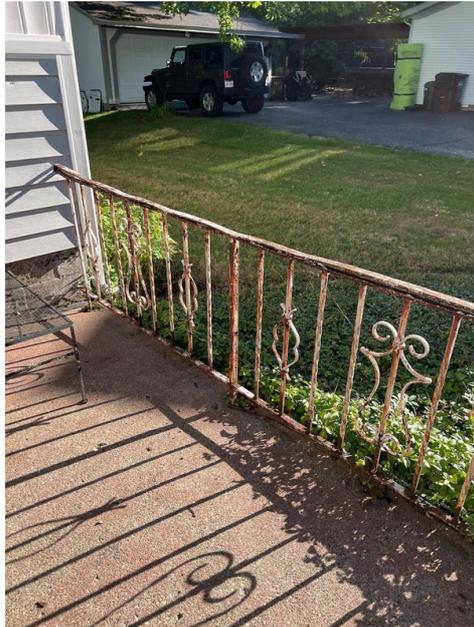
2.4.4 Porches, Decks & Balconies

GUARDRAIL (SEVERE DETERIORATION)

At the time of the inspection, the deck guardrail assemblies exhibited severe deterioration. The Inspector recommends that before the expiration of your Inspection Objection Deadline you consult with a qualified contractor to gain an idea of options and costs for repair or replacement.

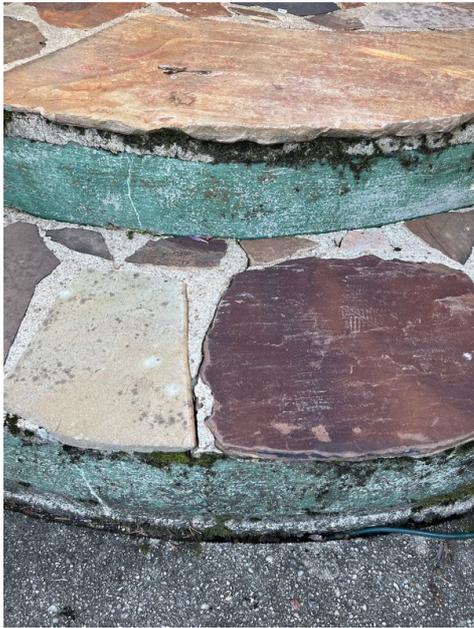
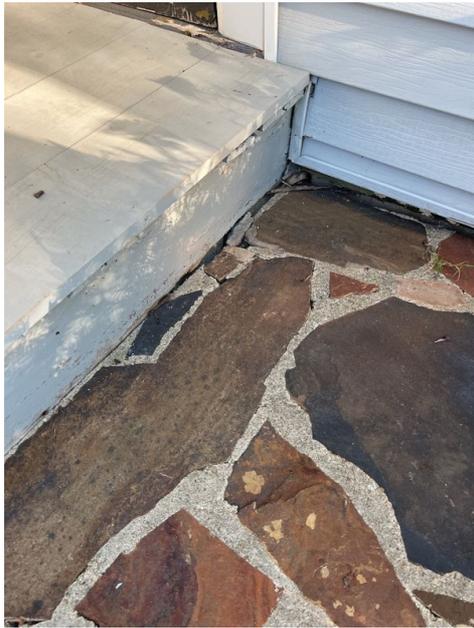
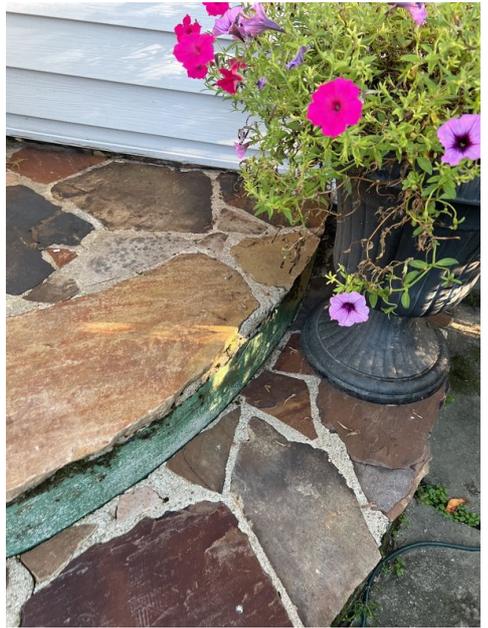
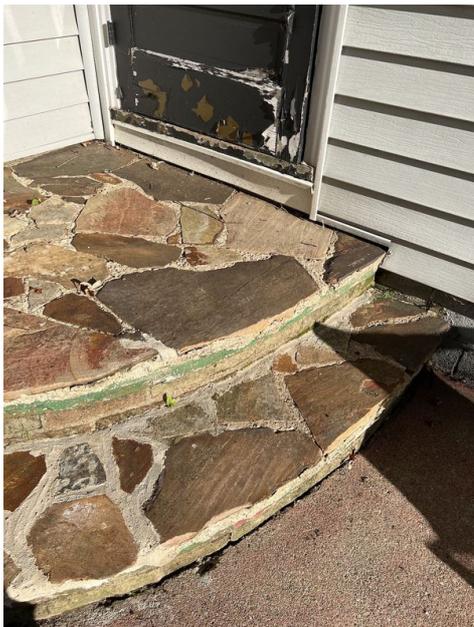
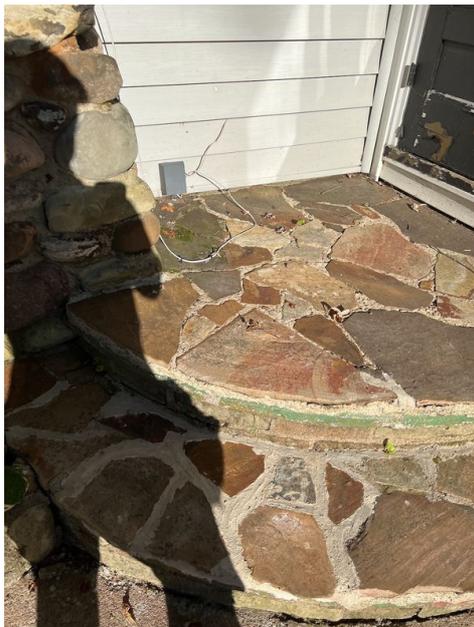
2.5.1 Patios

TUCK POINTING

Recommend tuck pointing exterior brick/block to prevent moisture and pest intrusion.

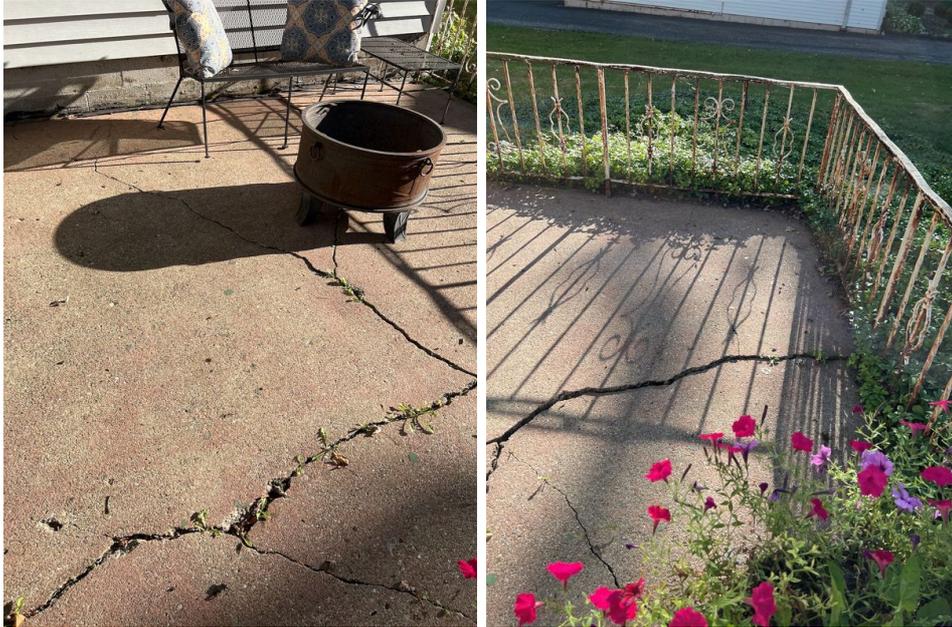
The patio surface had moderate cracking visible at the time of the inspection. Cracks should be filled with an appropriate material to help prevent continued deterioration.

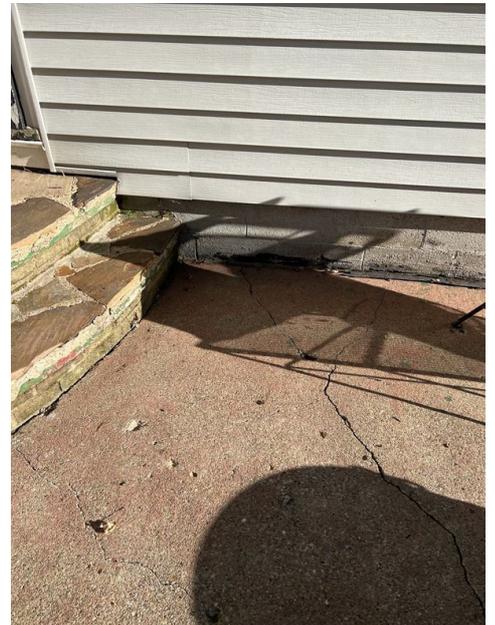
2.5.2 Patios

The patio has settled and is pitched towards the structure. Recommend lifting the patio back into place to help manage the flow of surface water away from the house.

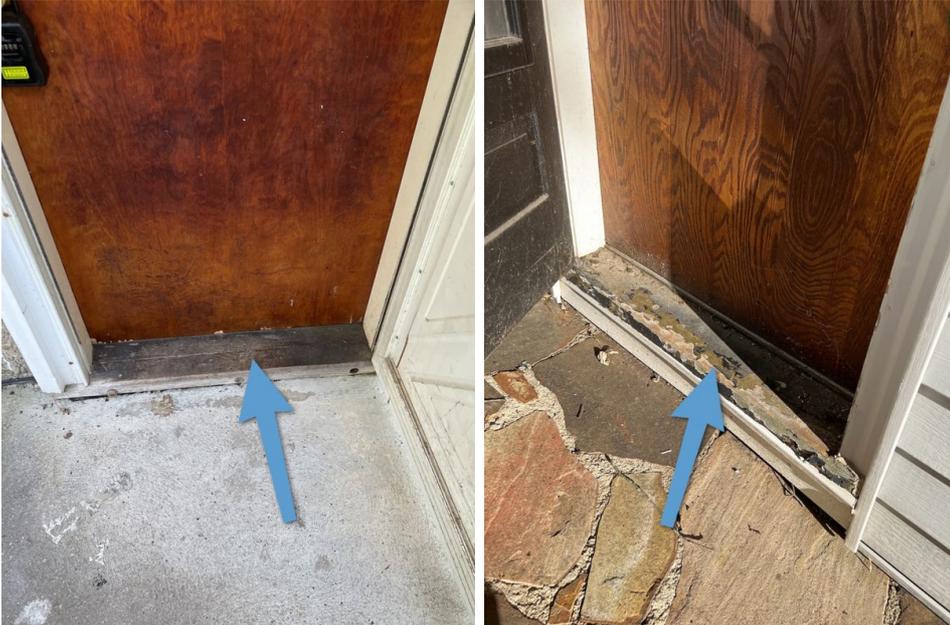
2.6.1 Exterior Doors

The threshold at an exterior door was showing signs of weathering and deterioration and needs fresh paint.

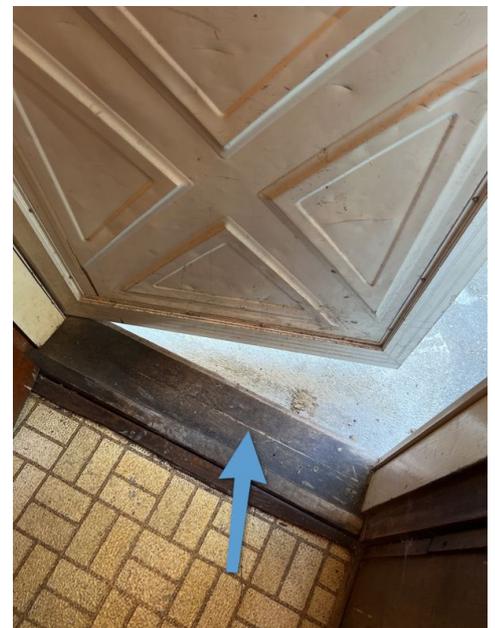
2.6.2 Exterior Doors

The threshold was loose and needs secured.

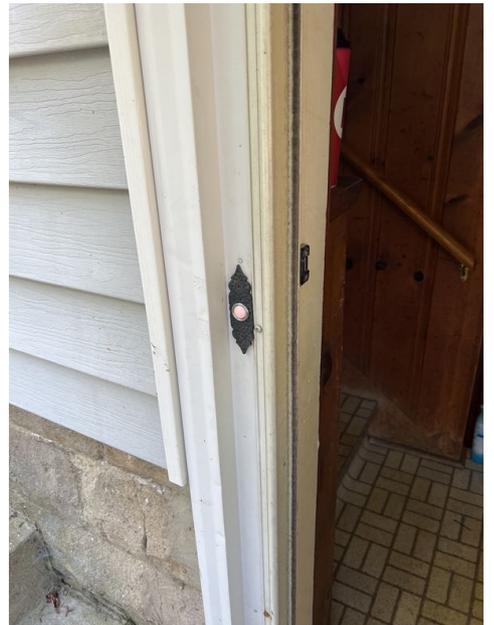
2.9.2 Electrical

**GFCI MISSING**

Modern building standards require GFCI protection at ALL kitchens, bathrooms, laundry areas, garages, and exterior areas. One or more locations at this property were noted as not having GFCI protection or the inspector was unable to verify if GFCI protection existed at these locations. Adoption of GFCI outlets was generally phased in over numerous years/decades. Recommend client evaluate upgrading these areas to GFCI protection at their discretion.

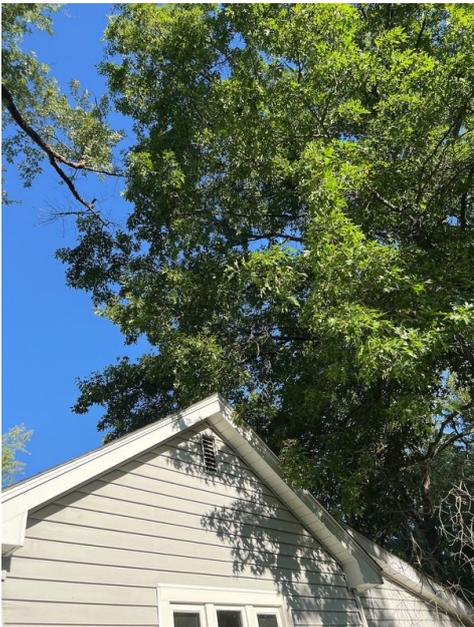
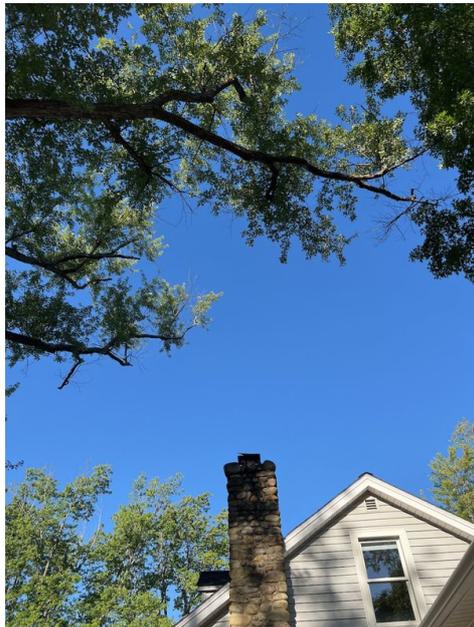
2.11.2 Vegetation

DENSE VEGETATION

Dense vegetation prevented portions of the homes exterior from being inspected.

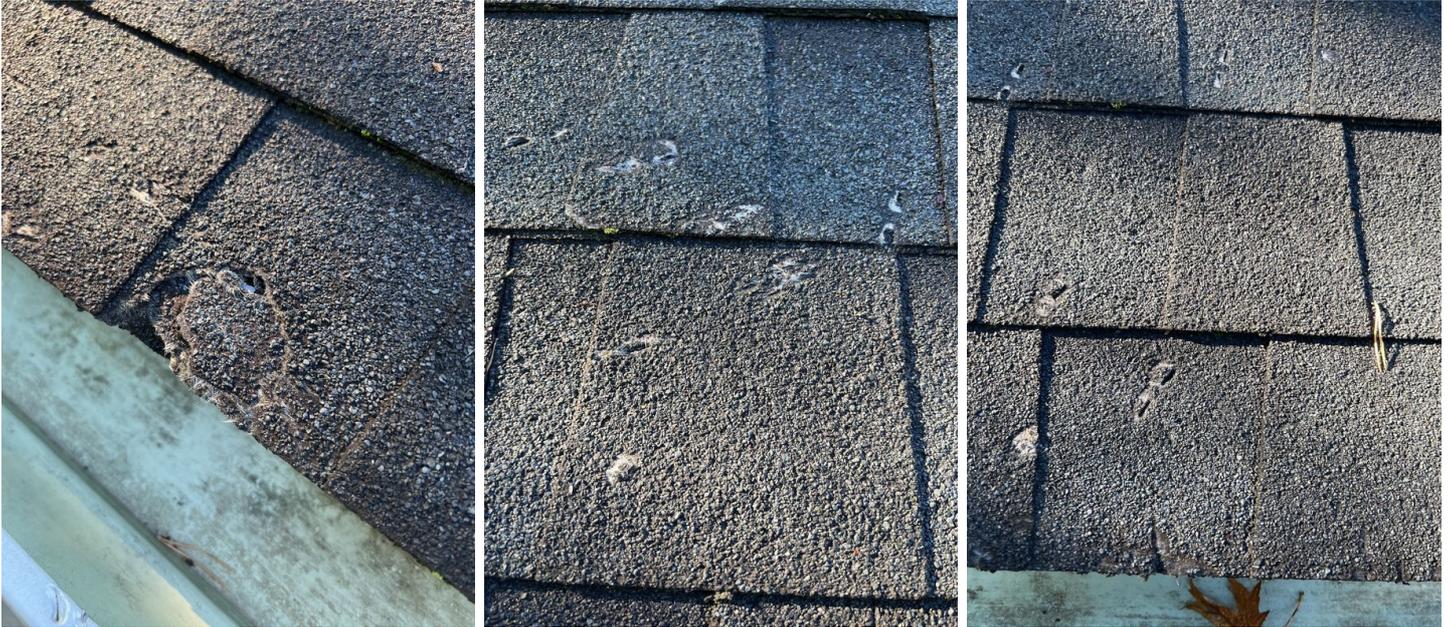
Roof coverings exhibited general damage that could affect performance. Recommend a qualified roofer evaluate and repair.
