FIRST-IN HOME INSPECTION

GENERAL HOME INSPECTION

104 Paw Paw Lake Dr
Chagrin Falls, OH 44022

Mindy Goodin
SEPTEMBER 1, 2022

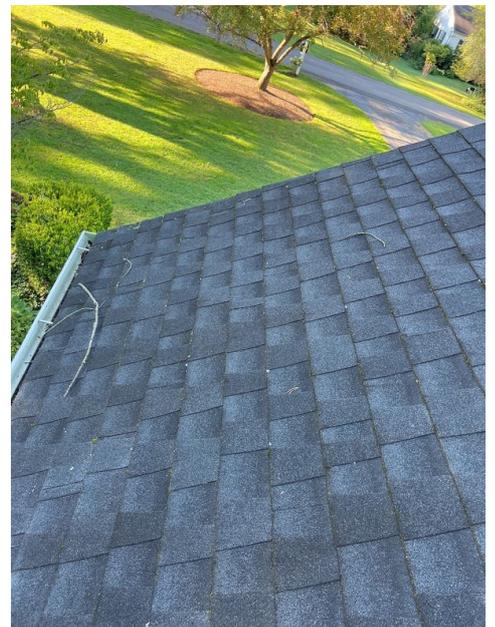
3.2.2 Shingles

Moss build up on the roof usually results from excessive shade and can lead to shortened roof life and increased risk of leaks.

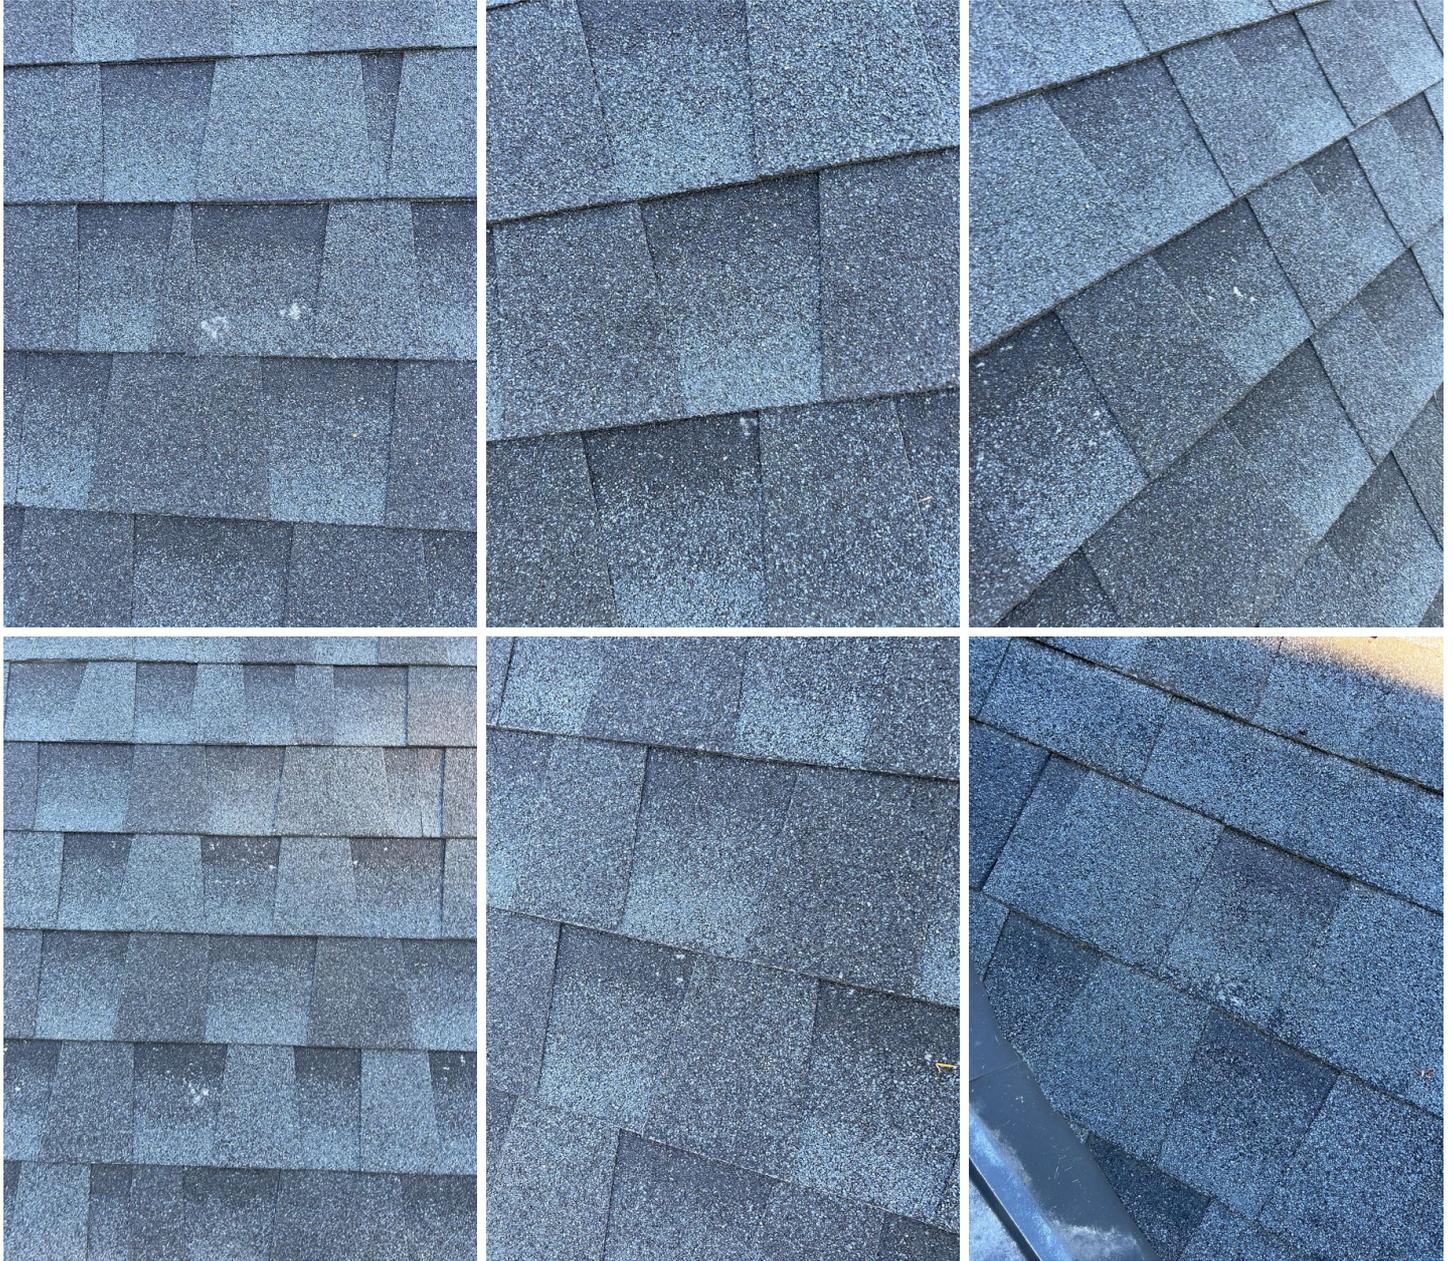
3.2.3 Shingles

Shingles in one area or more showed signs of aging such as granule loss or cupping and curling. The roof appeared to be fully functional at the time of the inspection. Recommend monitor and repair as needed.

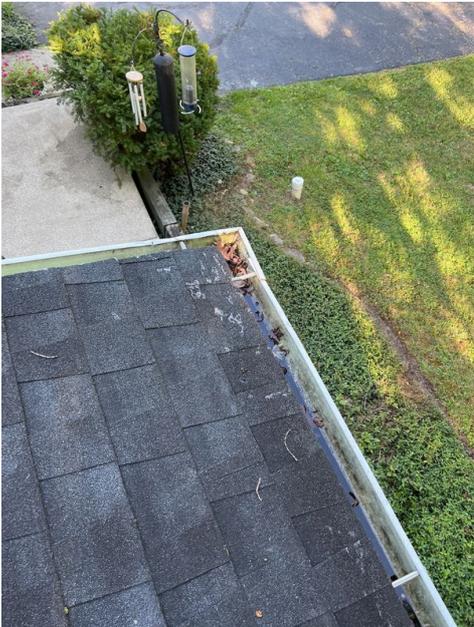
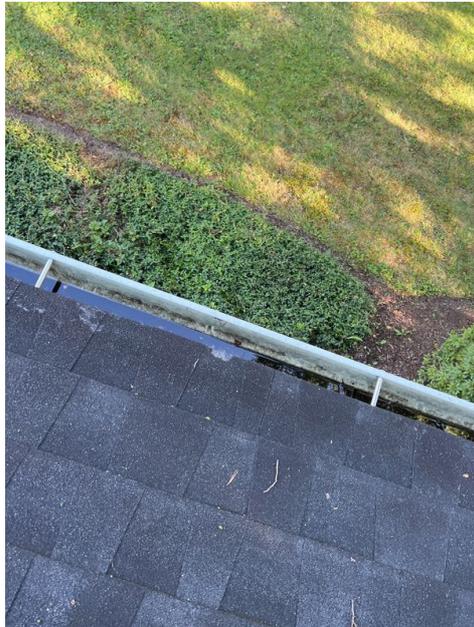
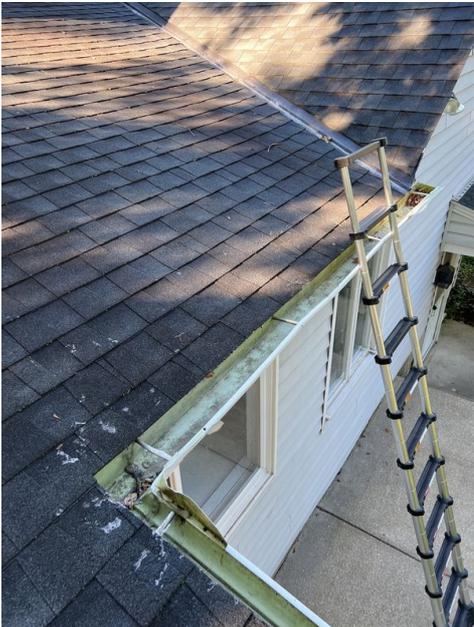
WORN SHINGLES

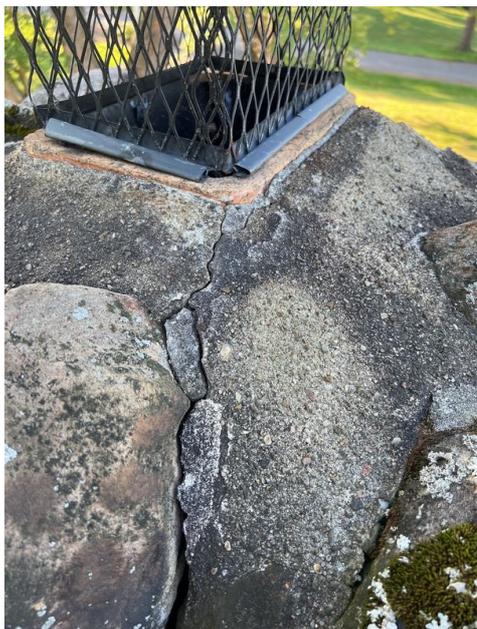
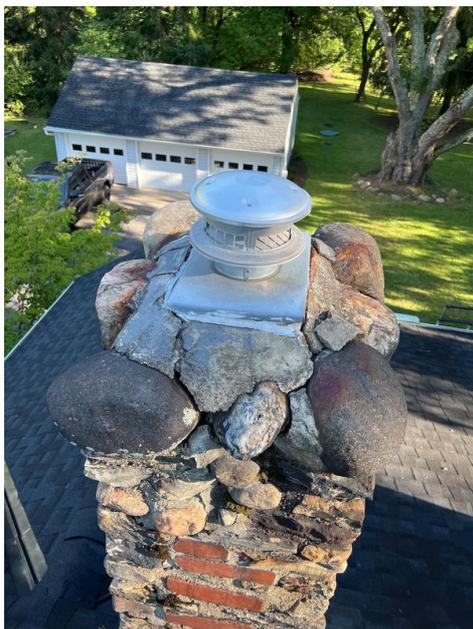
3.3.1 Chimney

CHIMNEY CAP (MINOR CRACKING)

Minor cracking visible in the chimney cap. Recommend sealing to prevent moisture intrusion.

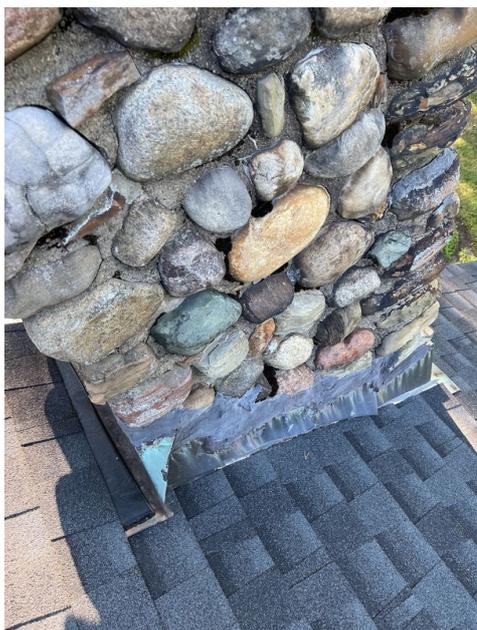
3.3.2 Chimney

FLASHING (SEALANT)

The areas at which the flashing meet the chimney were dependent upon a sealant alone to prevent moisture intrusion of the roof structure. Sealant will eventually dry, shrink and crack, allowing moisture intrusion with the potential to cause decay of the roof sheathing or framing, microbial growth, or damage to other home materials. The condition of the sealant should be checked annually and an appropriate sealant reapplied as necessary by a qualified roofing contractor.

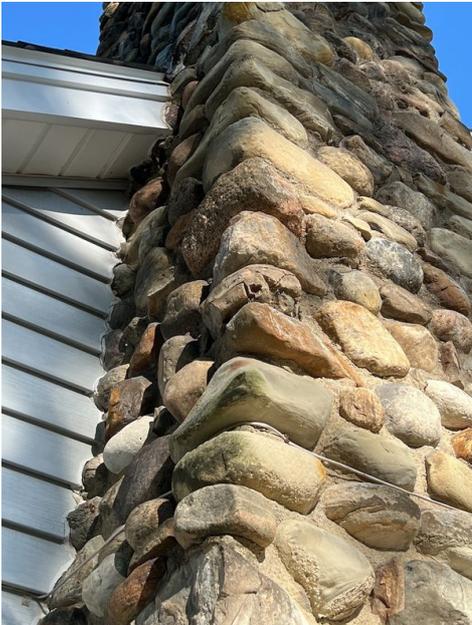
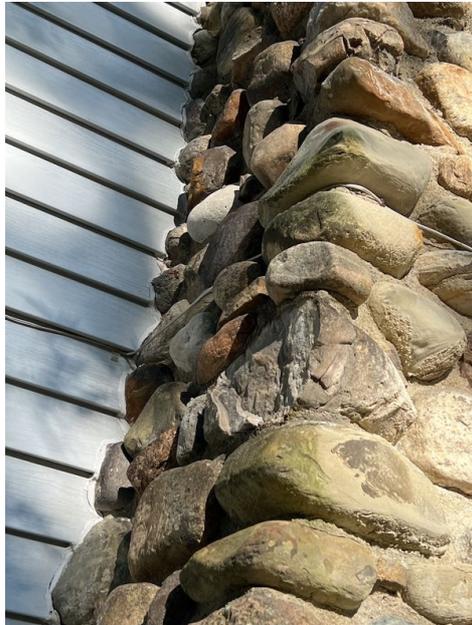
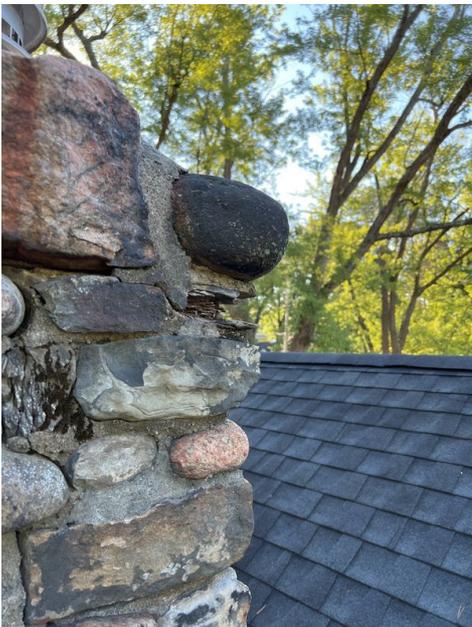
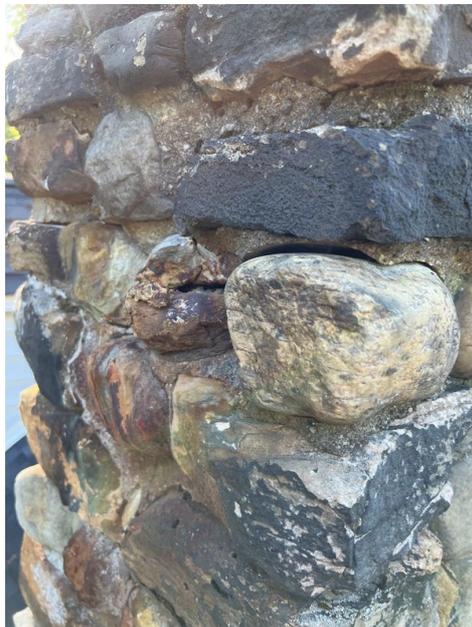
3.3.3 Chimney

FLAKING BRICKS

Water can penetrate brick. If it does and the temperature drops below freezing while the brick is saturated with water, the water then expands as it freezes. This expansion causes stress within the brick which then causes some of the clay to flake off. You can arrest and stop the flaking if you can stop water from entering the brick. The best way to try to do this is to saturate the brick with a clear masonry water repellent that contains silanes and siloxanes. Recommend evaluation and repairs to the chimney as needed from a professional chimney sweep.

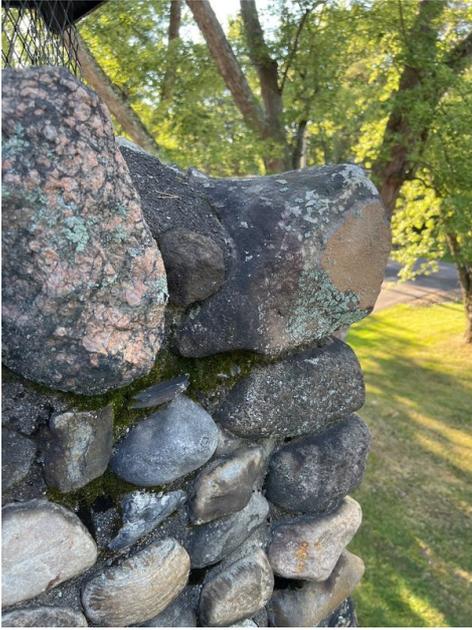
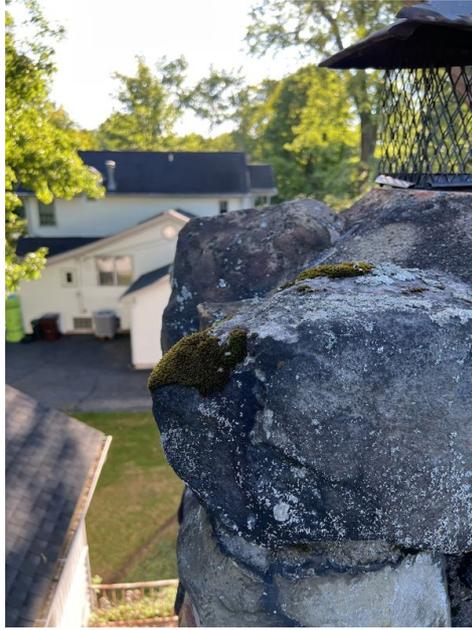
3.3.4 Chimney

MOSS

Moss/Algae is present on the chimney. This may hold moisture against the material and lead to early wear and tear. Recommend removal.

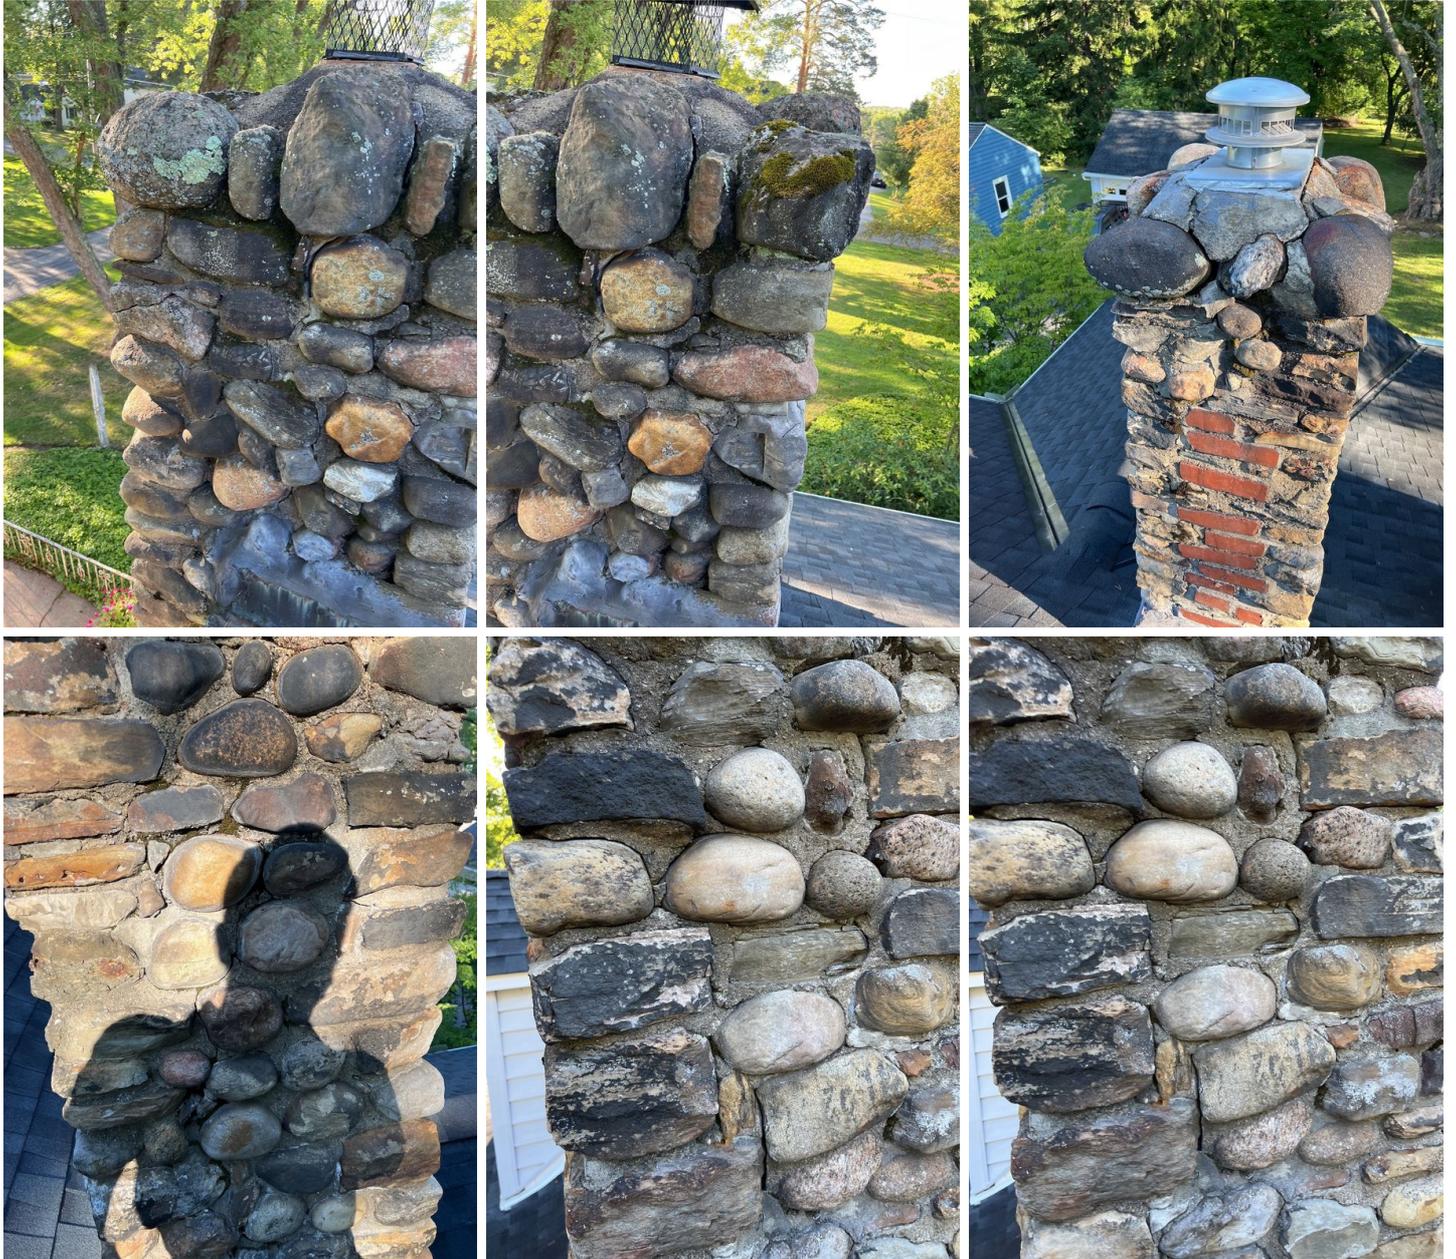
3.3.5 Chimney

Gaps at mortar joints around brick. Recommend evaluation and repairs as needed by a qualified chimney sweep.

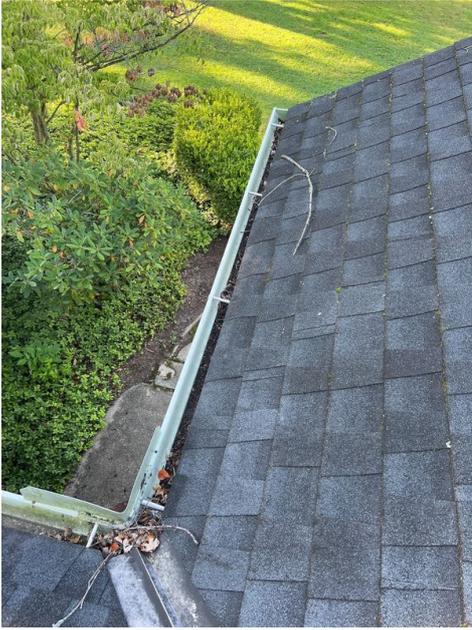
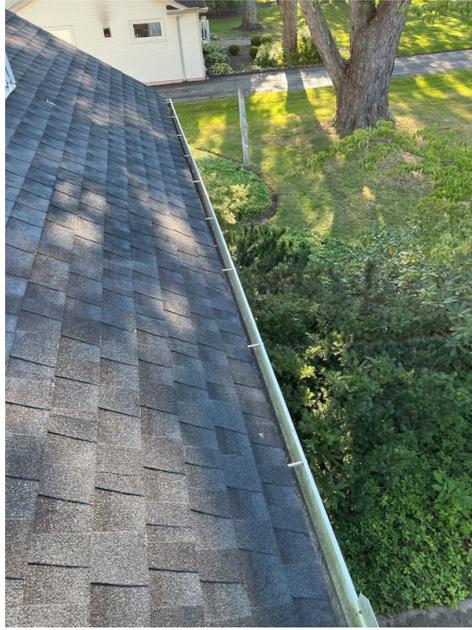
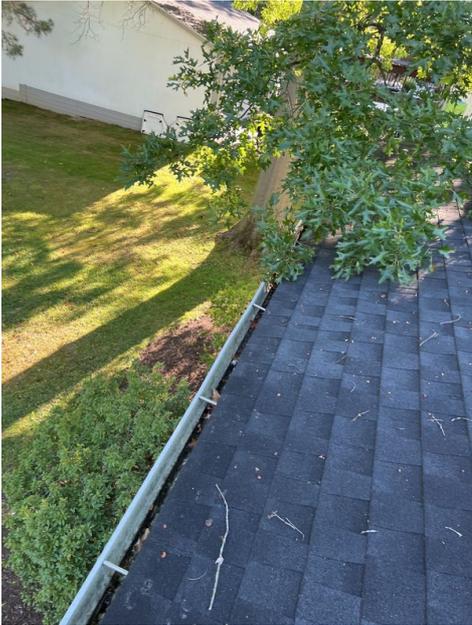
GUTTERS (DEBRIS)

Debris visible in the gutters at the time of the inspection should be removed to allow proper drainage.

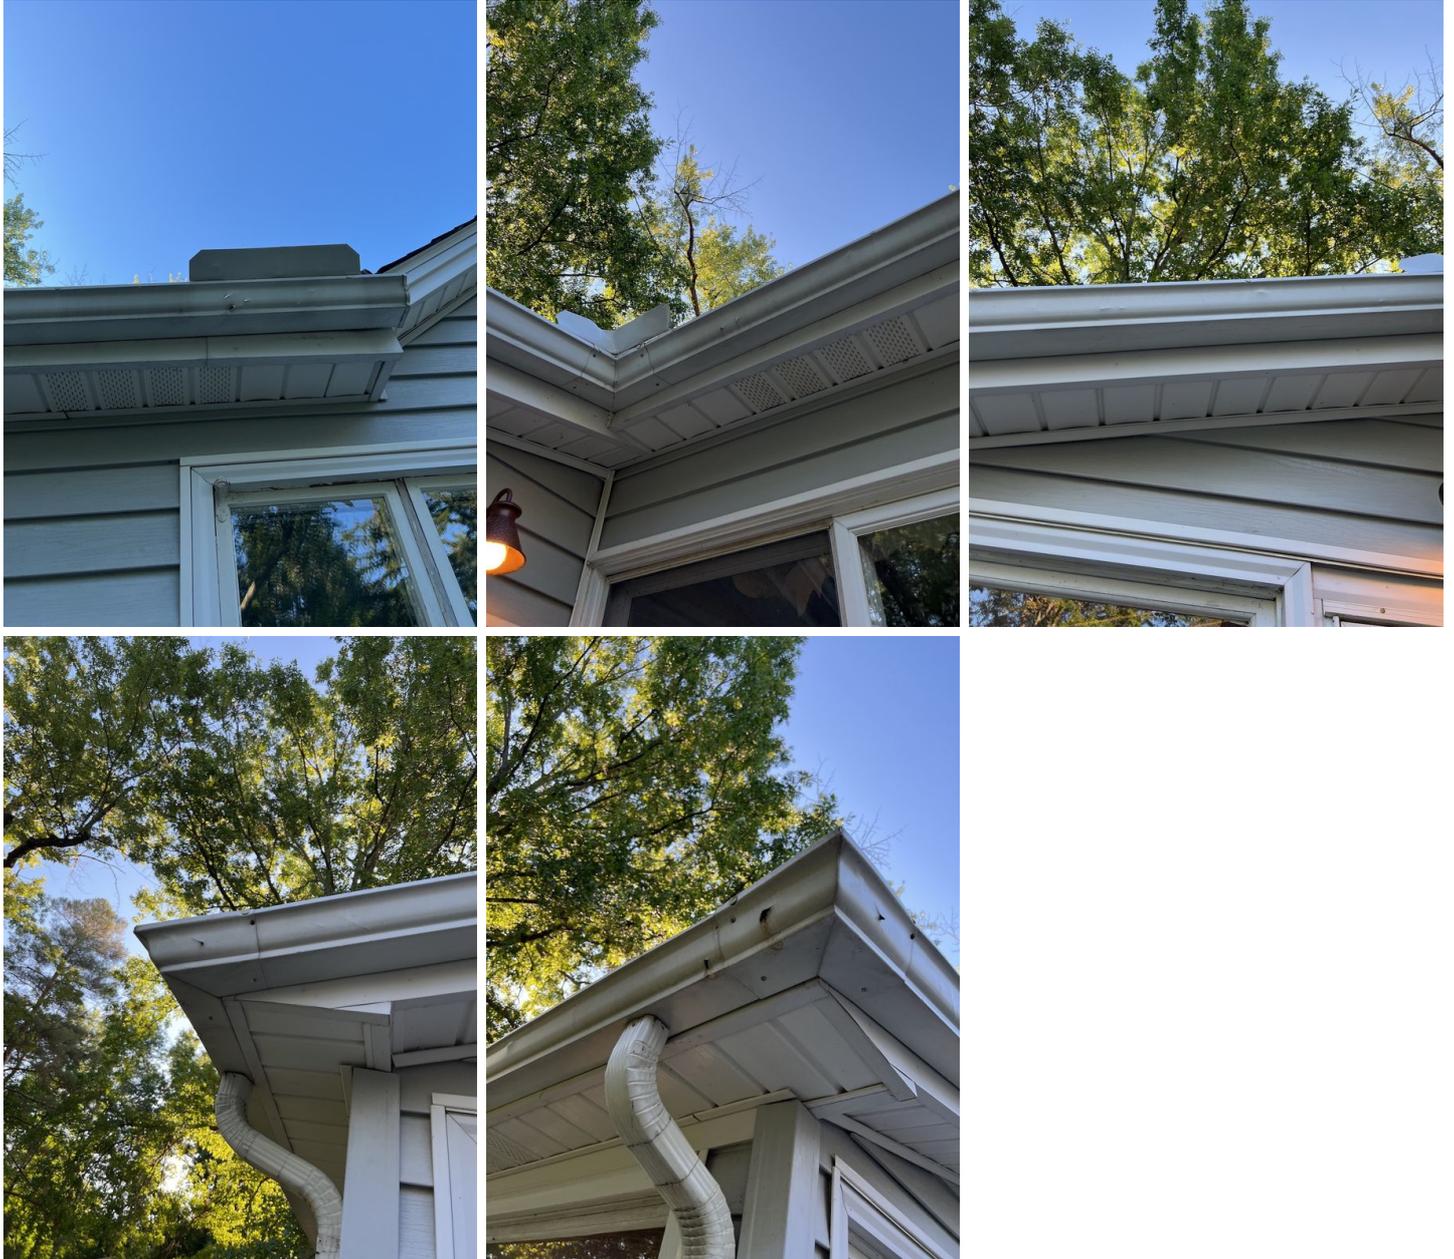
The gutters were bent or damaged in areas at the time of the inspection. This condition can result in excessively high moisture levels in soil at the foundation and can cause damage related to soil/foundation movement. Excessive moisture levels in soil near the foundation can effect the ability of the soil to support the weight of the structure above and can cause damage related to soil/foundation movement. The Inspector recommends repair to help protect the home structure. All work should be performed by a qualified contractor.

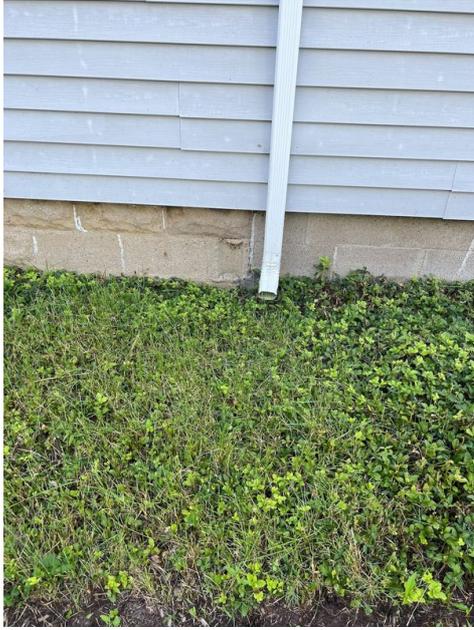
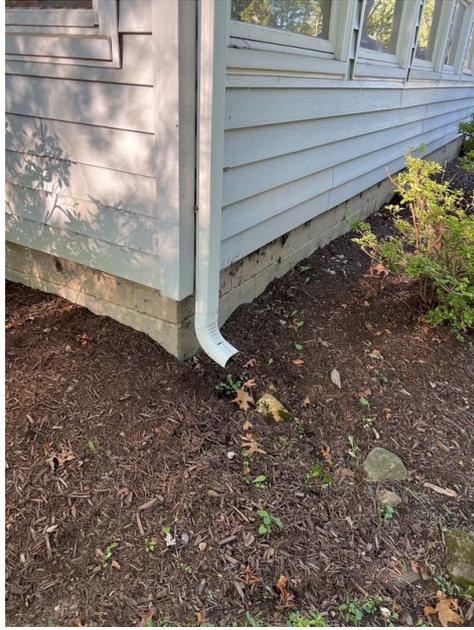
Moderate Defects**DOWNSPOUTS (DISCHARGES TO FOUNDATION)**

One or more downspouts discharged roof drainage next to the foundation. This condition can result in excessively high moisture levels in soil at the foundation and can cause damage related to soil/foundation movement. Excessive moisture levels in soil near the foundation can effect the ability of the soil to support the weight of the structure above and can cause damage related to soil/foundation movement. The Inspector recommends the installation of downspout extensions to discharge roof drainage a minimum of 6 feet from the foundation.

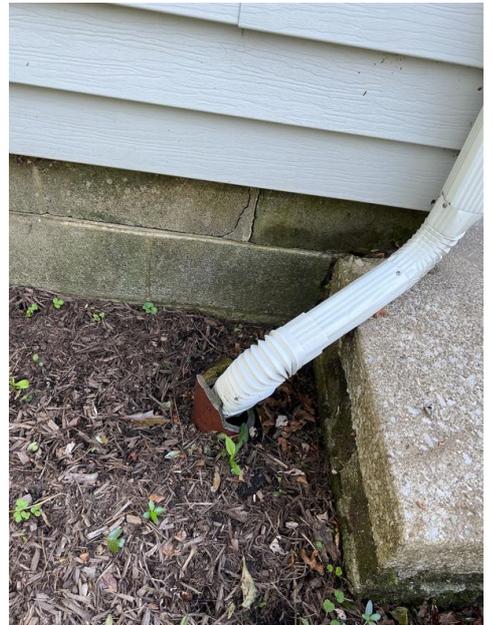
3.6.4 Roof Drainage Systems

Minor Defects/Maintenance Items/FYI**DAMAGED CROCK**

One or more downspout crocks were damaged and need replaced. Damaged crocks can allow water to pool near the foundation and lead to structural problems.

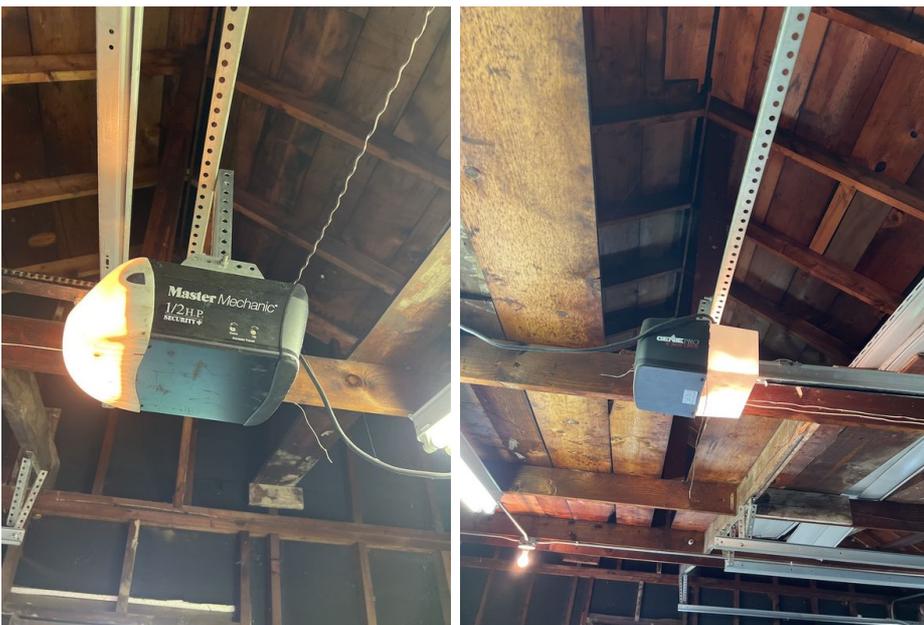
Automatic Opener: Manufacturer and Photo

Genie, Master Mechanic

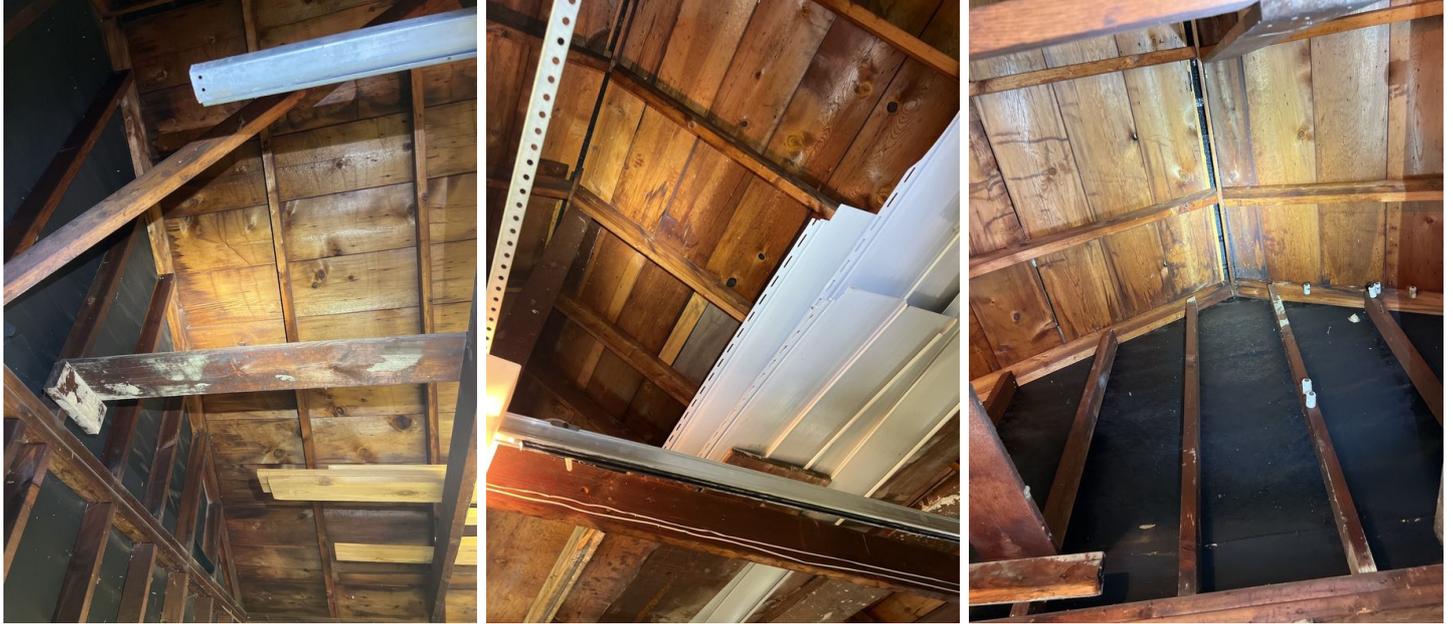
Dry stains were found in one or more ceiling areas. However, no elevated levels of moisture were found. The stain(s) may be due to past roof and/or plumbing leaks. Recommend asking the property owner(s) about this, and monitoring the stained area(s) in the future, especially after heavy or prolonged rain. If elevated moisture is found in the future, a qualified contractor should evaluate and repair as necessary.

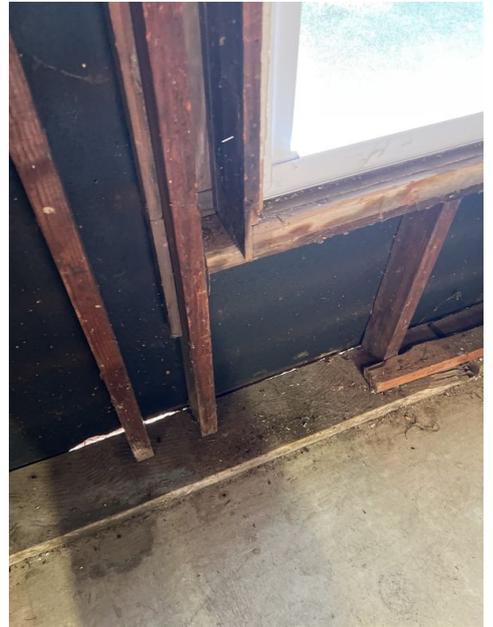
4.4.2 Walls/Firewalls

GAPS

Gaps present at garage walls. Recommend sealing these areas to prevent pest intrusion.

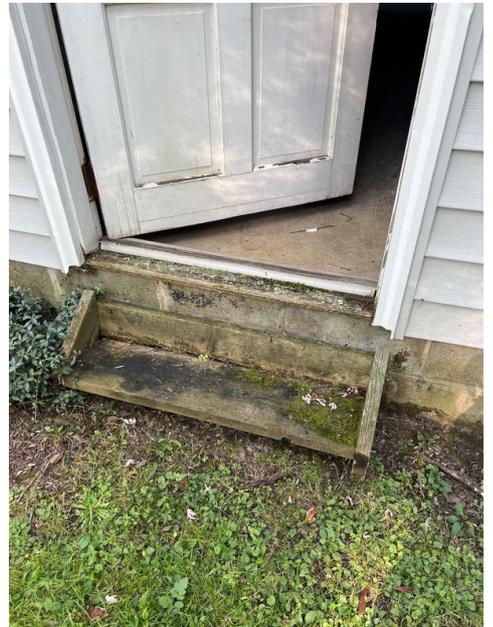
4.6.1 Stairs

RISERS (EXCESSIVE DIFFERENCE)

At the stairs from the garage to the living space, the greatest riser height exceeded the lowest riser height by more than the 3/8-inch limit recommended by generally-accepted current standards. This condition is a potential trip hazard. All corrections should be made by a qualified contractor

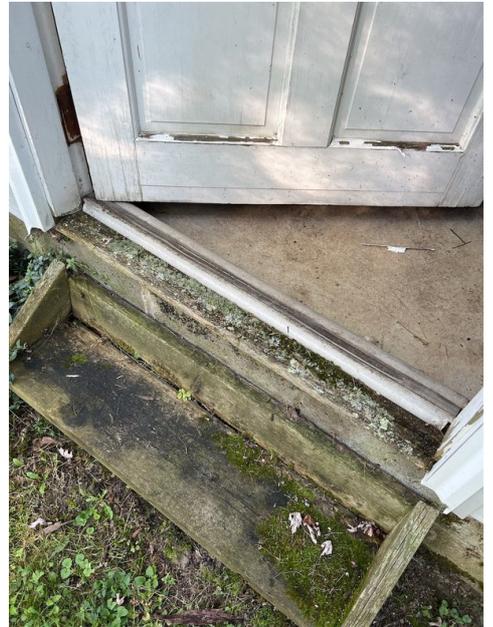
4.8.1 Man Doors

**THRESHOLD
(WEATHERED)**

Weathing present at threshold. Recommend repair.

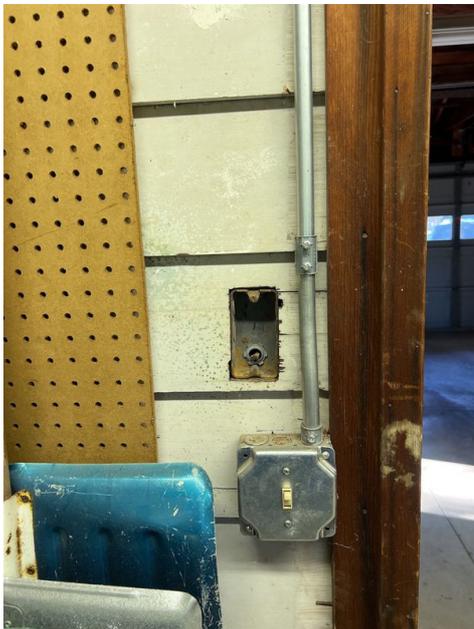
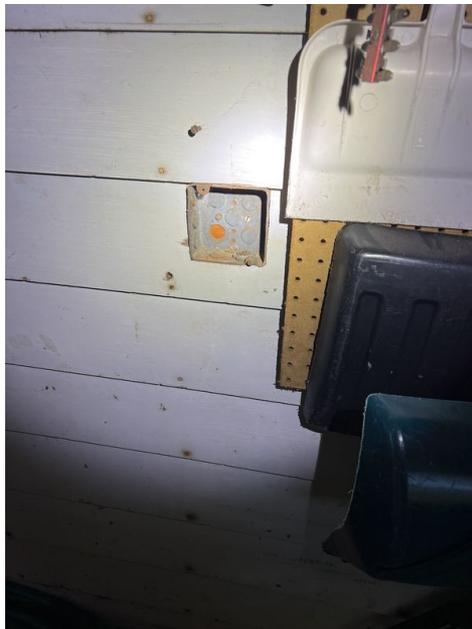
4.9.1 Electrical

COVER PLATE (MISSING)

At the time of the inspection, an electrical receptacle cover plate was missing in the garage. This condition left energized electrical components exposed to touch, a shock/electrocution hazard. The Inspector recommends that a cover plate be installed.

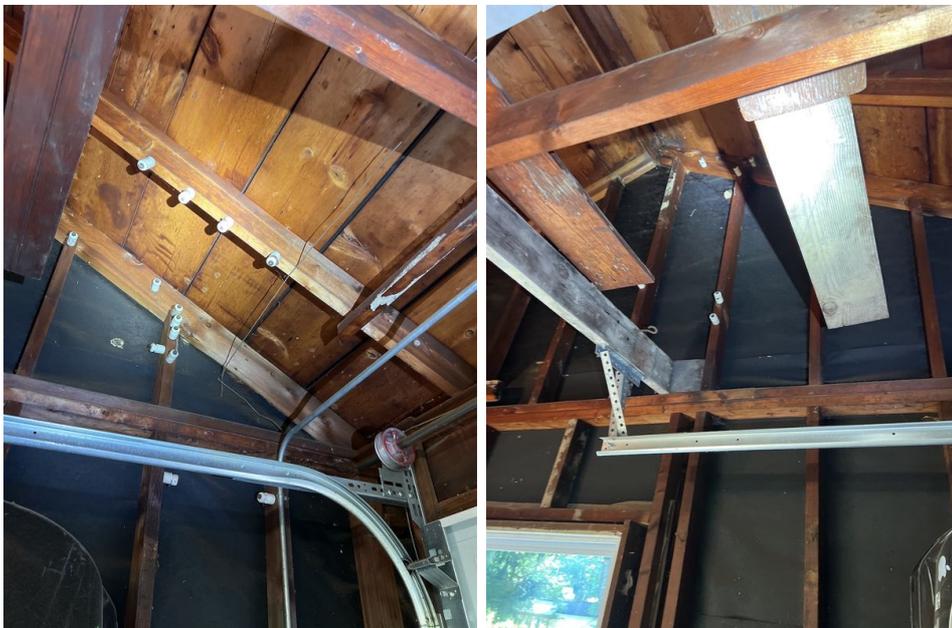
4.9.2 Electrical

This property has "knob and tube" wiring, which was commonly installed prior to 1950. It is ungrounded, and considered unsafe by today's standards. Over time, the wire's insulation may become brittle and fall apart or wear thin, resulting in exposed conductors and a risk of shock and/or fire. This wiring is also easily damaged by covering it with insulation (a common practice), and incorrectly tapping new wiring into it.

The inspector did not find any energized knob and tube wiring during the inspection. However this is no indication that all the knob and tube wiring has been abandoned. It is not within the scope of this inspection to determine what percentage of this property's wiring is of the knob and tube type, or to determine what percentage of the knob and tube wiring is energized vs. abandoned. A qualified electrician should evaluate this wiring and make repairs or replace wiring as necessary.

Note that some insurance companies may be unwilling to offer homeowner's insurance for properties with knob and tube wiring. Recommend that the client(s) consult with their insurance carrier regarding this.

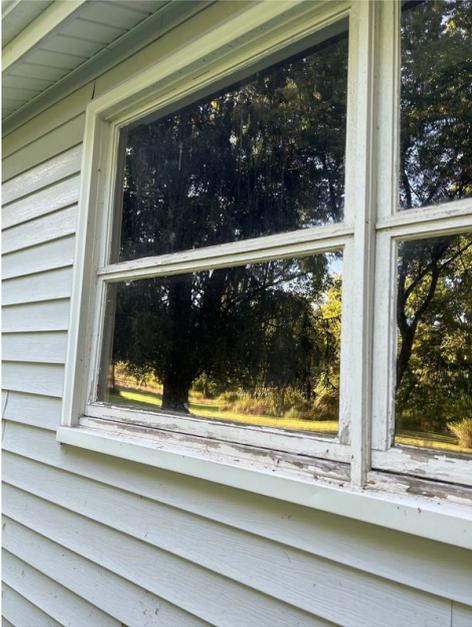
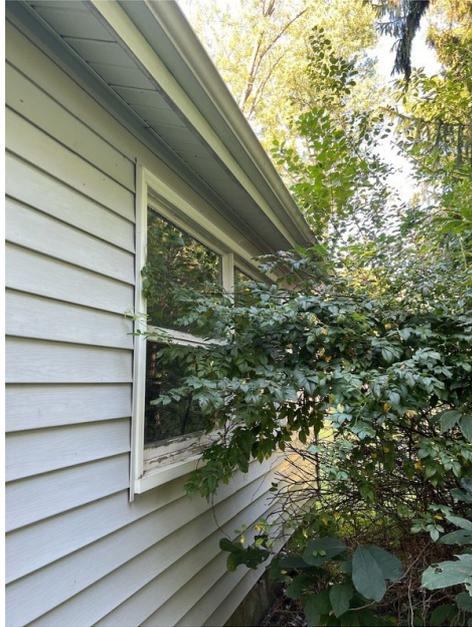
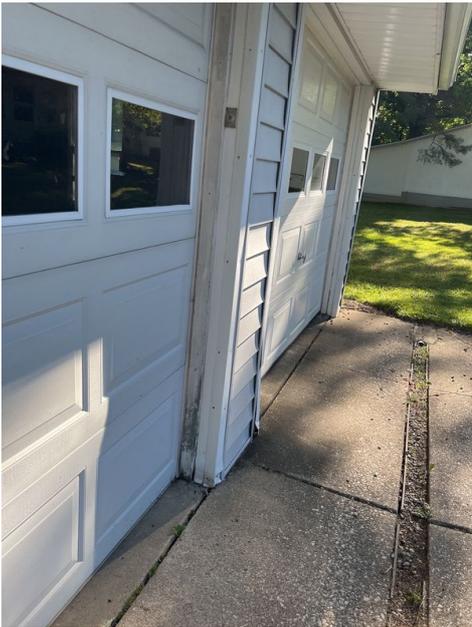
4.11.1 Exterior

PAINT NEEDED

Areas of siding/trim were worn/flaking and in need of maintenance. Recommend painting to prevent wood rot.

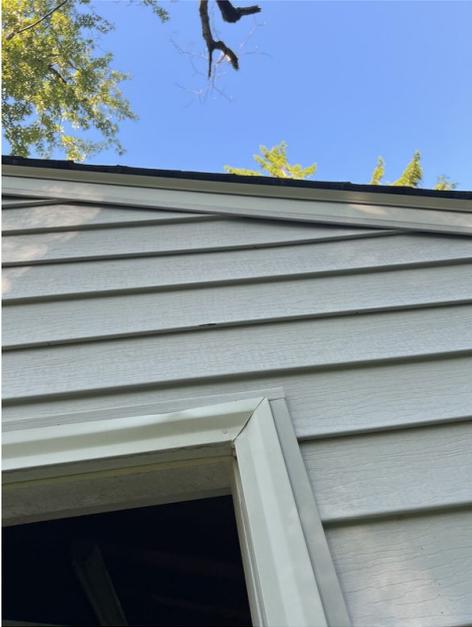
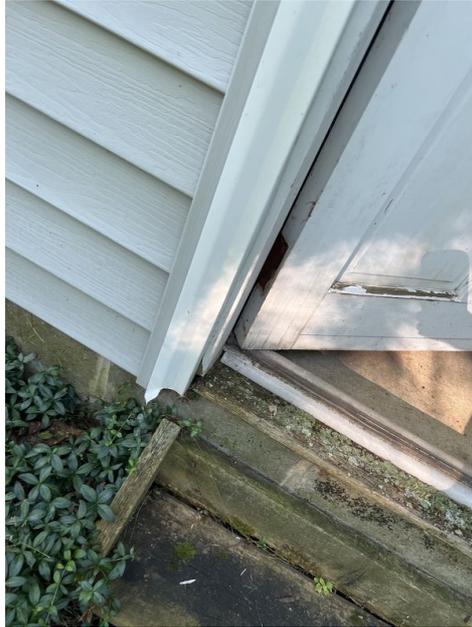
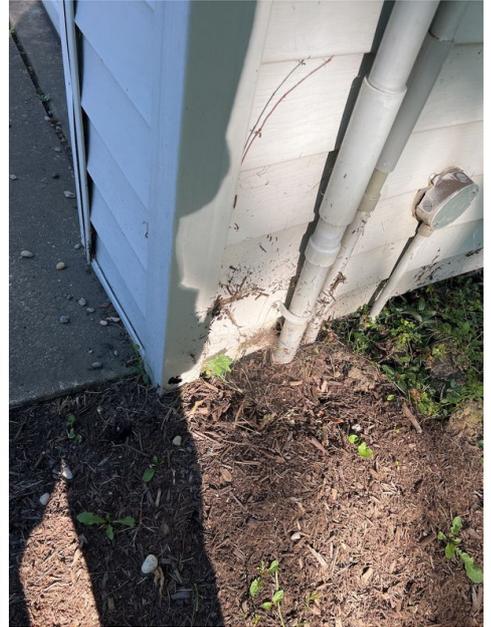
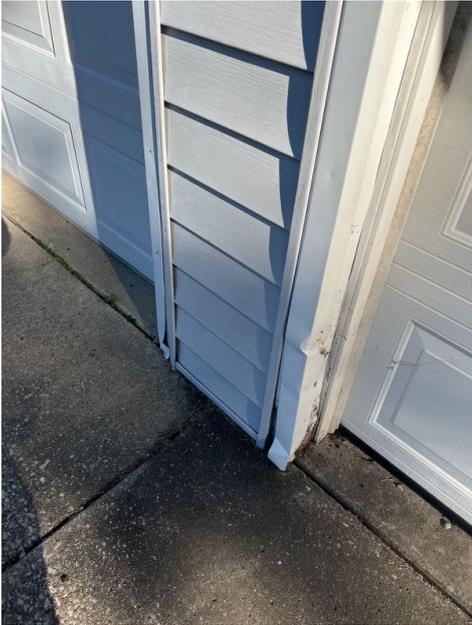
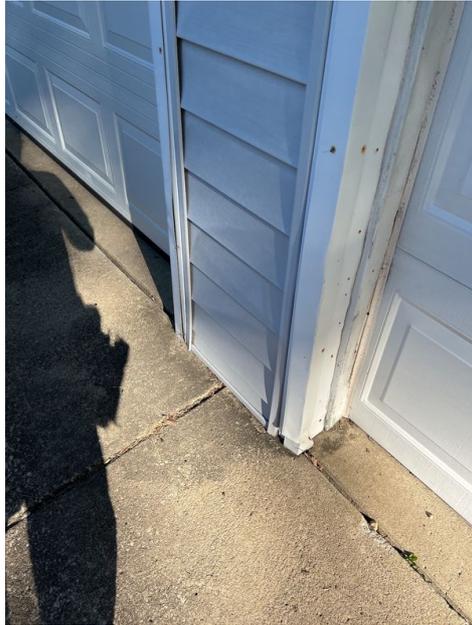
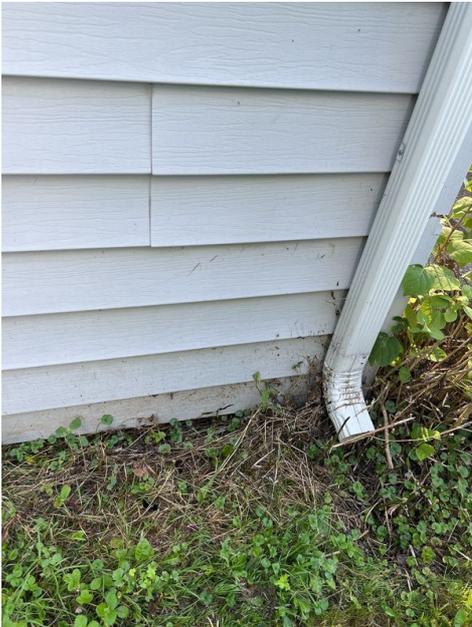
SIDING & TRIM (DAMAGED)

Damaged areas of siding and/or trim. Recommend replacing or sealing damaged areas to prevent moisture or pest intrusion.

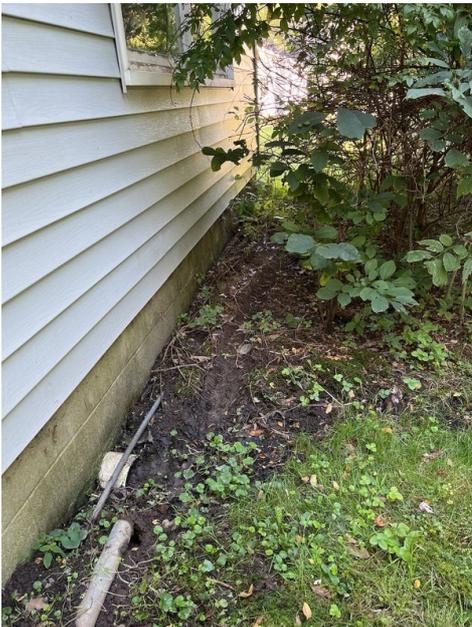
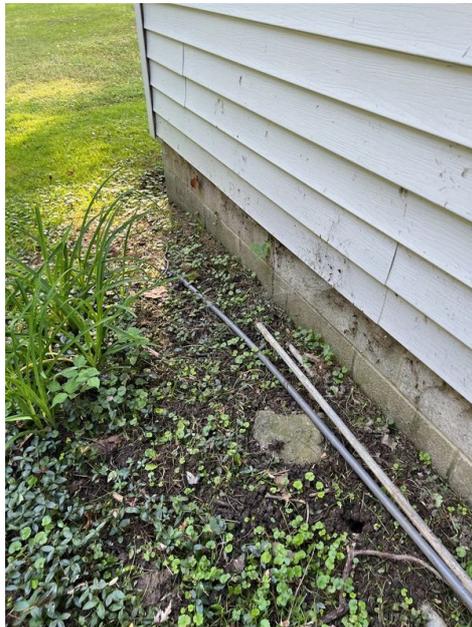
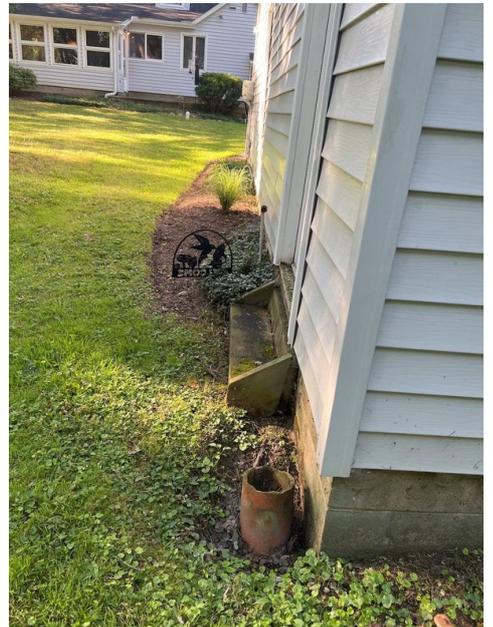
4.11.3 Exterior

NEGATIVE/FLAT GRADING

Negative grading present around garage foundation. Recommend repaiera to promote the flow of water away from foundation. Water can cause foundation problems if grading issues are not corrected.

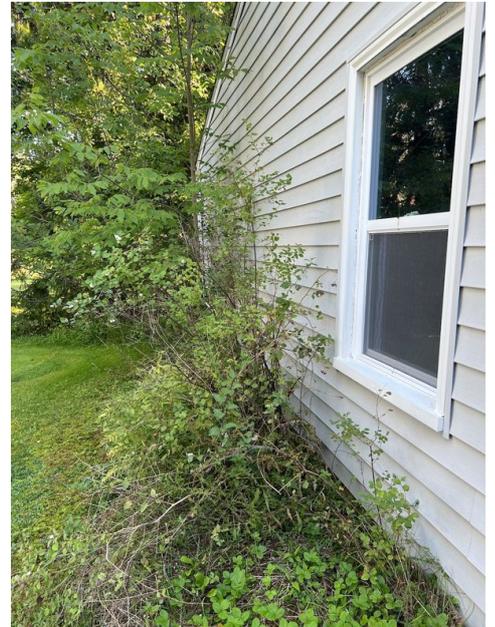
4.11.4 Exterior

VEGETATION IN CONTACT WITH SIDING

Recommend trimming vegetation back 6-12 inches.

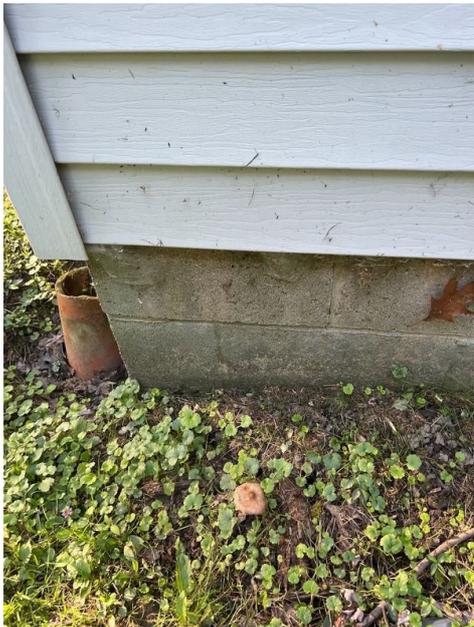
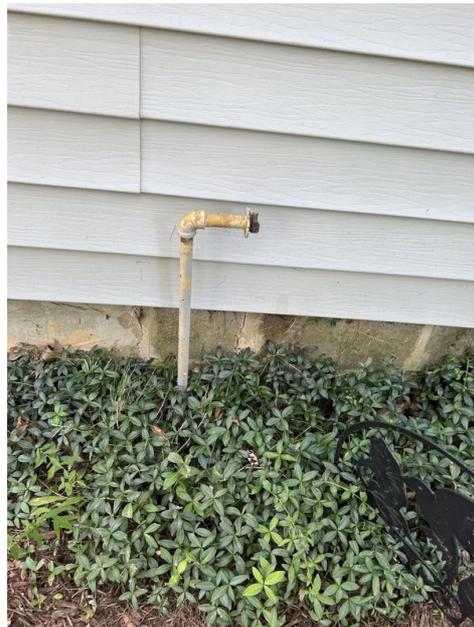
4.11.5 Exterior

TUCK POINT

Gaps at block need sealed or tuck pointing to prevent further settling and damage.

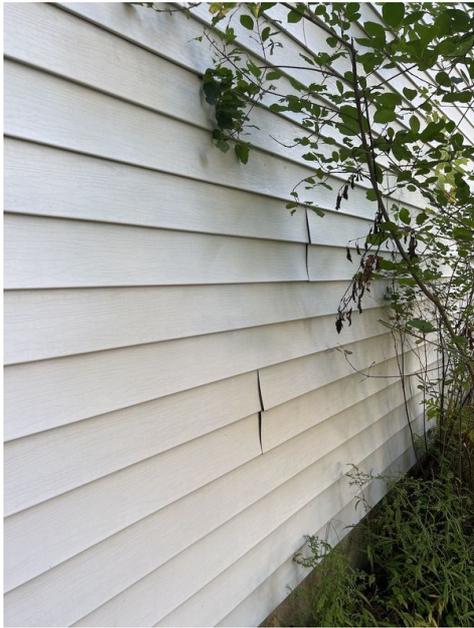
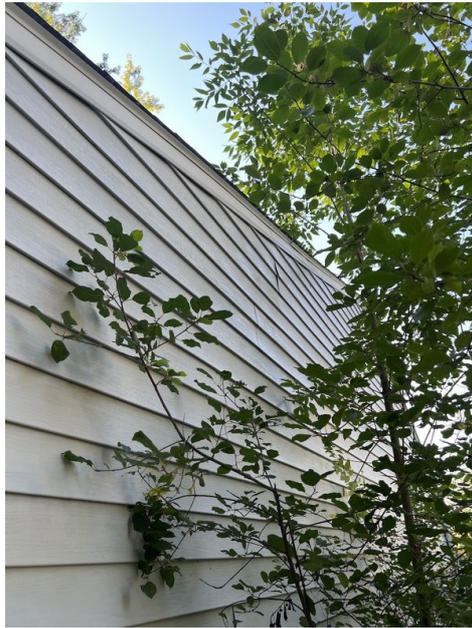
4.11.6 Exterior

GAPS AT TRIM/SIDING

Gaps at trim or siding. Recommend repair.

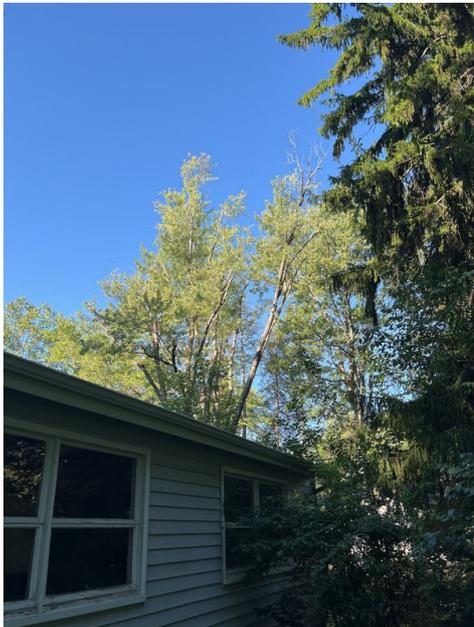
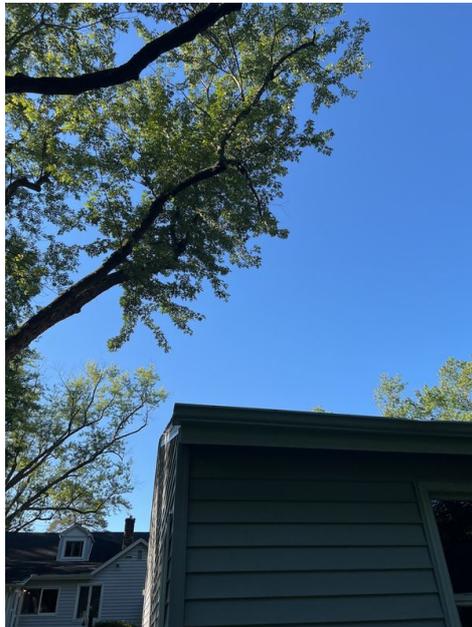
4.11.7 Exterior

TREE OVERHANG

Recommend trimming back trees that overhang the structure.

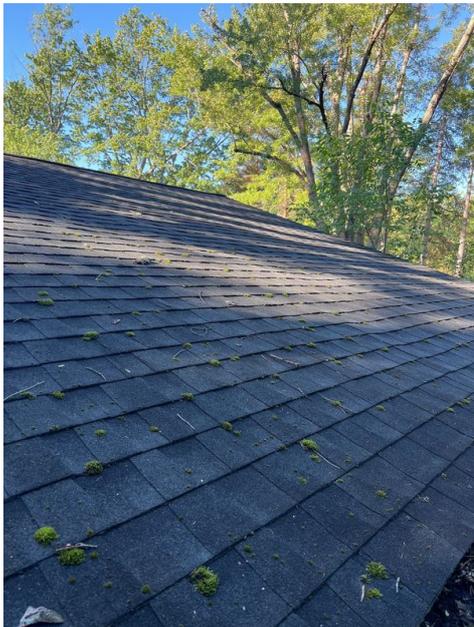
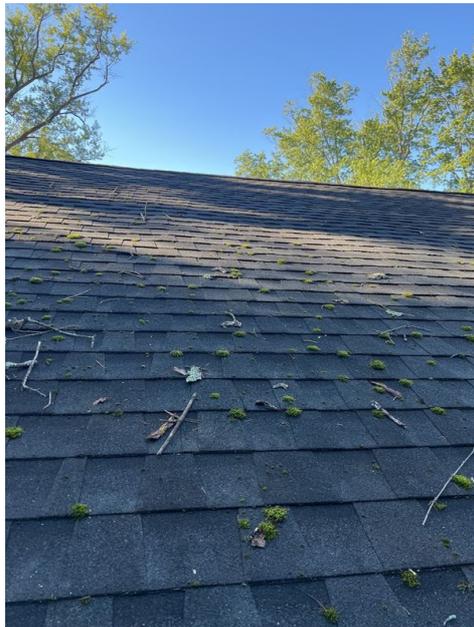
MOSS BUILD-UP

Moss build up on the roof usually results from excessive shade and can lead to shortened roof life and increased risk of leaks. Recommend removal and trim back any overhanging limbs.
