FIRST-IN HOME INSPECTION

GENERAL HOME INSPECTION

104 Paw Paw Lake Dr
Chagrin Falls, OH 44022

Mindy Goodin
SEPTEMBER 1, 2022

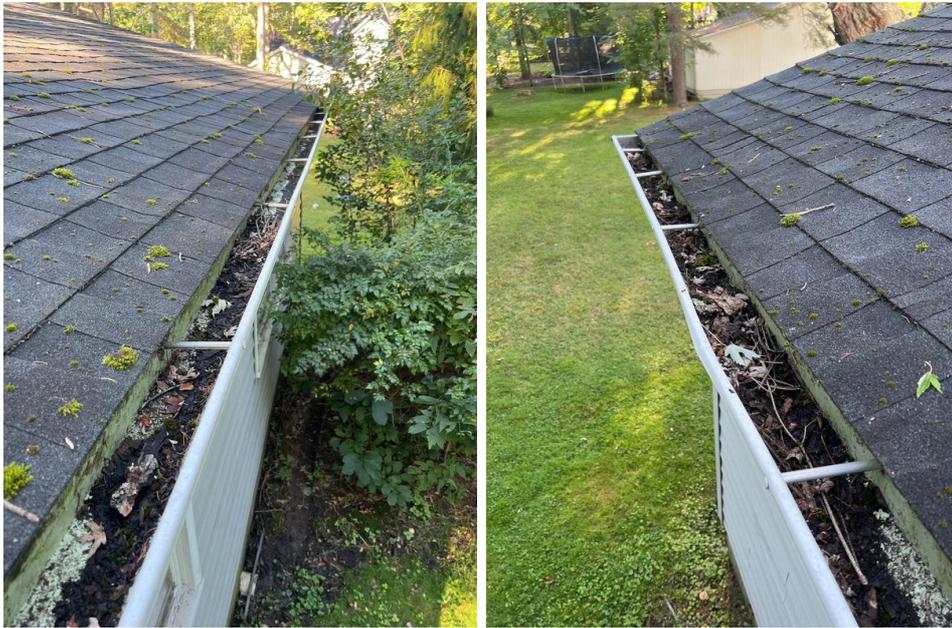
4.12.2 Roofing

GUTTERS NEED CLEANED

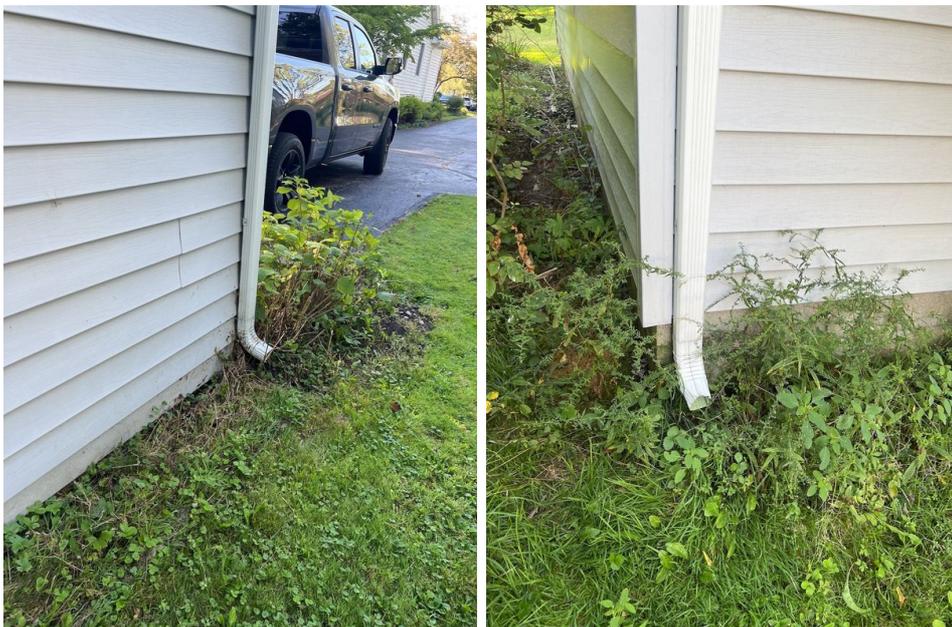
4.12.3 Roofing

GUTTER DISCHARGE TO FOUNDATION

One or more downspouts discharged roof drainage next to the foundation. The home had downspouts missing at the time of the inspection. This condition can result in excessively high moisture levels in soil at the foundation and can cause damage related to soil/foundation movement. Excessive moisture levels in soil near the foundation can effect the ability of the soil to support the weight of the structure above and can cause damage related to soil/foundation movement. The Inspector recommends the installation of downspout extensions to discharge roof drainage a minimum of 6 feet from the foundation.

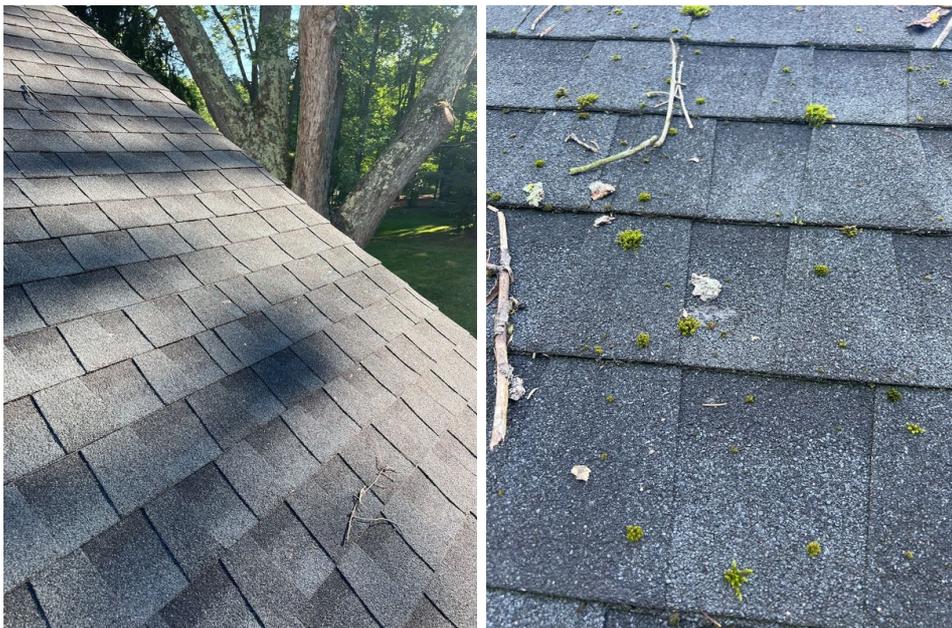
WORN SHINGLES

Shingles in one area or more showed signs of aging such as granule loss or cupping and curling. The roof appeared to be fully functional at the time of the inspection. Recommend monitor and repair as needed.

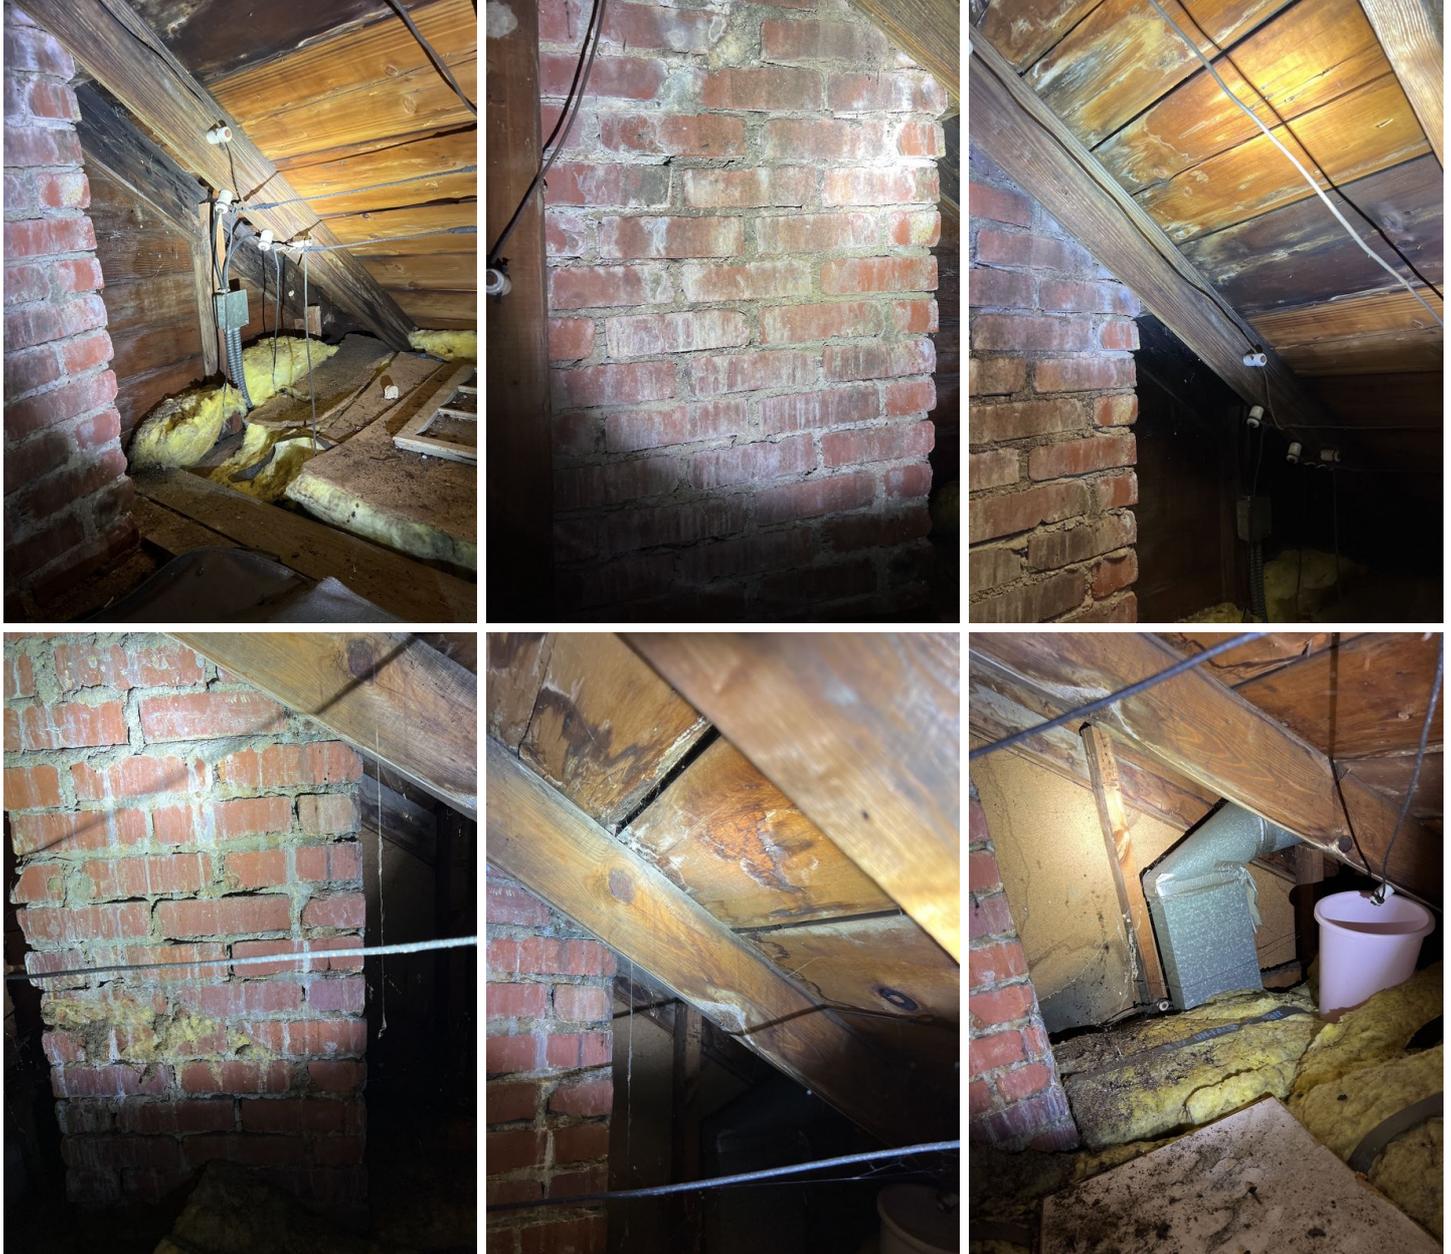
Stains were visible on the roof structure in one or more areas. These areas were dry at the time of the inspection. The stains may be caused by a past leak. Recommend asking the property owner(s) about past leaks. The client(s) should monitor these areas in the future, especially after heavy rains, to determine if active leaks exist. If leaks are found, a qualified roofing contractor should evaluate and repair as necessary.

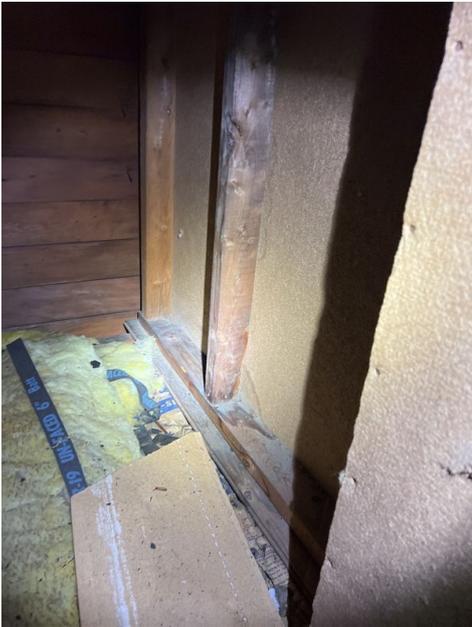
DRY STAIN

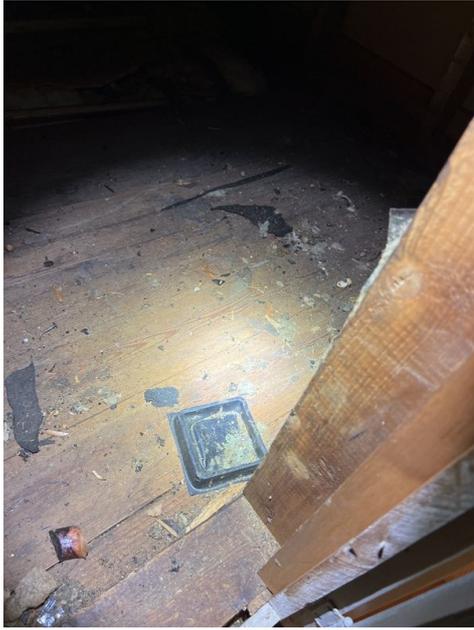
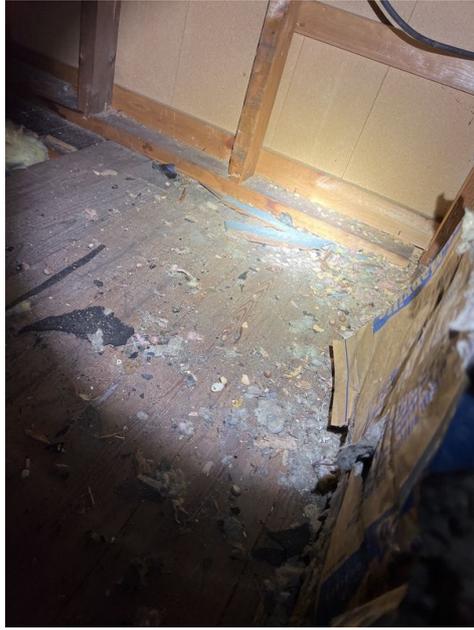
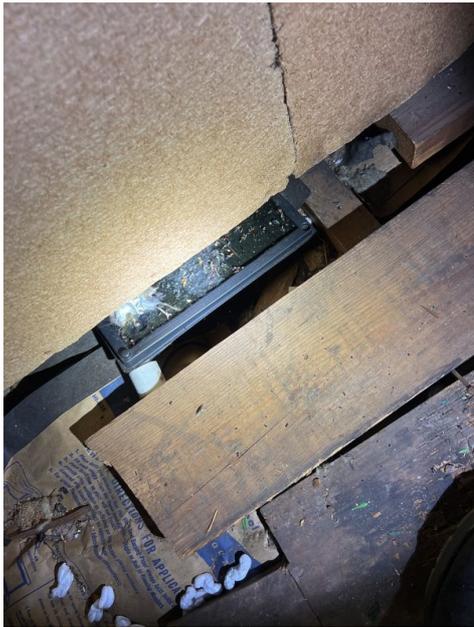
5.1.2 General

LIGHT TO MODERATE-PEST

Evidence of "light to moderate" rodent droppings was found in one or more areas. Recommend to monitor and remove as needed.

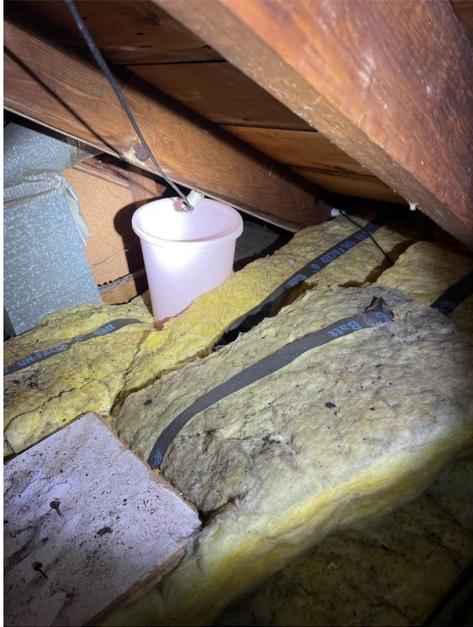
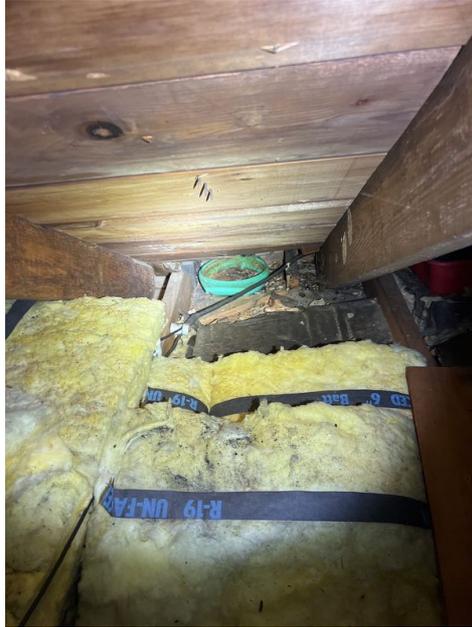
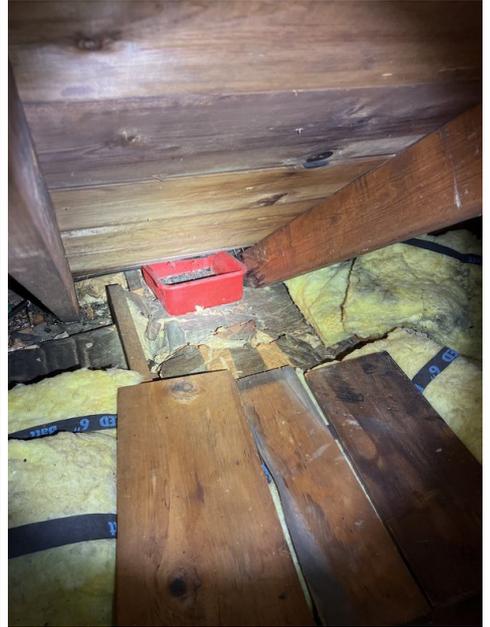
5.1.3 General

TARPS, BUCKETS, RAGS FOUND

Tarps, buckets or rags were found in the attic. They appeared to be there in an attempt to catch water from roof leaks. Consider consulting with the property owner, and/or having a qualified contractor evaluate and repair if necessary.

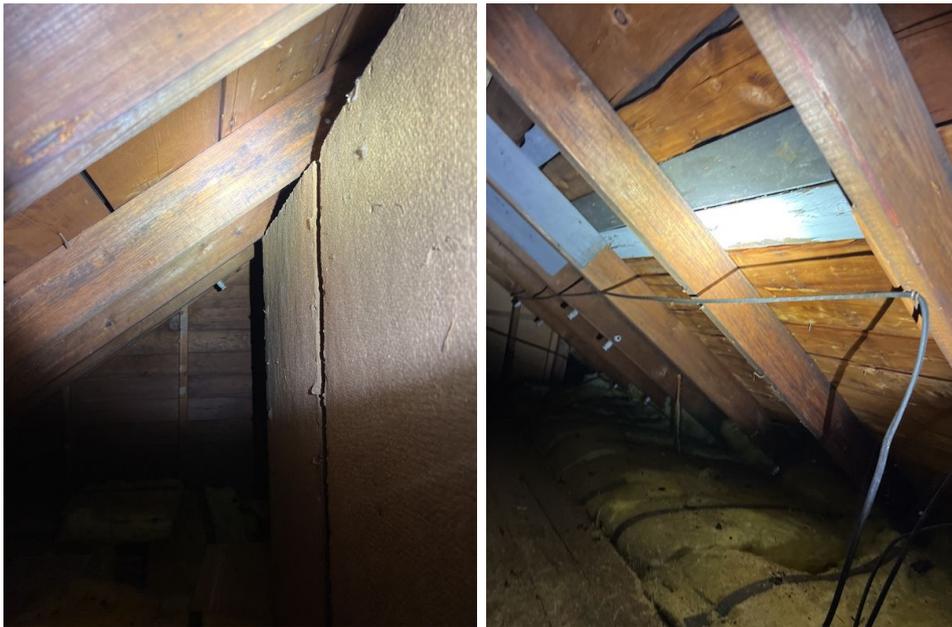
5.1.4 General

Moderate Defects**MICROBIAL GROWTH**

There was fungal growth present on areas of the attic. This can be the result of a range of issues from improper air sealing of ceiling protrusions (lights, ceiling fans, etc.) allowing conditioned air into the attic area, which can allow condensation to form. But can also be present from improper ventilation of the attic, moisture present in crawl space or basement areas reaching the attic via stack effect, and/or bathroom exhaust fans terminating in the attic. Or some combination of all of these issues. Evaluation and repairs to the source of the growth is recommended by a qualified contractor familiar with building sciences and ventilation, and then evaluation of the fungal growth is recommended by an environmental contractor with remediation conducted as needed.

Amended 9/13/2022 - per seller, microbial growth has been cleaned and remediated.

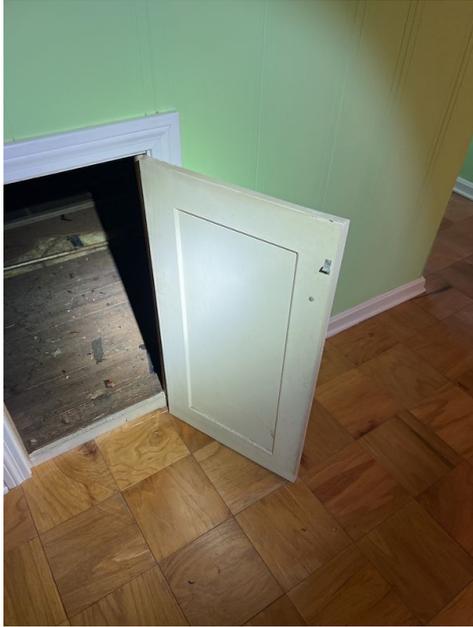
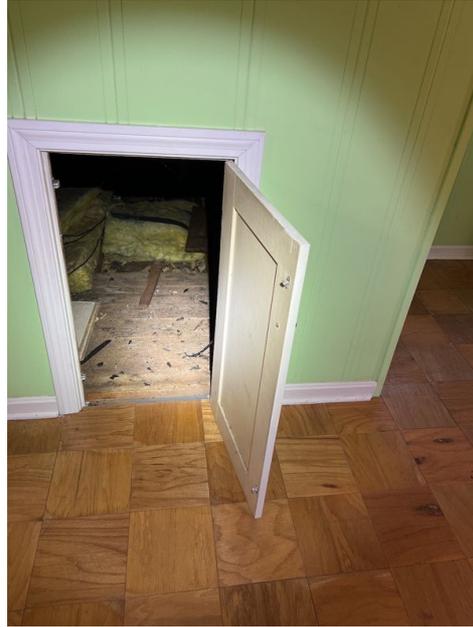
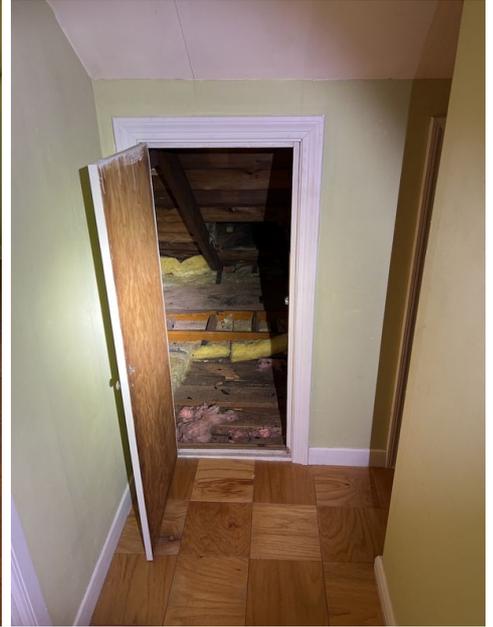
5.2.1 Attic Hatch

NO INSULATION OVER

No insulation is installed over the attic access hatch. Recommend installing insulation above hatch for better energy efficiency.

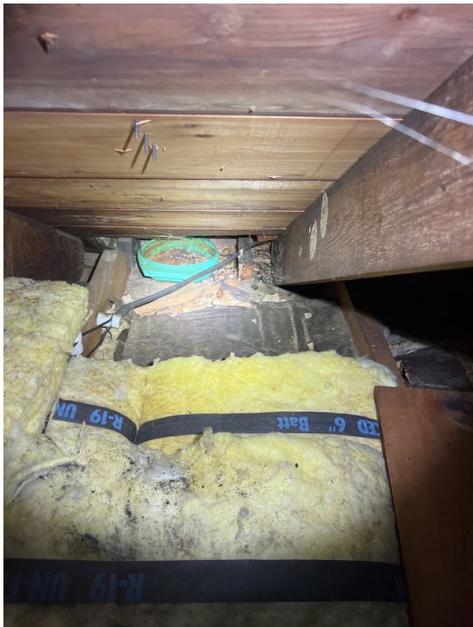
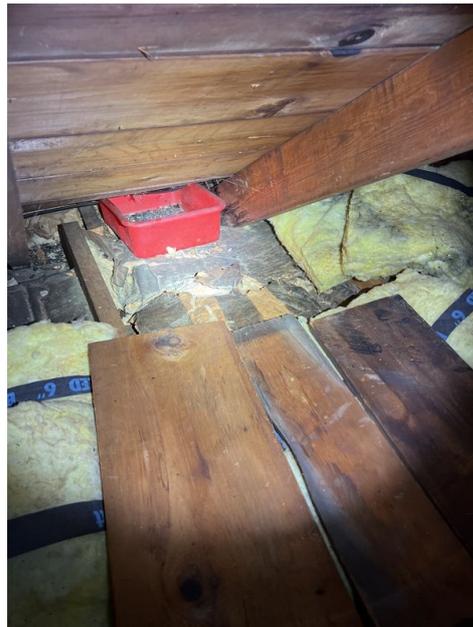
5.4.1 Attic Insulation

FLATTENED INSULATION

Insulation in the attic was aged and flattened which will result in unwanted heat gain or loss. This condition will increase heating and cooling costs and reduce comfort levels and may contribute to ice damming of the roof during the winter.

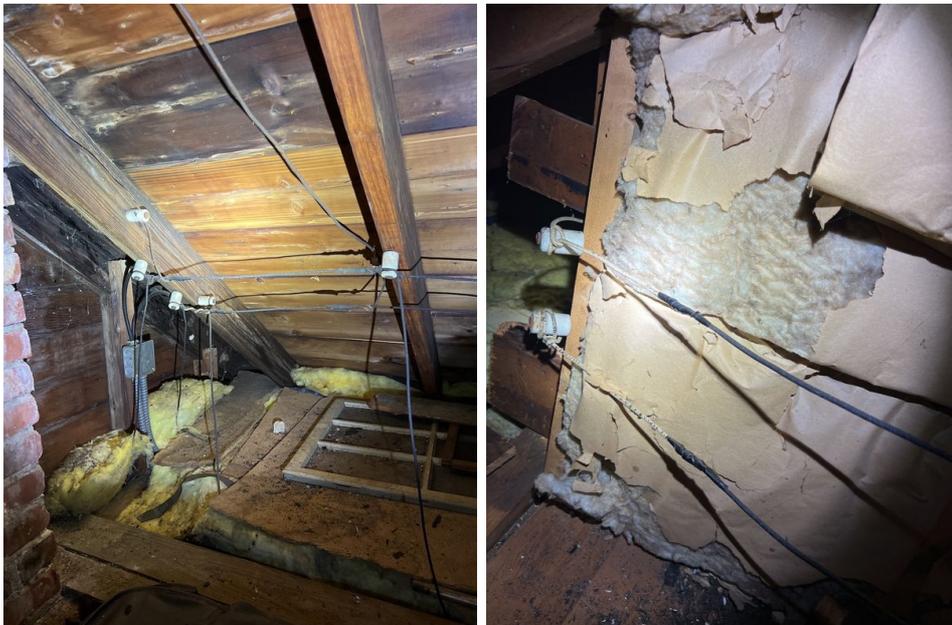
This property has "knob and tube" wiring, which was commonly installed prior to 1950. Knob and tube wiring is not inherently dangerous. The dangers arise from, its age, improper modifications, and situation where building insulation envelopes the wires.

Have the system evaluated by a qualified electrician. Only an expert can confirm that the system was installed and modified correctly. Where the wiring is brittle or cracked, it should be replaced.

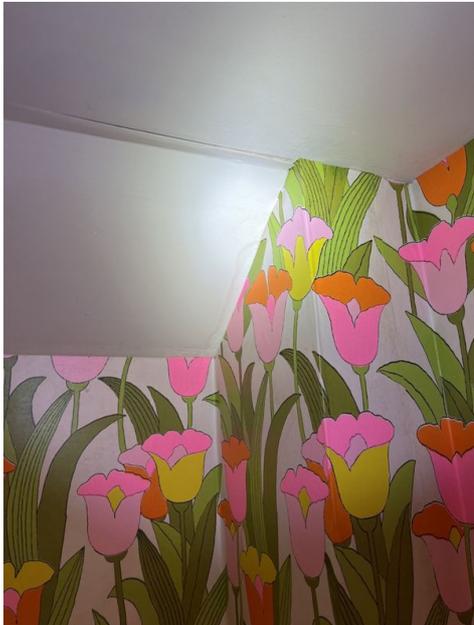
2nd Floor Bathroom

CEILING-DRY STAINS

Stains were found in one or more ceiling areas. However, no elevated levels of moisture were found using thermal imaging and a moisture detector. The stain(s) may be due to past roof and/or plumbing leaks. Keep in mind conditions can change and these could be active leaks. Damage may also exist behind these areas. Recommend asking the property owner(s) about this, and monitoring the stained area(s) in the future, especially after heavy or prolonged rain. If elevated moisture is found in the future, a qualified contractor should evaluate and repair as necessary.

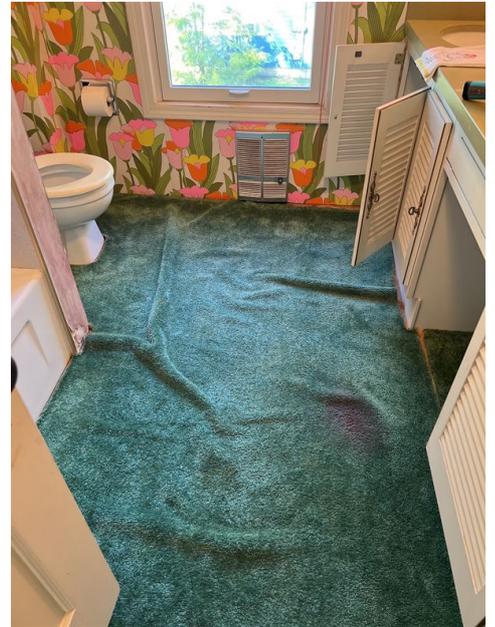
Carpeting in one or more rooms is loose. Recommend having a qualified carpeting installation contractor restretch carpet as necessary.

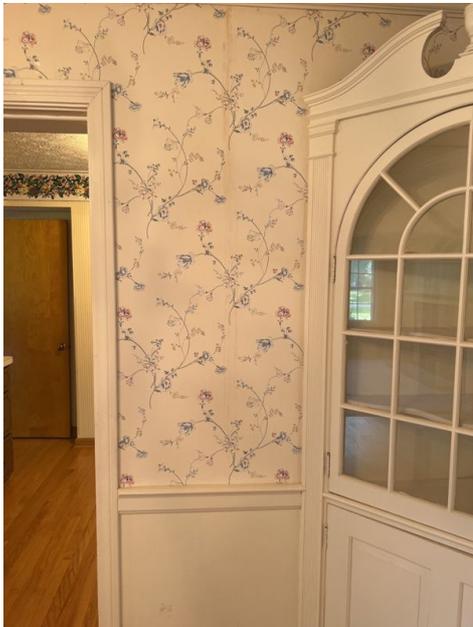
Dining Room

WALL-DRY STAINS

Stains were found in one or more wall areas. However, no elevated levels of moisture were found. The stain(s) may be due to past plumbing leaks. Recommend asking the property owner(s) about this, and monitoring the stained area(s) in the future, especially after heavy or prolonged rain. If elevated moisture is found in the future, a qualified contractor should evaluate and repair as necessary.

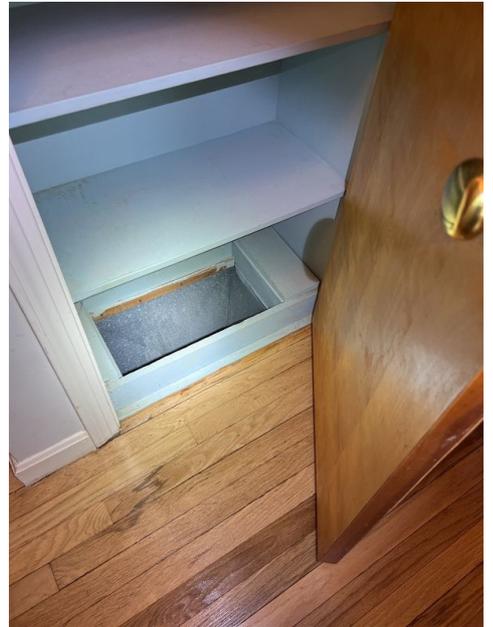
**LAUNDRY SHOOT
DOOR -FALL RISK**

Laundry shoot is ground level and does not have a locking latch. This could pose a fall hazard for young children. Recommend adding a locking latch.

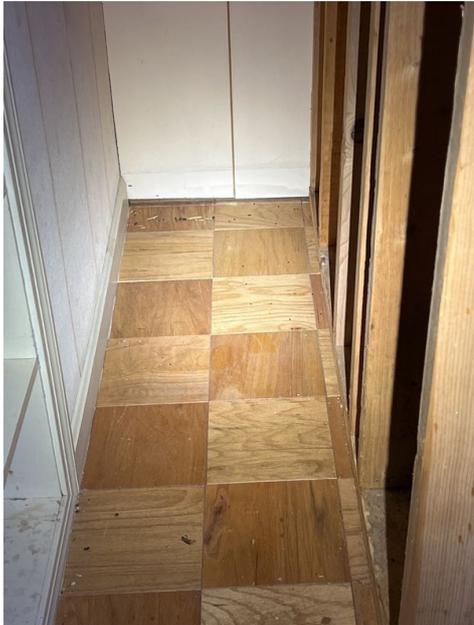
2nd Floor

ANIMAL DROPPINGS

Animal droppings were present at one or more locations in the home. You may wish to have the floors professionally cleaned after moving in.

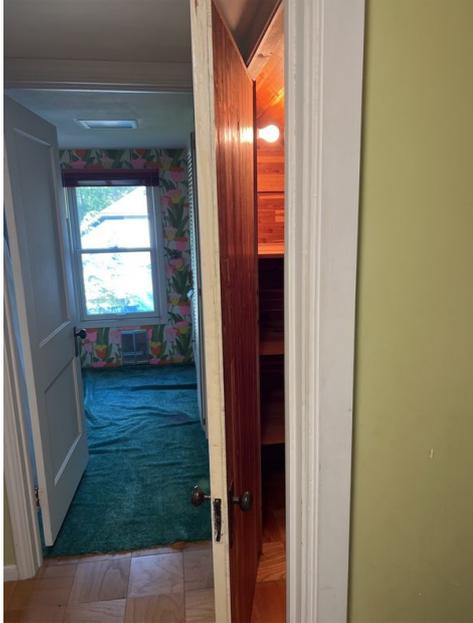
2nd Floor Closet

DOOR-WON'T LATCH

One or more doors will not latch properly when closed. Repairs should be made as necessary, and by a qualified contractor if necessary. For example, aligning strike plates with latch bolts and/or replacing locksets.

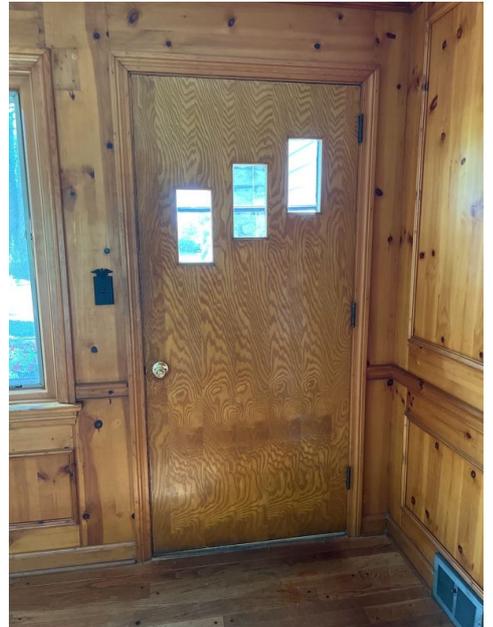
Office

DOOR HARD TO OPEN/CLOSE

One or more doors are difficult to open/close. The doors should be adjusted so that they will open and close freely and all necessary repairs should be made by a qualified contractor.

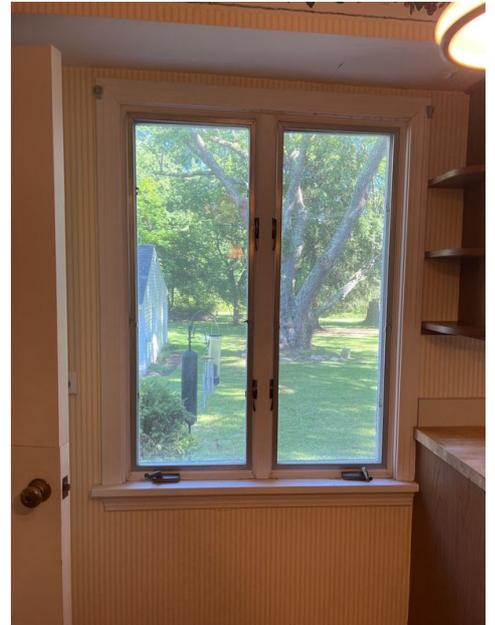
Multiple

Minor Defects/Maintenance Items/FYI**WINDOW HARD TO OPEN/CLOSE**

One or more windows are difficult to open/close. The windows should be adjusted so that they will open and close freely all necessary repairs should be made by a qualified contractor.

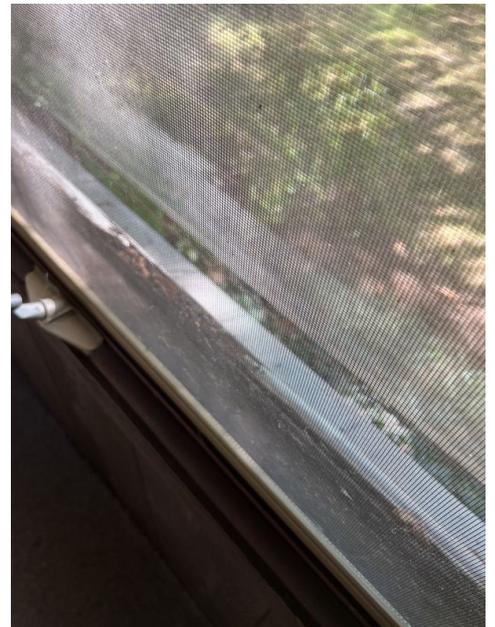
The window had signs of wood decay and rot from previous water intrusion. Recommend repair.

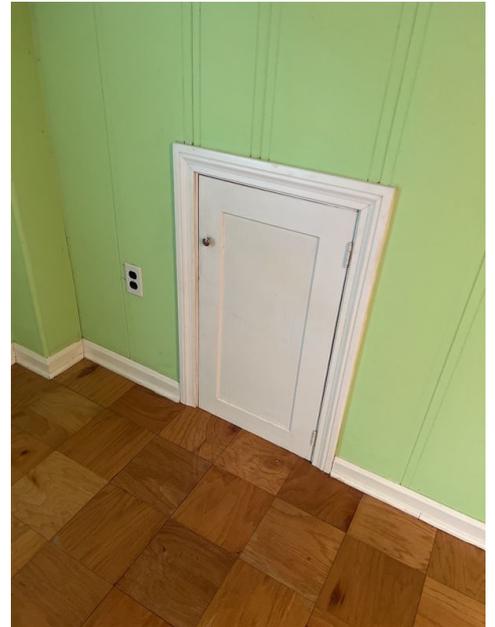
The door bonds on the floor when opening and closing which may wear the floor. Recommend repair.

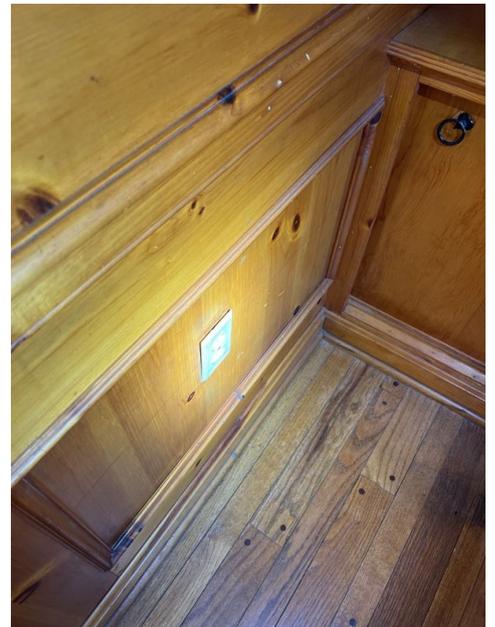
One or more electric receptacles and/or the boxes in which they were installed were loose and/or not securely anchored. Wire conductors can be damaged due to repeated movement and/or tension on wires, or insulation can be damaged. This is a shock and fire hazard. Recommend that a qualified electrician repair as necessary.

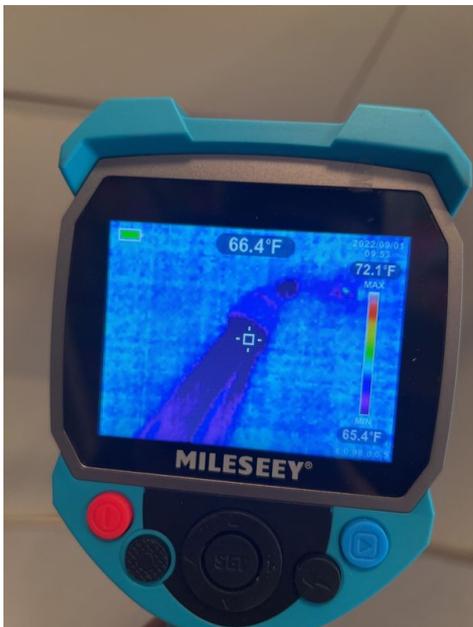
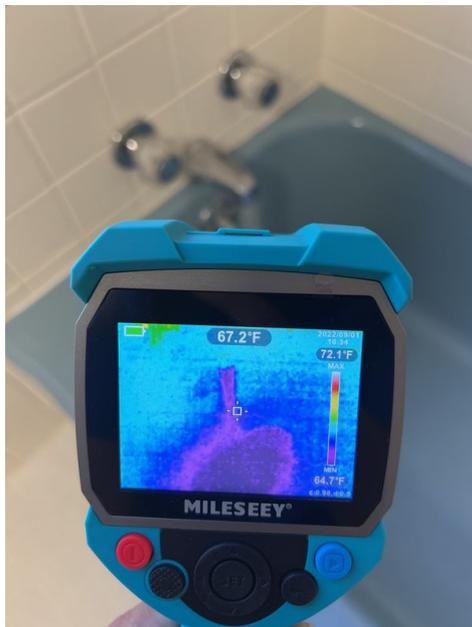
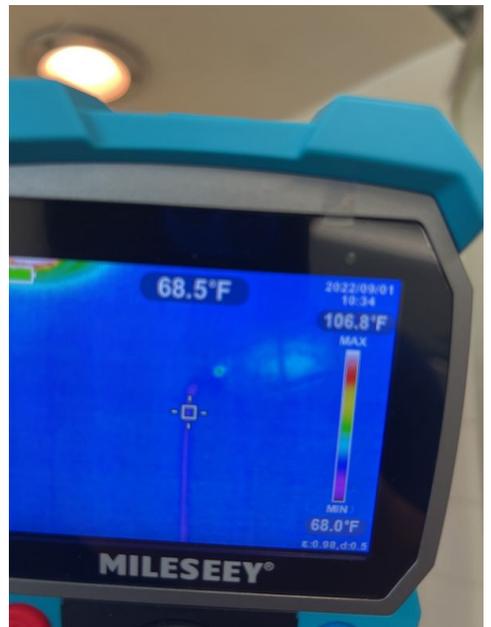
NO HOT WATER

No hot water at time of inspection. Recommend ensuring pilot light to water heater gets lit and hot water tested at all fixtures/faucets.

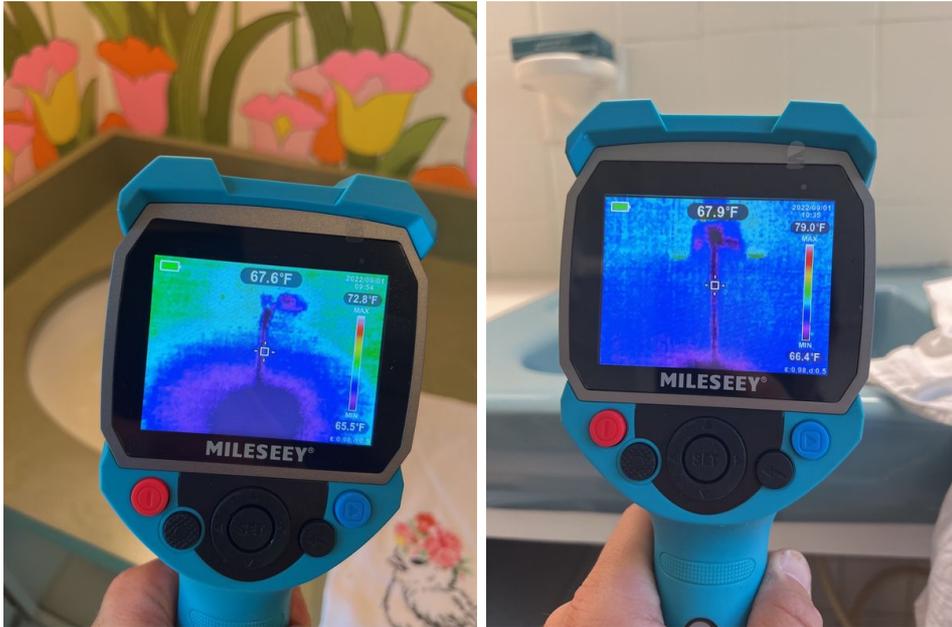
NO HOT WATER

No hot water at time of inspection. Recommend ensuring pilot light to water heater gets lit and hot water tested at all fixtures/faucets.

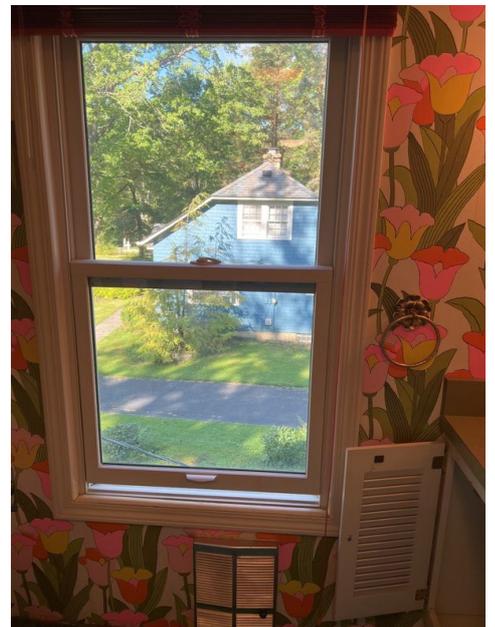
No exhaust fan was installed to exhaust moist air. This condition is likely to result in excessively high humidity levels in this bathroom. Elevated moisture levels may cause a number of problems, such as deterioration of materials and shower wall tile detachment. High humidity can also encourage the growth of microbes such as mold fungi. Excessive growth of mold fungi can produce high concentrations of mold spores in indoor air which can cause serious health problems in some people. Consider installation of an exhaust fan in this bathroom to prevent problems from excessively high humidity.

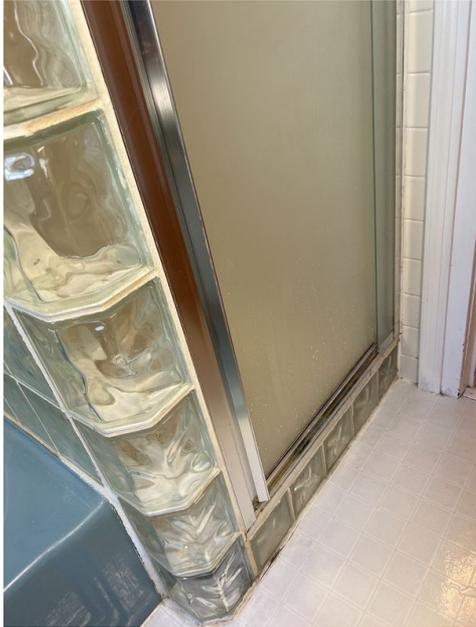
1st Floor

CAULKING/GROUT

Areas of missing caulking/grout around bathroom fixtures and/or surrounds. Recommend replacing caulking/grout to prevent moisture intrusion.

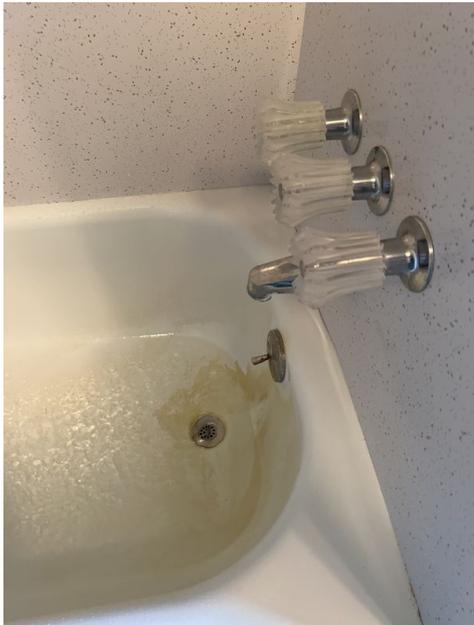
2nd Floor

DRAIN STOPPER DID NOT OPERATE

The drain stopper did not properly operate when tested. Recommend replacement.

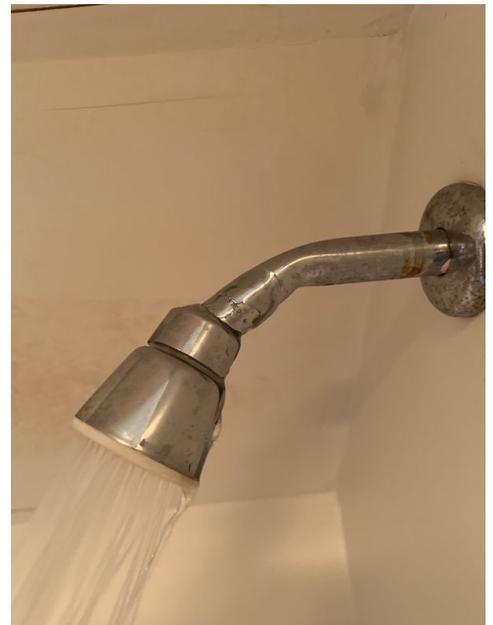
2nd Floor

SHOWER HEAD LEAKS

The shower head is leaking and should be repaired or replaced.

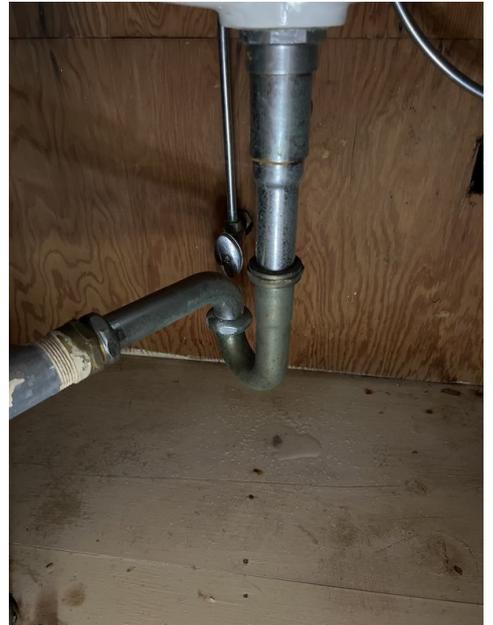
Basement

FIXTURE LEAKING (BELOW)

A faucet is leaking and/or dripping from under the counter which could cause damage to underlying surface. Recommend fixture is replaced.

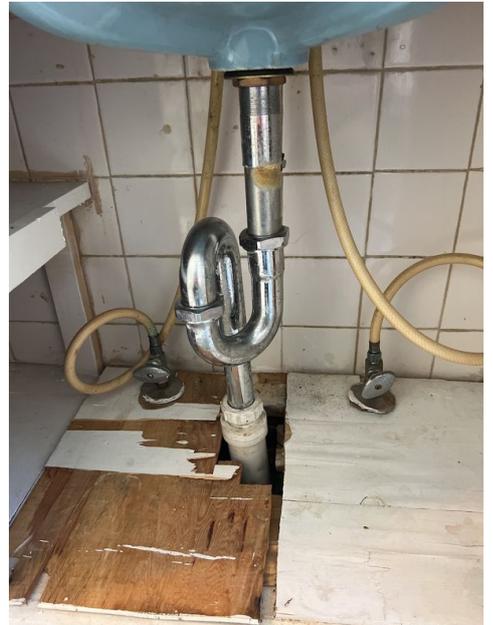
1st Floor

S-TRAP INSTALLED

An S-trap was installed which has the potential to suck, or siphon, water out of the p-trap as the water flows down the drain; not all areas may be shown. This could cause too much water to leave the trap and let sewage gases into space. Recommend correction by removing S-trap and installing only one p-trap.

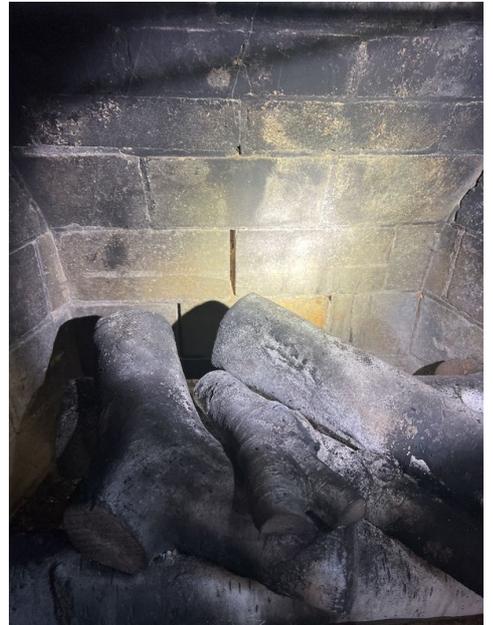
Gaps were visible in between firebricks. Recommend repair.

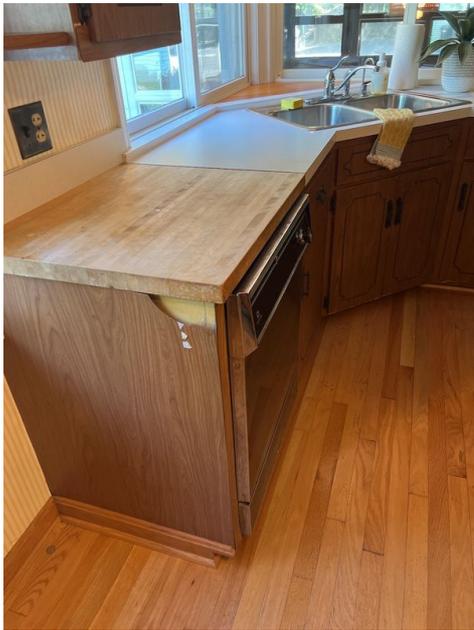
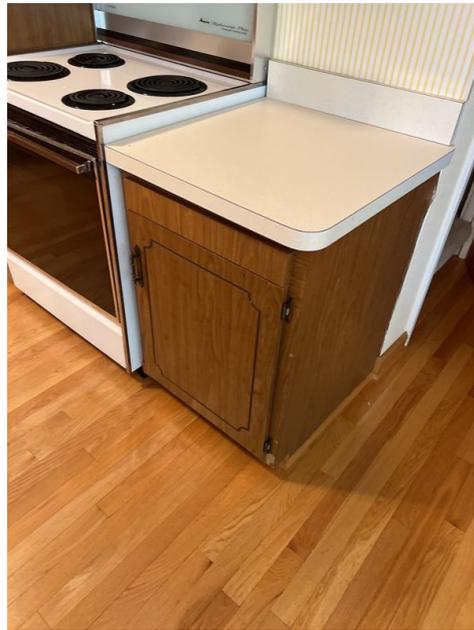
COUNTERTOPS AND CABINETS (MINOR WEAR)

The countertops and cabinets exhibited minor wear. Recommend monitor and repair as needed.

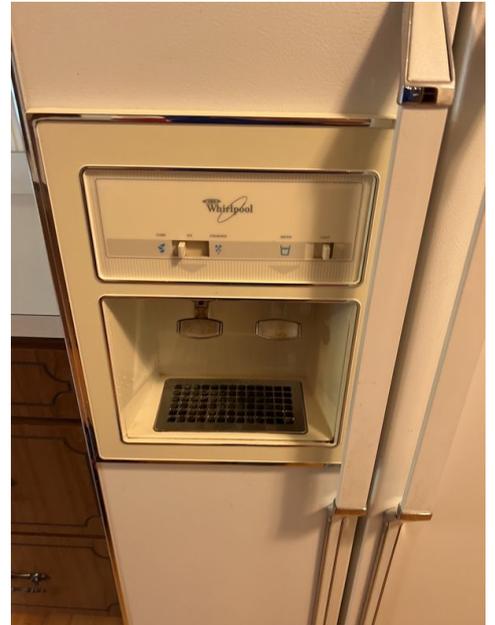
WATER DISPENSER DID NOT OPERATE

Water dispenser did not operate when tested. Recommend evaluation and repairs as needed.

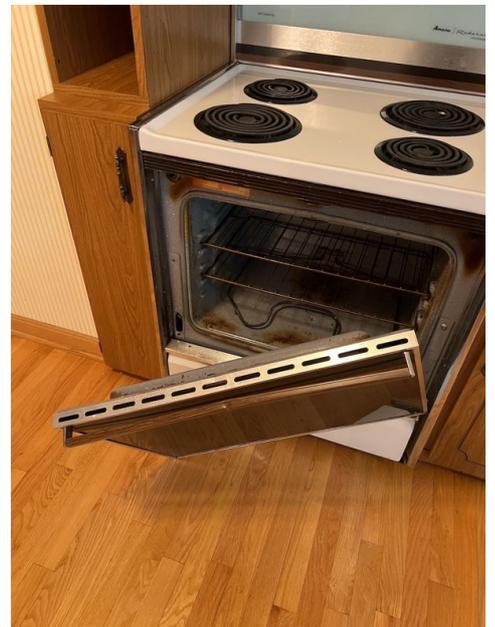
The range door was damaged and will need replaced.

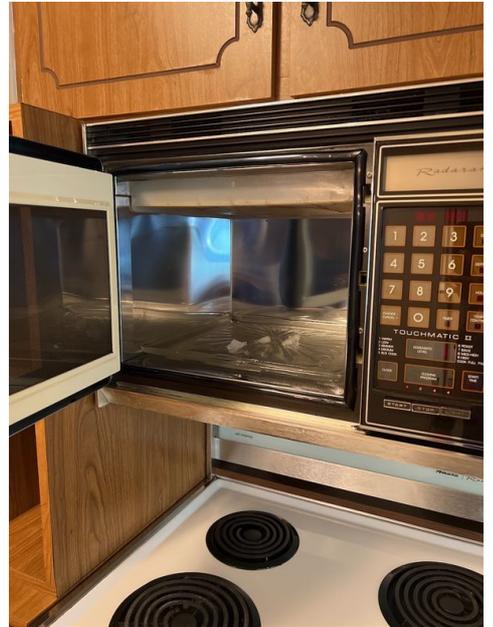
The built-in microwave was inoperable at the time of inspection. The Inspector recommends service by a qualified appliance technician for repair or replacement as necessary.

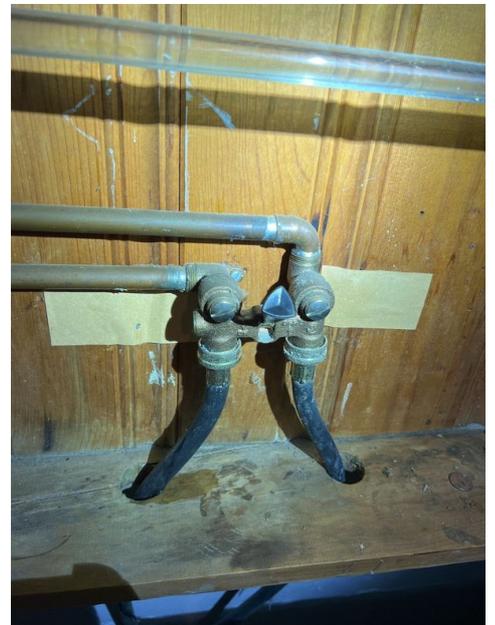
WATER VALVE LEAKING

One of the water valves is leaking. The valve should be repaired or replaced.

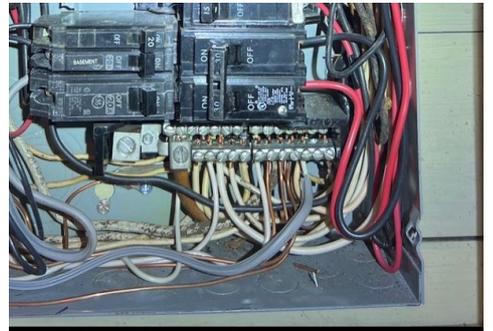
Neutrals and grounds are not isolated. Neutrals and grounds should be isolated in sub panels. If we bond the ground wire to the neutral in the sub-panel, current will flow on both the neutral AND on the ground wire. Which means that if you do not keep the ground wires separate from the neutral wires, you will be allowing return currents to flow on the ground wires back to the main panel. Recommend repairs from a licensed electrician.

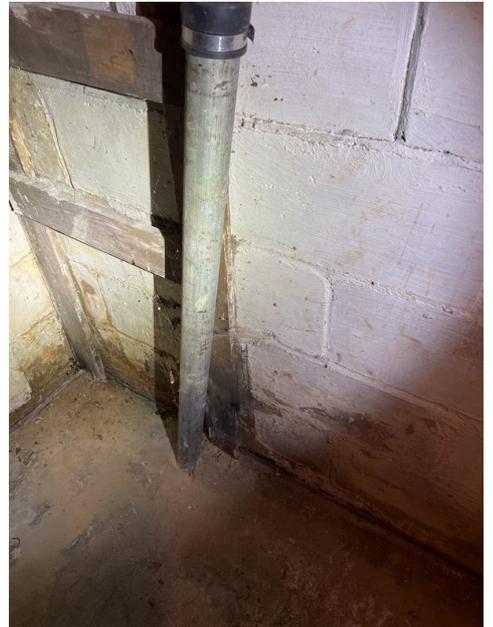
GALVANIZED STEEL

Galvanized pipes are steel pipes that have been dipped in a protective zinc coating to prevent corrosion and rust. Galvanized piping was commonly installed in homes built before 1960. When it was invented, galvanized pipe was an alternative to lead pipe for water supply lines. However decades of exposure to water will cause galvanized pipes to corrode and rust on the inside. No slow drains or low water pressure was noted which would be a common sign of internal corrosion of these pipes. No leaks were observed during the inspection.

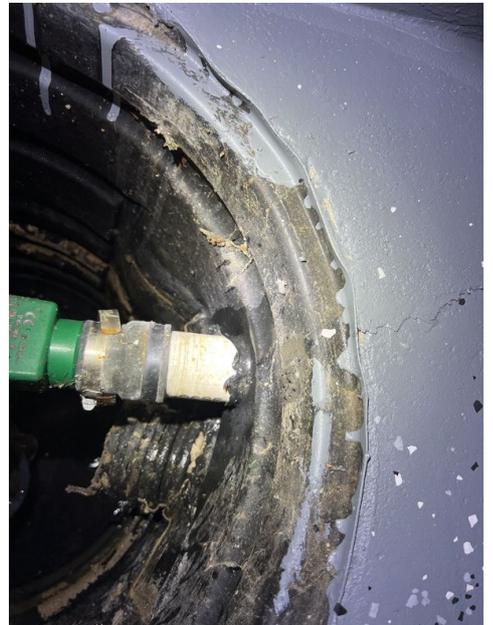
SUMP PUMP LEAKS

Areas of the sump pump were leaking. Recommend repairs by a qualified plumber.

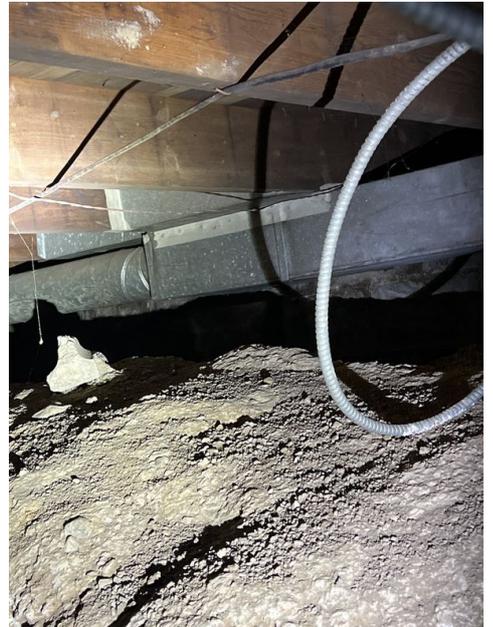
Wrap on ductwork may contain Asbestos, a known carcinogen.

Asbestos fibers may be released into the air by the disturbance of asbestos-containing material during product use, demolition work, building or home maintenance, repair, and remodeling. In general, exposure may occur only when the asbestos-containing material is disturbed or damaged in some way to release particles and fibers into the air. Testing is recommended before disturbing this material.

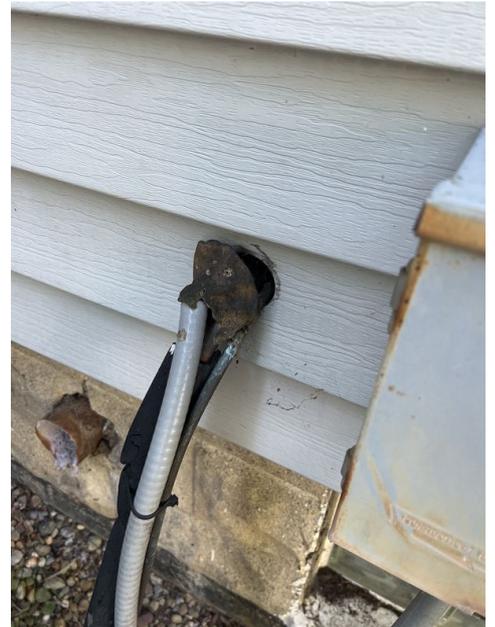
The hole in the exterior wall-covering cut to allow penetration of air-conditioning lines should be sealed with an appropriate sealant to prevent moisture and insect entry.

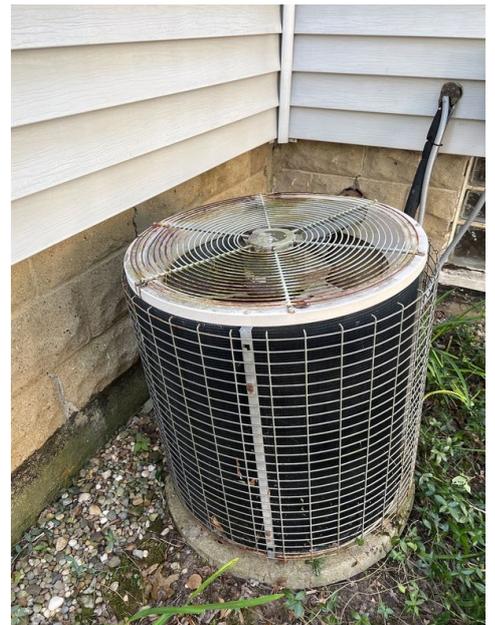
AC (OLD/FUNCTIONAL/PAST DESIGN LIFE)

The air-conditioning system appeared to be old, well past the mid-point of its design life but functional at the time of the inspection. A system at this point in its lifespan might need replacement at any time. Recommend annual maintenance by a licensed HVAC technician.

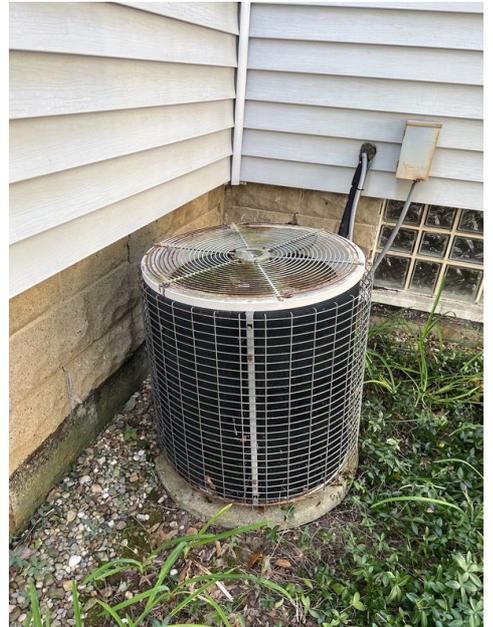
The pad supporting the air-conditioner compressor housing was not level. Over time, this may result in damage to the fan bearings and a shortened fan lifespan, or it may result in movement of the compressor housing which can stress the refrigerant lines resulting in damage and expensive service. The Inspector recommends that the compressor housing be leveled by a qualified HVAC contractor.
