FIRST-IN HOME INSPECTION

GENERAL HOME INSPECTION

104 Paw Paw Lake Dr
Chagrin Falls, OH 44022

Mindy Goodin
SEPTEMBER 1, 2022

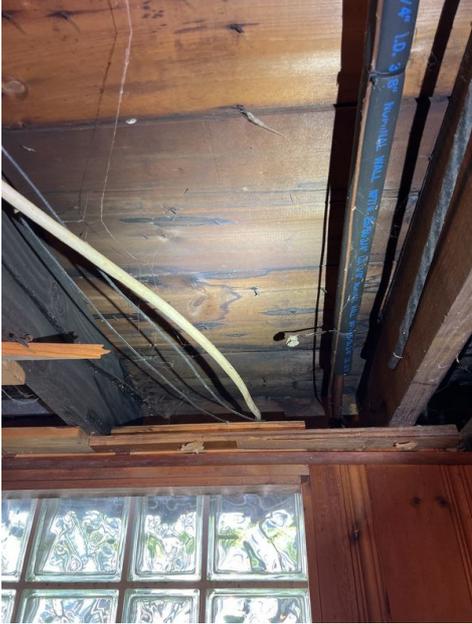
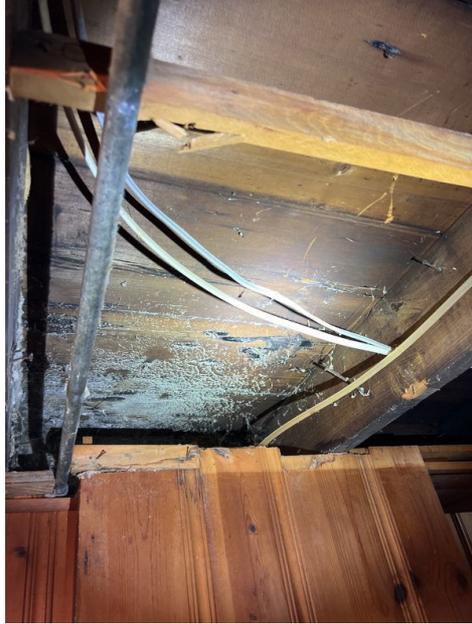
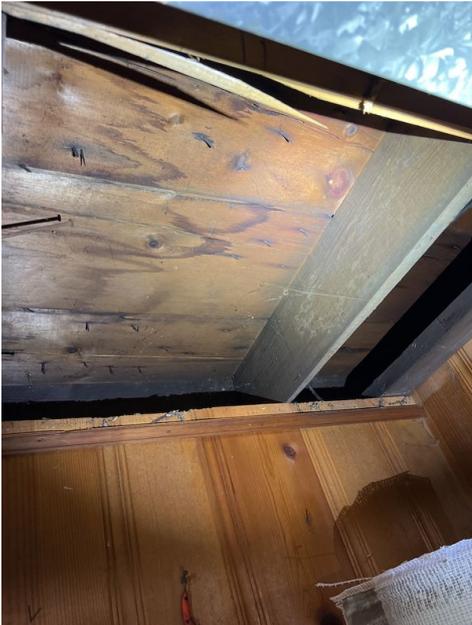
DRY-STAINS

Stains were found in one or more floor areas. However, no elevated levels of moisture were found. Recommend asking the property owner(s) about this, and monitoring the stained area(s) in the future, especially after heavy or prolonged rain. If elevated moisture is found in the future, a qualified contractor should evaluate and repair as necessary.

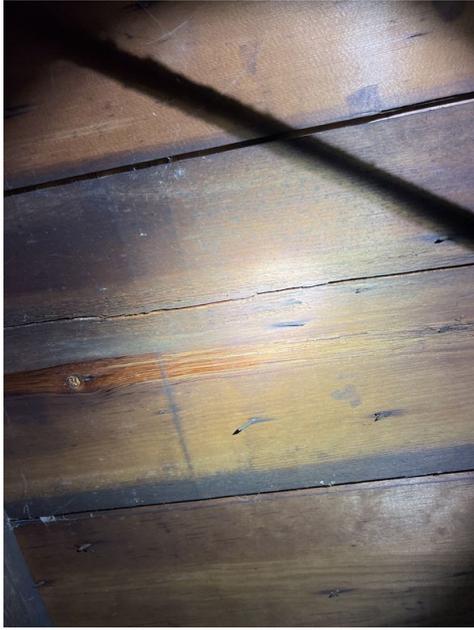
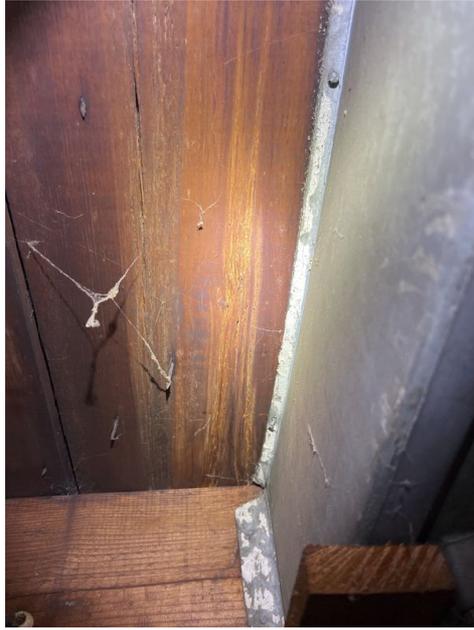
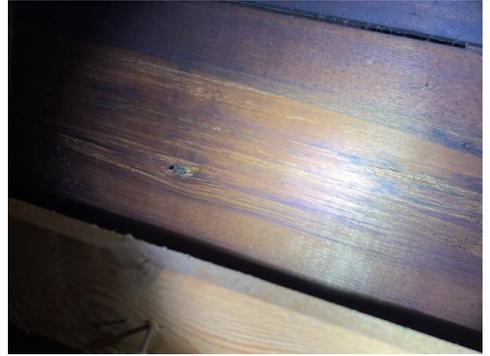
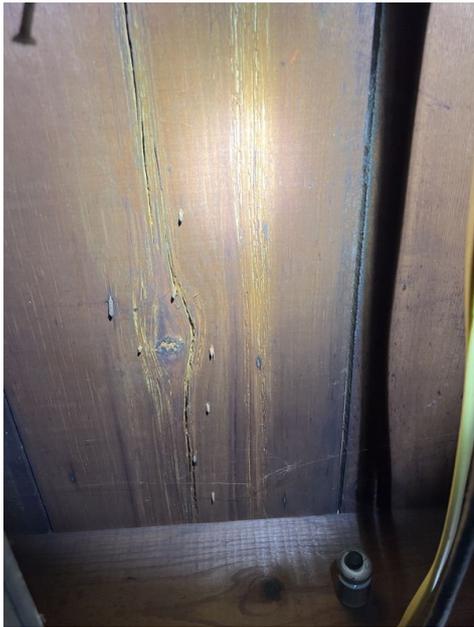
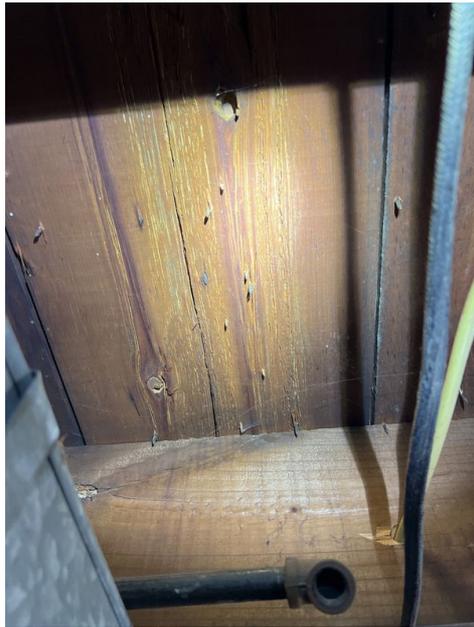
WOOD DESTROYING INSECT DAMAGE

In various locations of the home there are areas that show past wood destroying insect damage. No live activity discovered during inspection. These areas should be evaluated and treated and repaired as necessary.

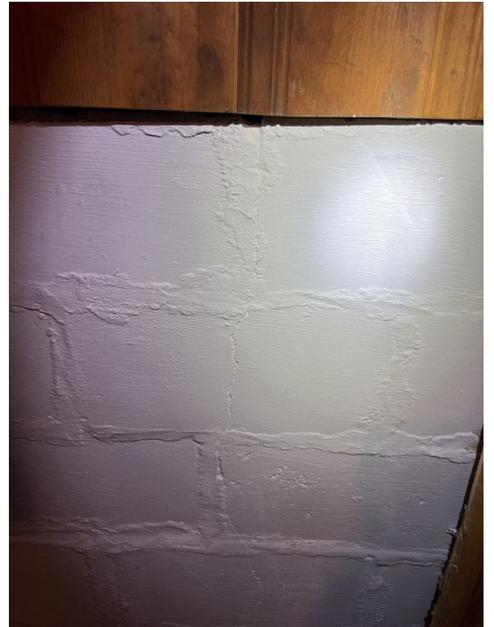
Minor cracking was noted at the foundation. This is common as concrete ages and shrinkage surface cracks are normal. Recommend sealing to prevent water intrusion. Recommend monitoring for more serious shifting/displacement. [Here is an informational article](#) on foundation cracks.

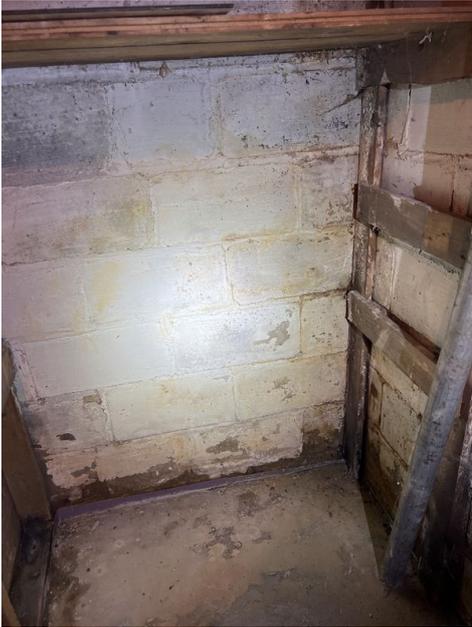
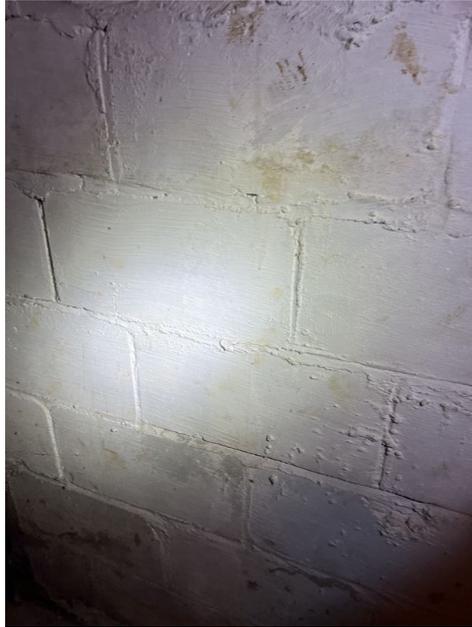
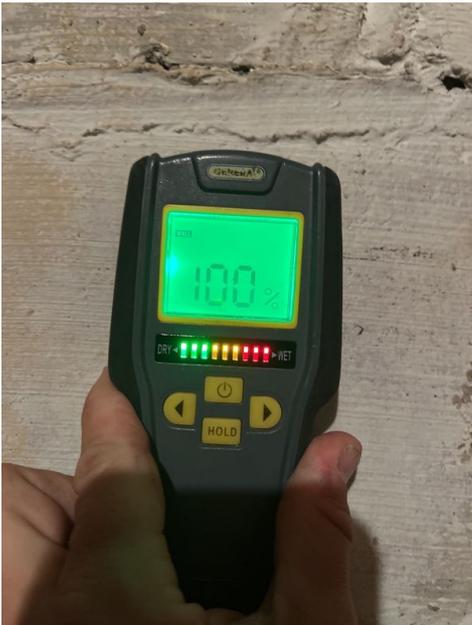
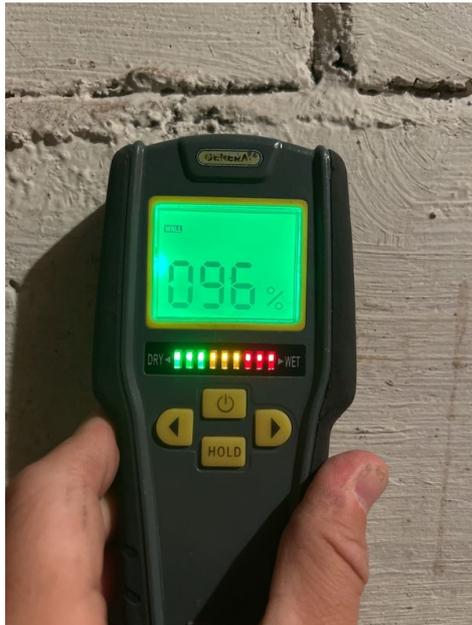
MOISTURE LEVELS/EFFLORESCENCE

Elevated moisture readings at basement walls. Recommend backfill and grade. Recommend painting with dry lock and running a dehumidifier. Reassess after repairs.

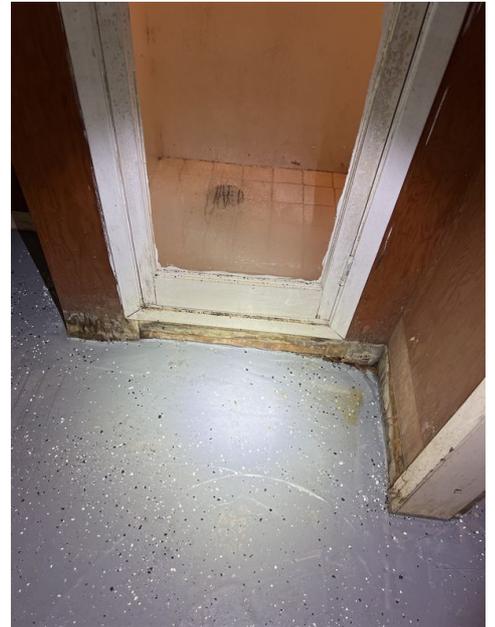
WOOD ROT

Wood rot was present at basement walls. This is an indication that water intrusion has occurred in the past. Recommend monitor and repair as needed.

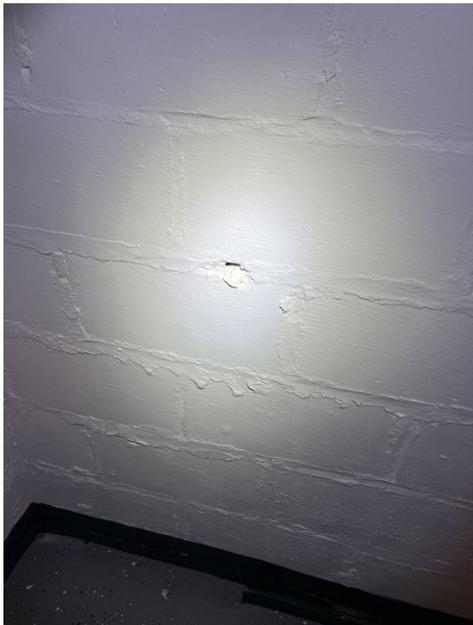
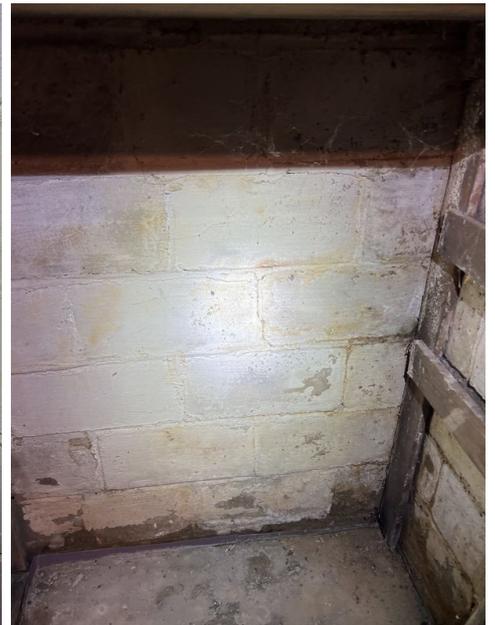
GAPS

Gaps at mortar joints. Recommend tuck pointing to prevent moisture or pest intrusion.

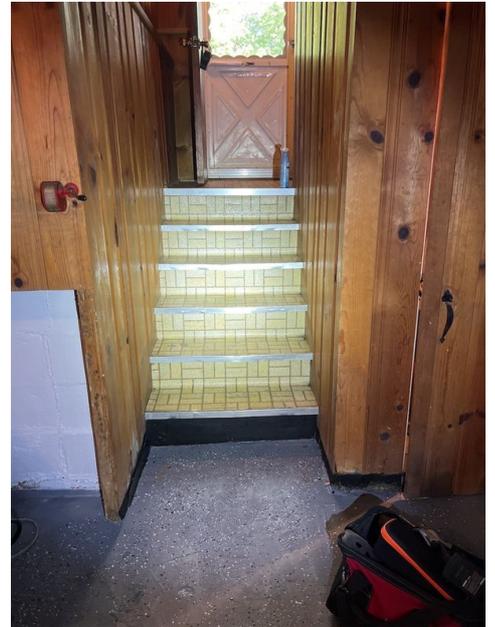
Handrails at one or more flights of stairs were missing. This is a potential fall hazard. Handrails should be installed at stairs with four or more risers or where stairs are greater than 30 inches high. Recommend that a qualified contractor install handrails where missing and per standard building practices.

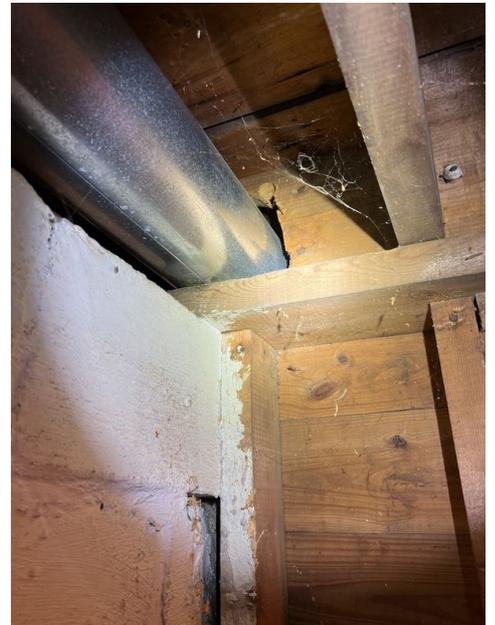
IMPROPER NOTCHING

Improper notching at joists. Recommend monitor and repair as needed.

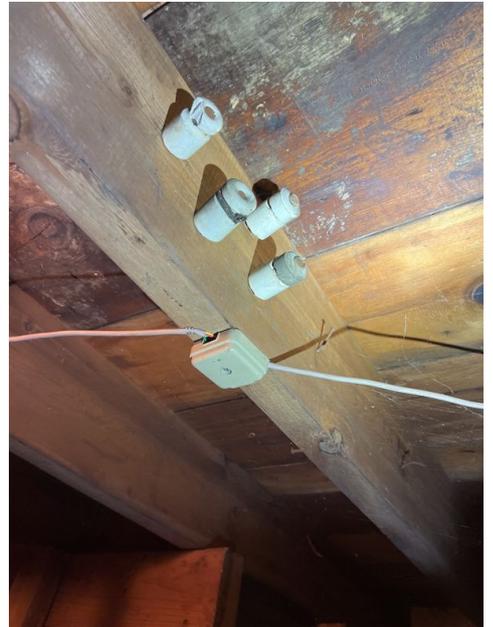
ABANDONED KNOB AND TUBE

Old knob and tube wiring was terminated and abandoned in the basement. There are areas of the electrical system that run behind walls and floors and these sections could not be inspected. Therefore all knob and tube wiring may not have been removed. Knob and tube wiring is not inherently dangerous and is the original wiring in this home.

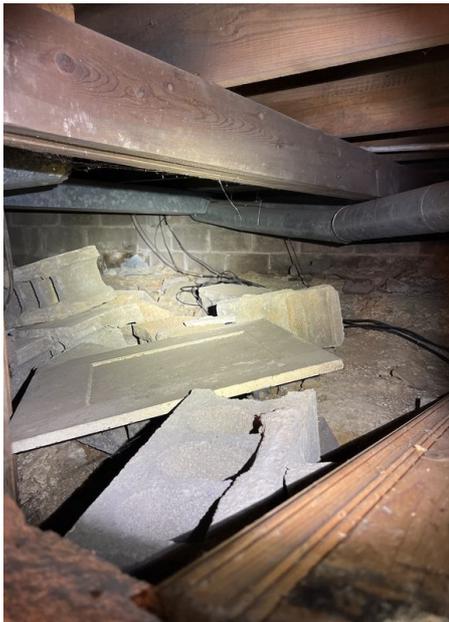
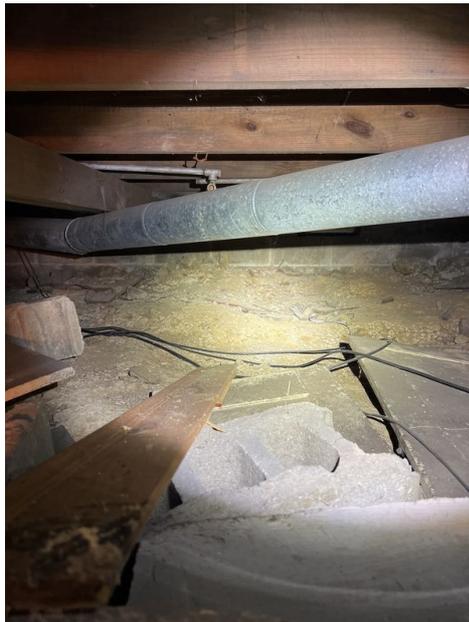
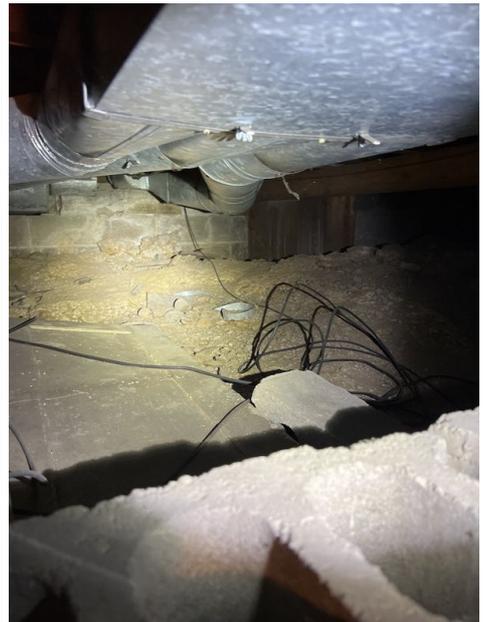
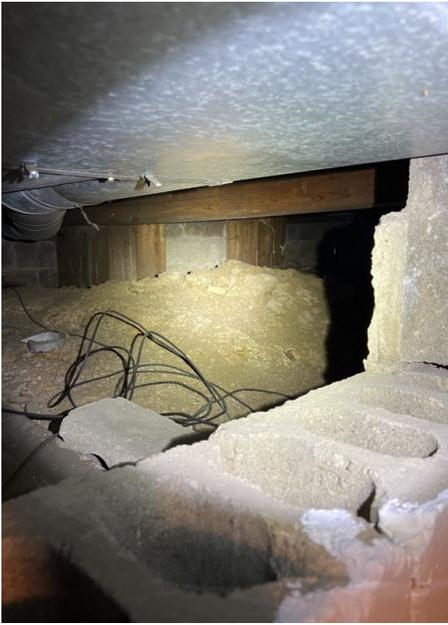
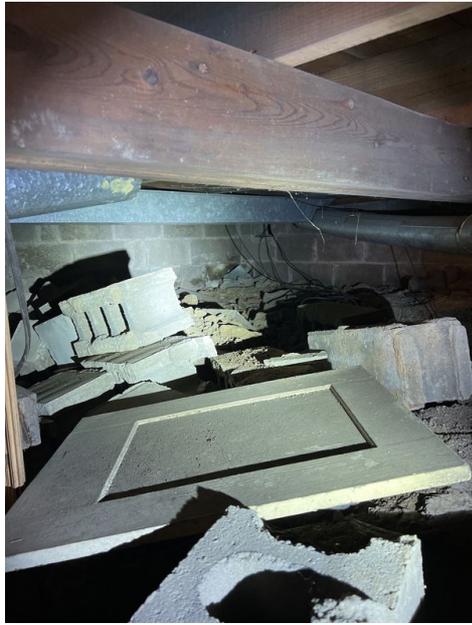
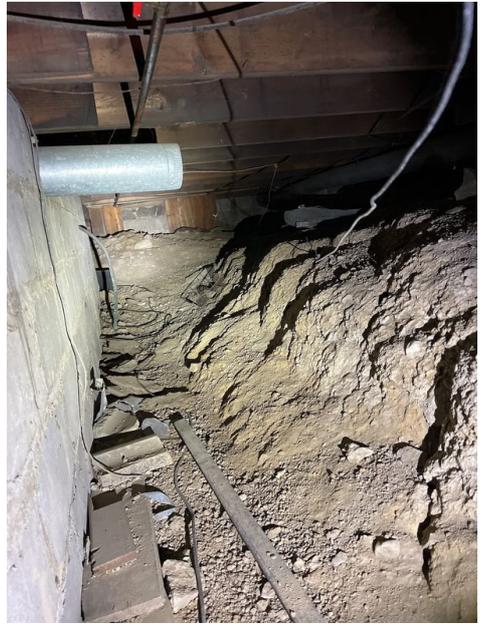
General: Crawlspace Photos

Ventilation-Insulation in Crawlspace: Conditioned Space/No Ventillation

The crawlspace was a conditioned area and does not need vents.

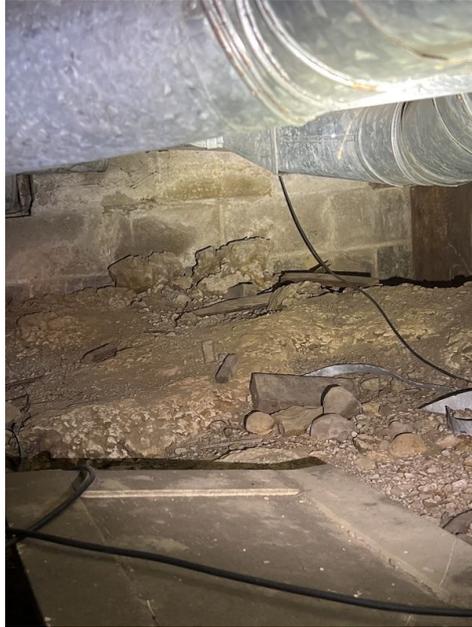
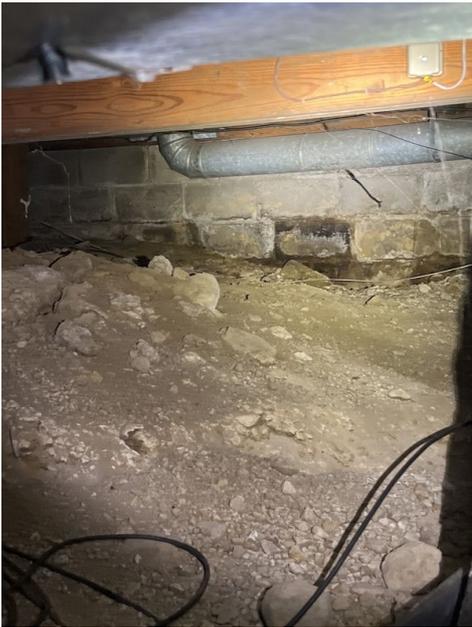
EFFLORESCENCE

Efflorescence noted on the crawlspace surface. This a white, powdery deposit that is consistent with moisture intrusion. This can compromise the soil's ability to support the home structure and/or lead to mold growth. Recommend correction of negative grading and extending downspouts, then reassess.

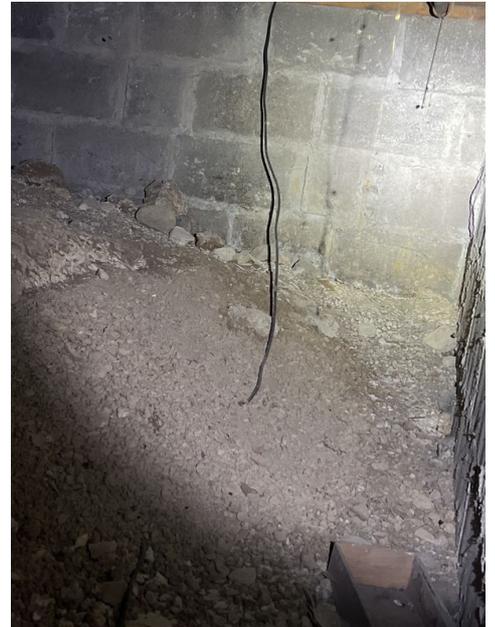
17.3.2 Foundation Walls

Gaps at mortar joints. Recommend tuck pointing to prevent moisture or pest intrusion.
